Preliminary Ignition Investigation Report

Ignition Database Index:	450
Electric Incident Investigation (EII) Number:	N/A
HAWC Incident Name:	N/A
PG&E Facilities Ignition?	Y
CPUC Reportable Ignition?	Y
Date & Time of Incident:	April 18, 2022, at approximately 1809 hours
Street Address:	Near State Hwy 49, 1.80 miles east of Forest Route 93
City:	Sierra City
County:	Sierra
Latitude/Longitude:	39.566503, -120.709942
PG&E Division:	Sierra
High Fire Threat District (HFTD):	Tier 2
Fire Index Area:	350
Fire Potential Index (FPI) Rating:	R1
Was there a PSPS event at the time of ignition?	No
Failure Driver:	Utility work/Operation
Failure Sub-driver:	Improper Construction
Circuit:	Alleghany 1101
Circuit Protection Zone:	Alleghany 1101-LR804
Nominal Voltage:	12kV
PG&E Equipment associated with ignition:	Connector
EPSS enabled at time of ignition?	N
Fault Type:	None
Wire Down (Primary)?	N
MAVF Score	537.9695
Lead Agency/Agency Having Jurisdiction:	Sierra City Fire Department

Executive Summary

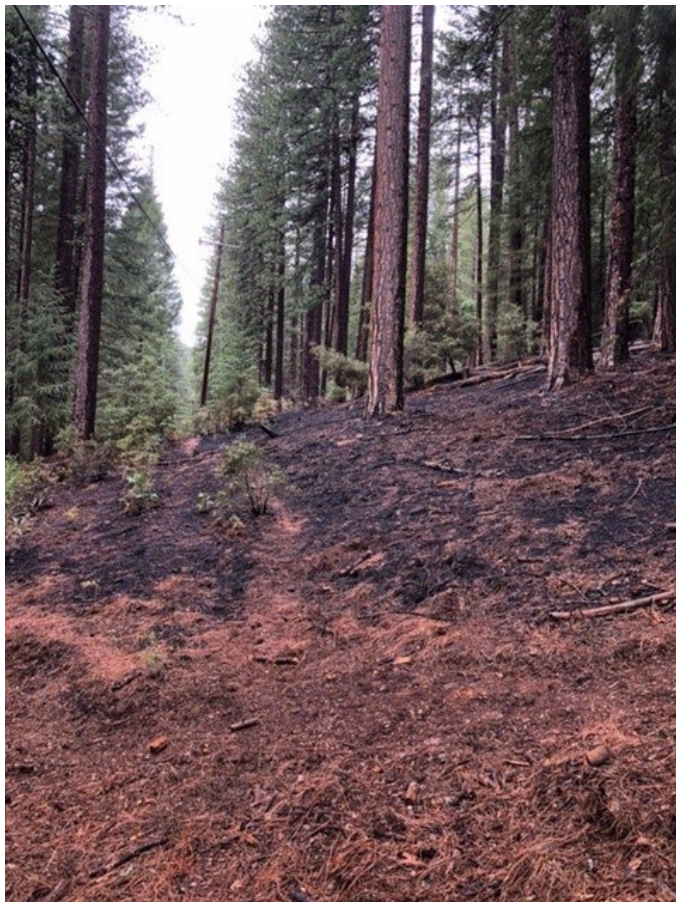
Figure 3 Burn scar near SAP Pole ID 1001118181. Photo taken by troubleman on April 18, 2022.

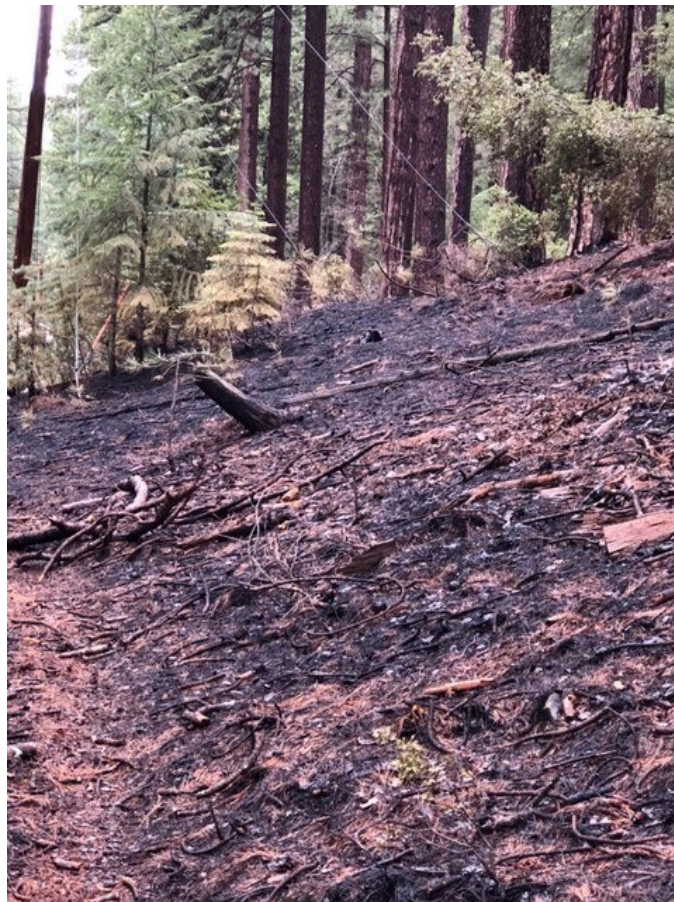
Figure 4 Burn scar near SAP Pole ID 1001118181. Photo taken by troubleman on April 18, 2022.

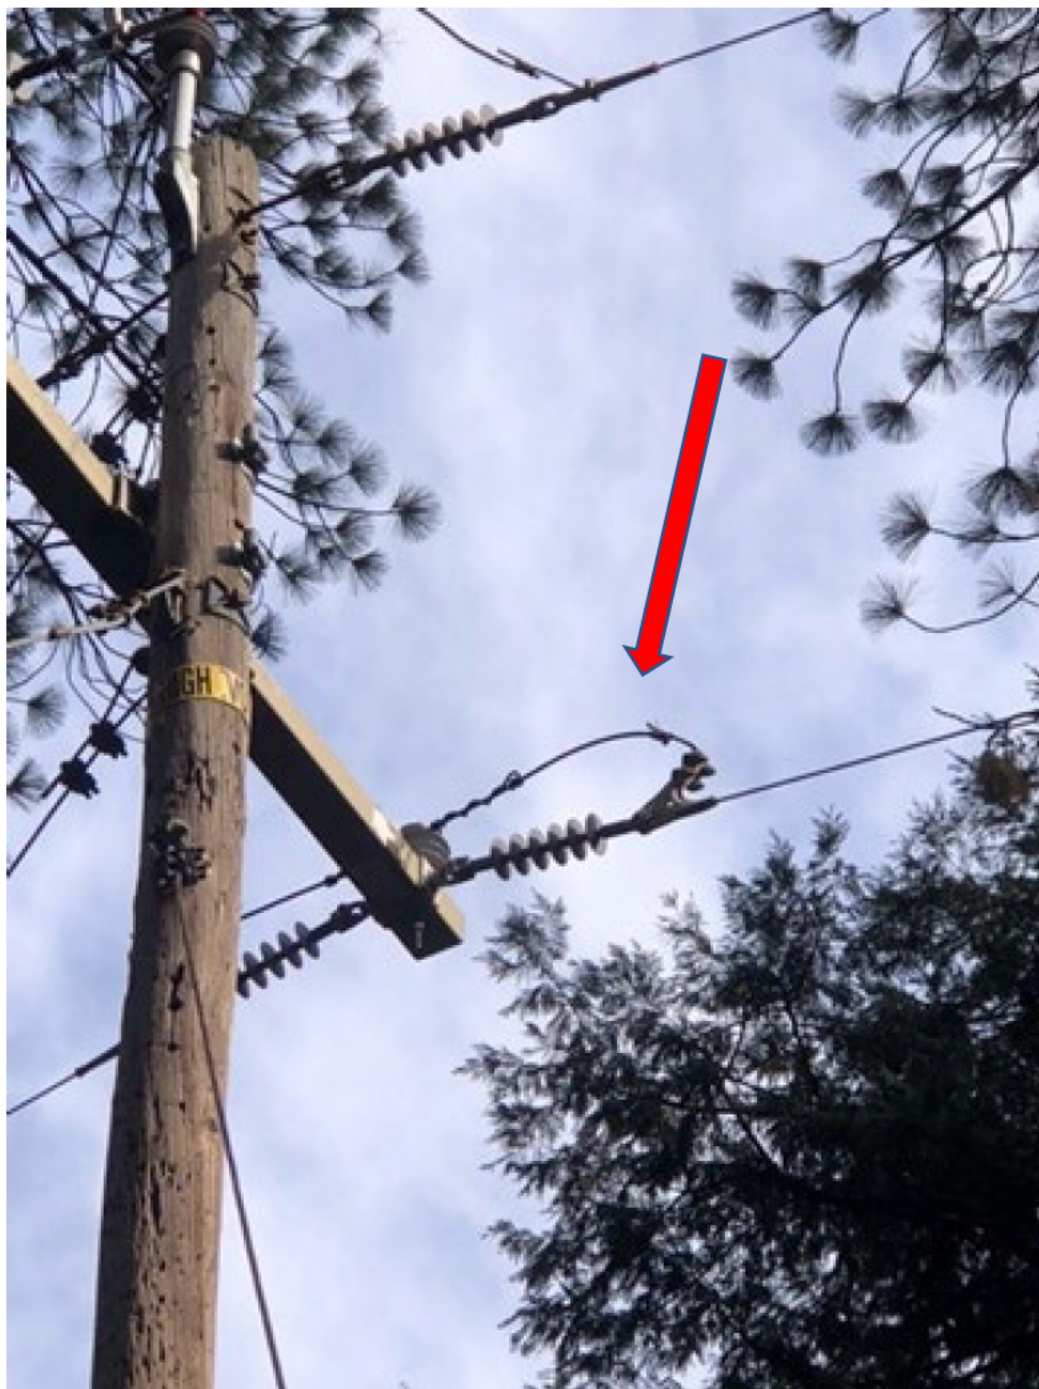
Figure 5 SAP Pole # 100111818, photo taken by troubleman on April 18, 2022, the arrow pointing at the location where the bad connector was located before failing.

On April 18, 2022, the responding troubleman created EC Tag #123360159 for a bad connector on the highway side of SAP Pole ID 100111818, seven poles source side of C535. On April 19, 2022, a PG&E repair crew replaced six connectors, two jumpers and installed 'High' signs.

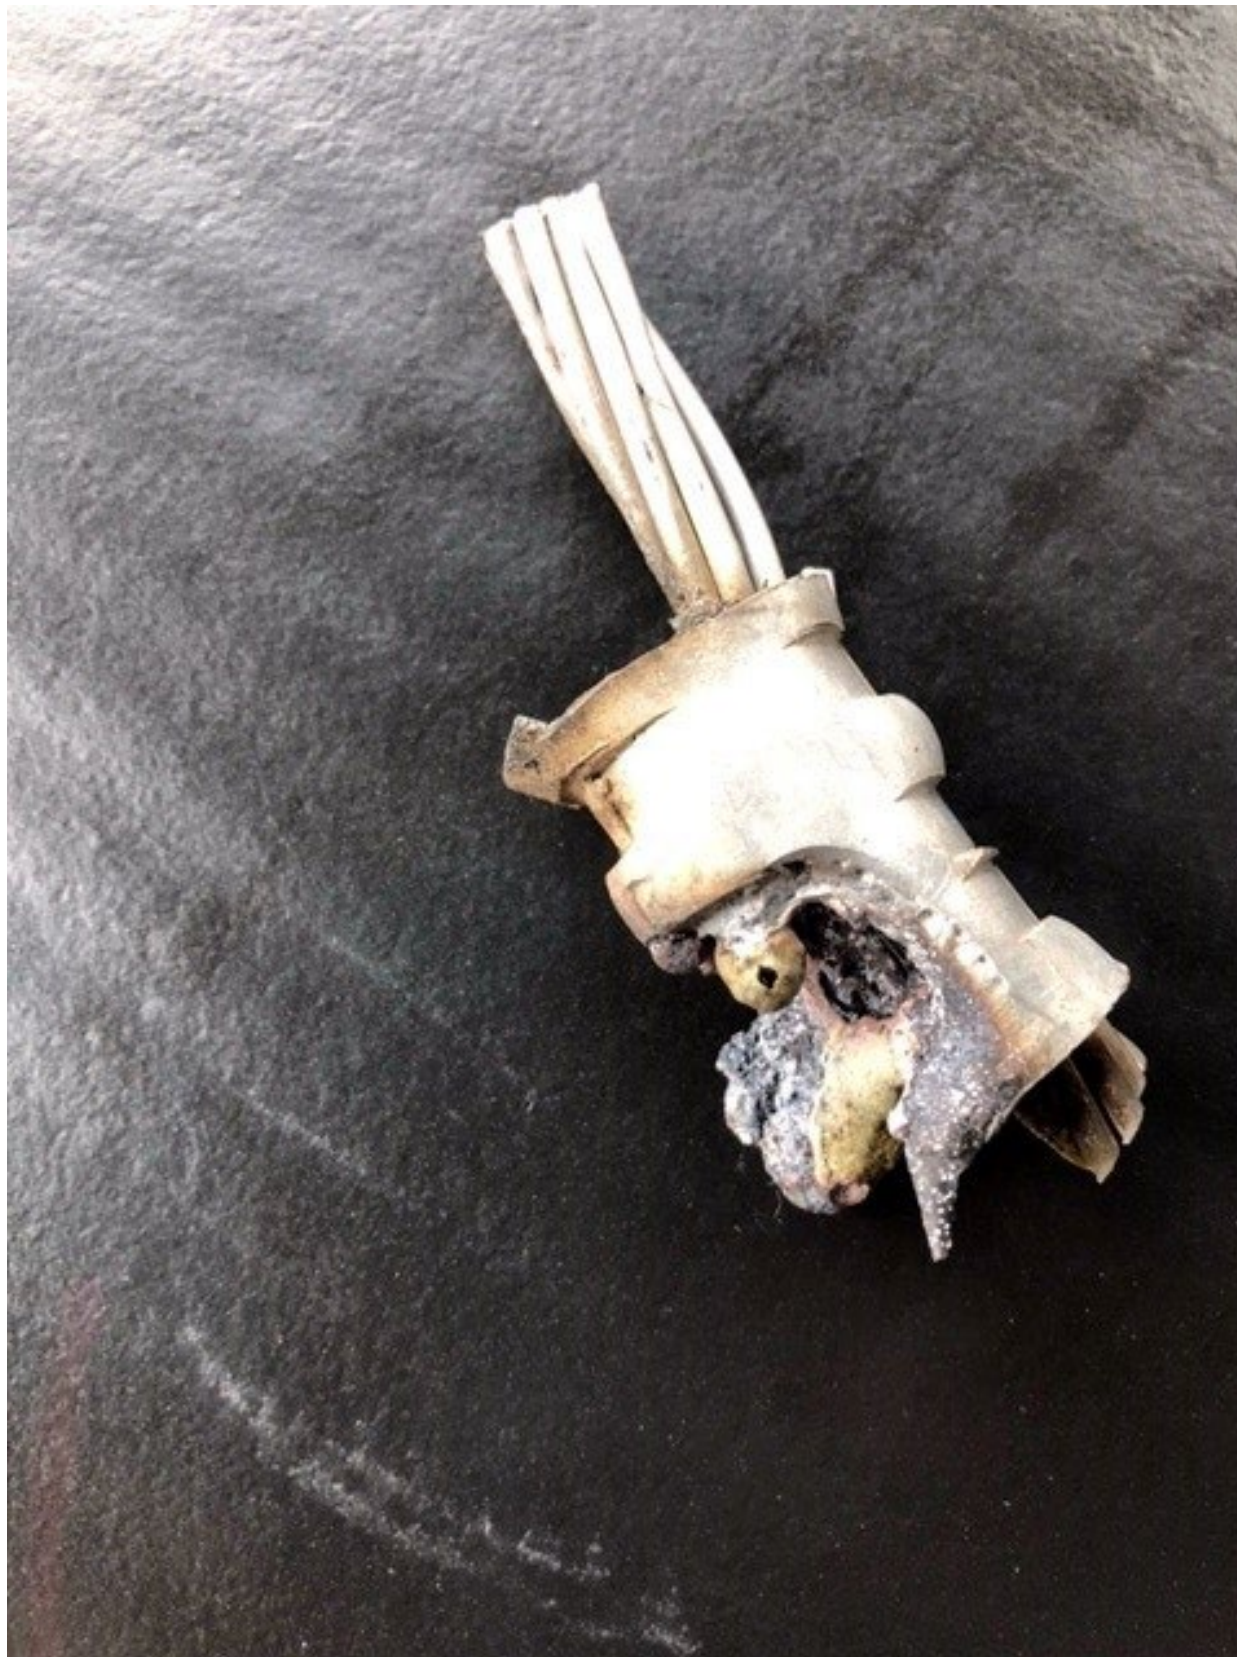
A PG&E Standards & Work Methods specialist was able to analyze photos from the site and noted the compression connection that failed (commonly called an 'H' block) did not have the required number of crimps, which is four crimps. The failed compression connection only had three crimps (See Figure 8). Additionally, it was noted that a 'no-oxide' (corrosion inhibitor) was applied and may have corroded internally due to signs of heat damage observed, as indicated in [TD-2907P-01](#) "Installing Overhead Conductor Splices".

Figure 6 Photo of faulty/bad connector taken on April 18, 2022, by the responding troubleman.

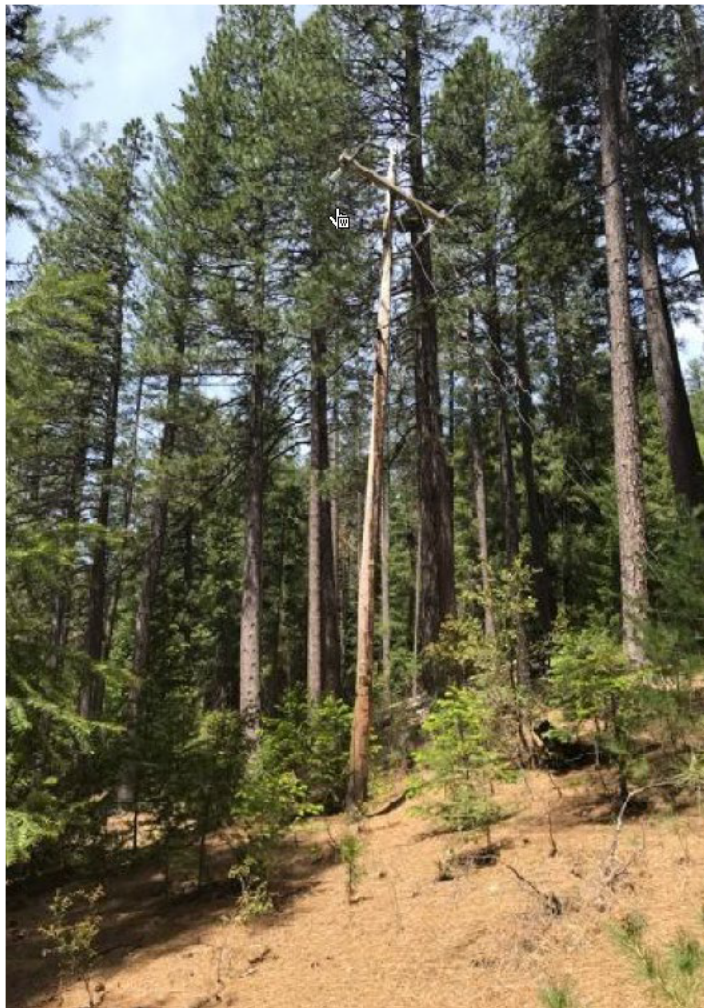
A Wildfire Safety Inspection Program (WSIP) inspection took place on May 14, 2019, noting a reduced/deformed circumference due to animal activity (bear or mountain lion) of Pole #1. There was no tag created for the reduced circumference. However, it was noted that the guy/anchor assembly was loose. EC Tag #117235246 was created on May 14, 2019, with a due date of May 14, 2024, for the guy/anchor assembly. The tag was completed on March 7, 2020, for loose guy wires in which they were re-pulled down.

Figure 7 SAP Pole ID 100111818 taken on May 14, 2019, by WSIP inspector.

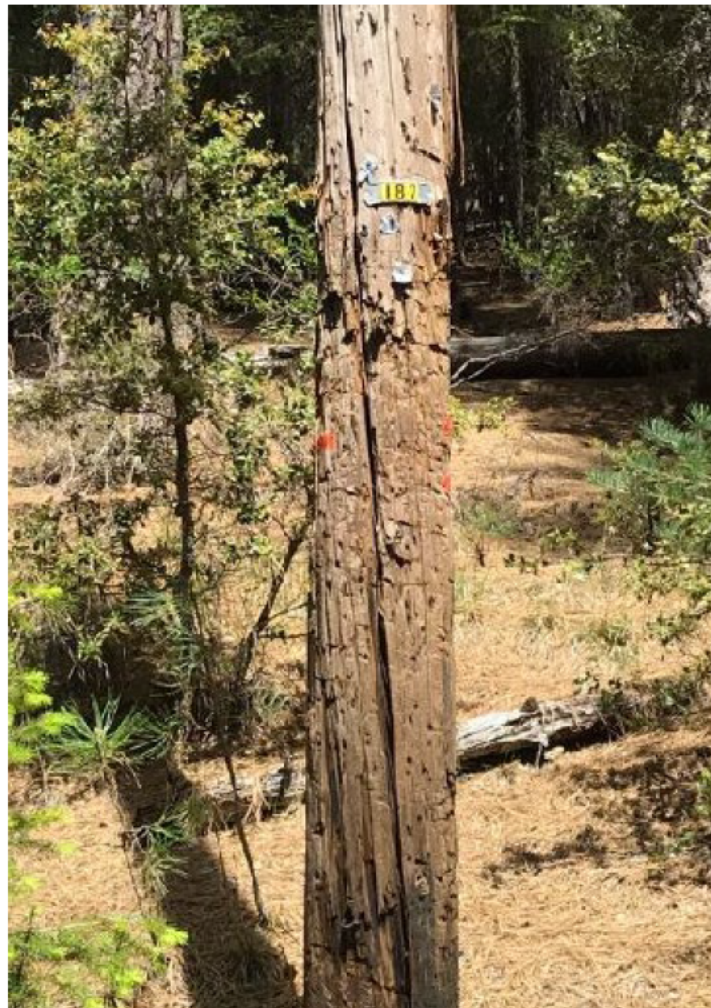
Figure 8 SAP Pole ID 100111818 (showing animal damage) taken on May 14, 2019, by WSIP inspector.

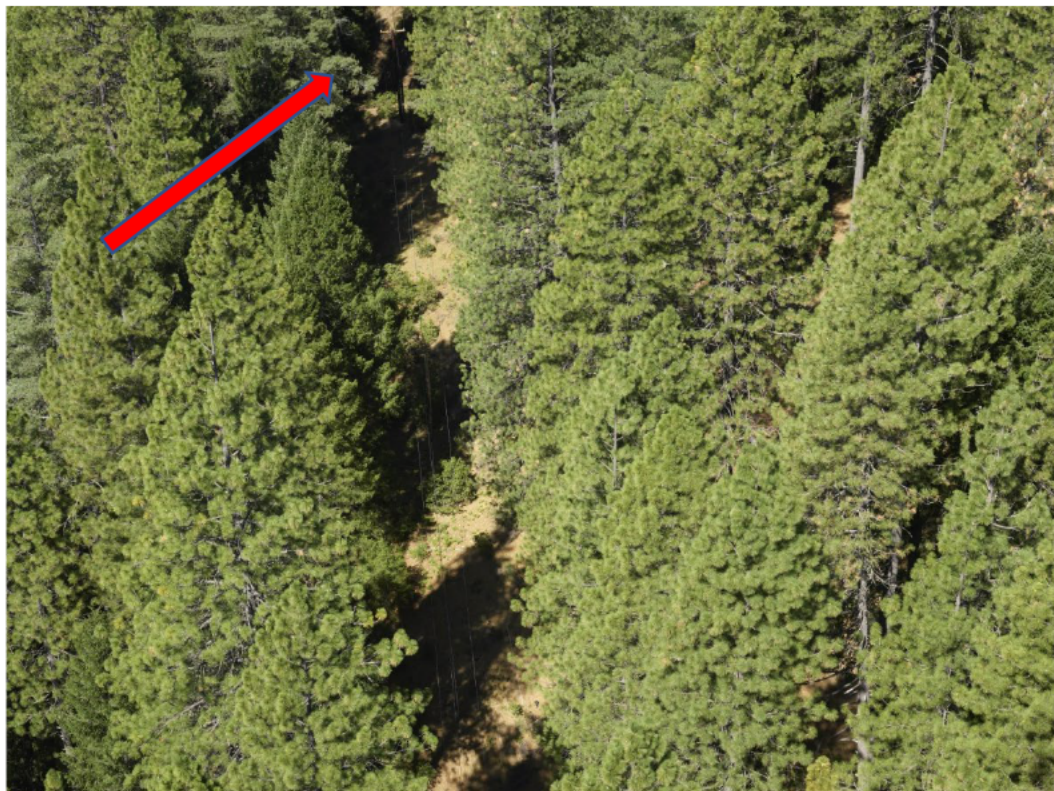
Figure 9 Photo from Sharper Shape aerial inspection of Pole SAP ID 100111818 that took place on August 11, 2019.

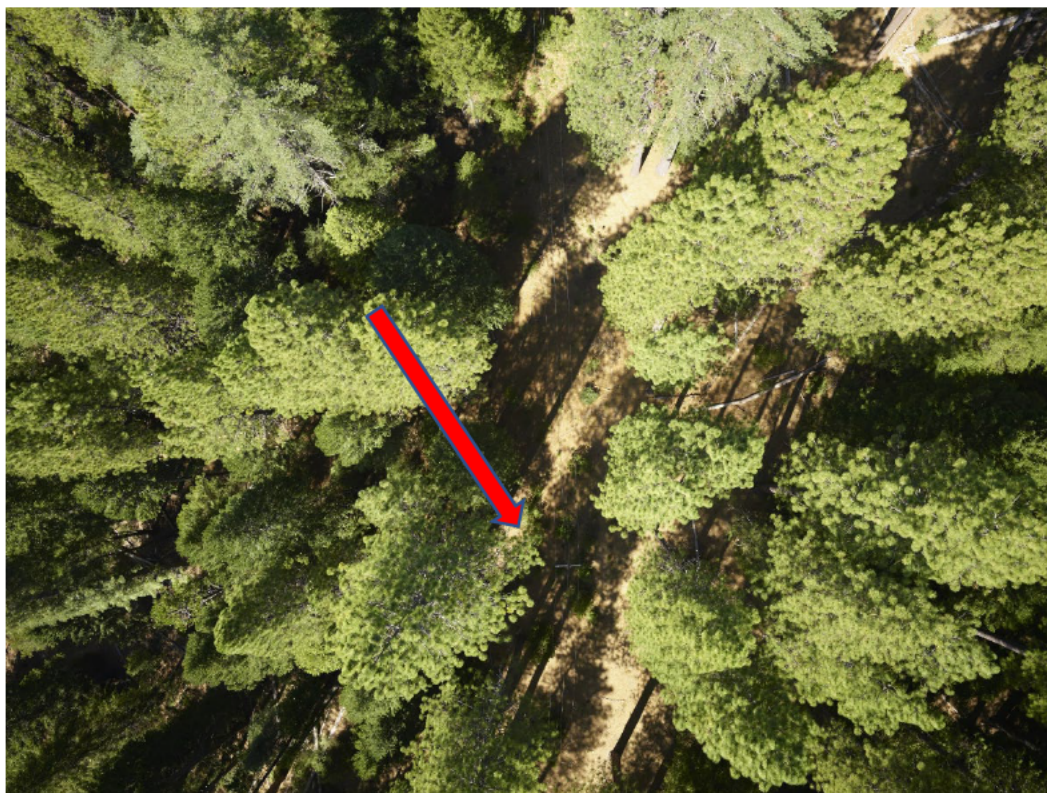
Figure 10 Photo from Sharper Shape aerial inspection of Pole SAP ID 100111818 that took place on August 11, 2019.

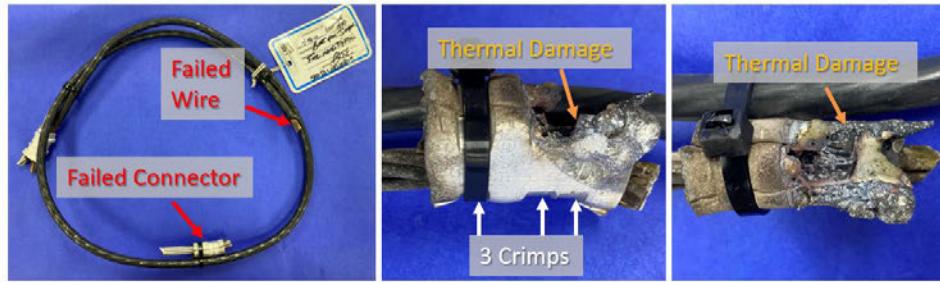
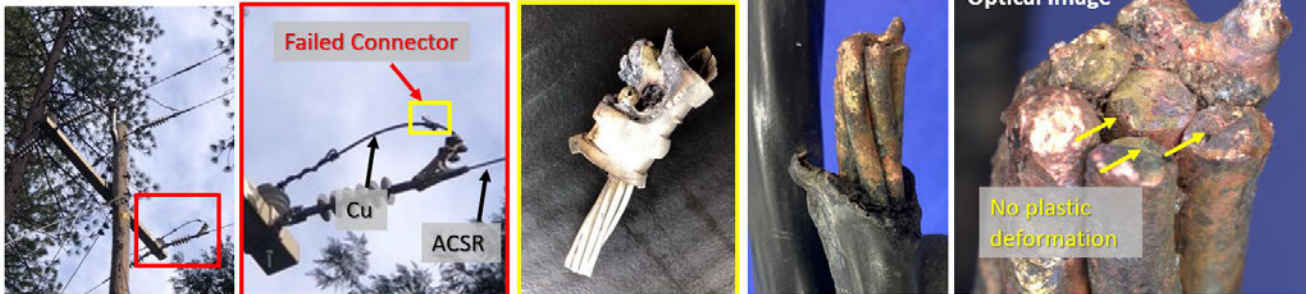
Applied Technology Services (ATS) was able to analyze the failed connector. Visual observations combined with optical microscopy shows little to no deformation on the fracture surface of the copper strands. The jumper failure within the compression connector appears to be at least partially attributed to a fatigue fracture combined with improper installation. The connector had one less crimp than required per Standard [041010](#)-page 6 note 2 for the Homac OB-101 connectors. The permanent fault from the earlier vegetation contact in combination of the broken strands and workmanship, could have contributed to the localized arcing and thermal damage within the joint (See Figure 13).

Figure 11 Visuals from analysis performed by ATS on the failed compression connector.

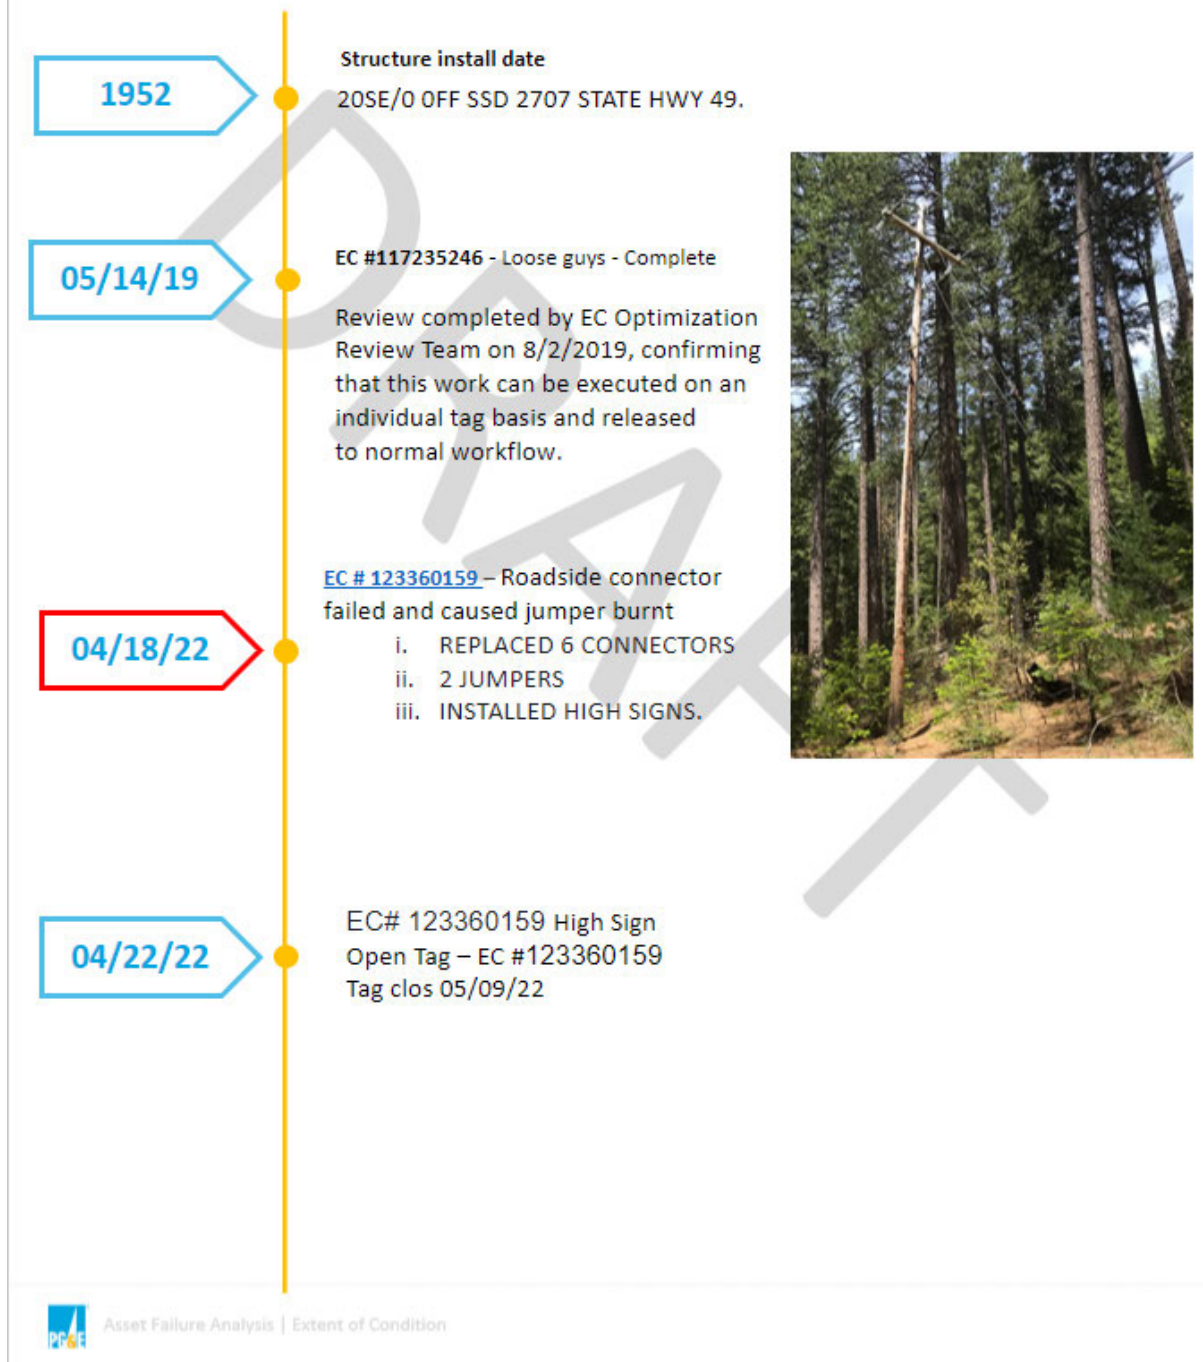
Asset Failure Analysis (AFA) performed an analysis of the event, concluding the connector failed due to various voltage conditions on the Alleghany 1101 circuit by fatiguing it with higher-than-normal and more frequent-than-normal power fluctuations. Prior to this incident, there were four unplanned, emergency outages on this circuit in the year 2022 alone as well as one planned for system hardening work. Following the incident on April 18, 2022, two more outages, one planned and one emergency outage happened within ten days. Additional analysis placed this circuit in a Tier 2 and Tier

Figure 12 AFA Timeline of Relevant Events pertaining to the incident.

- SCAR analysis/inspection of the Alleghany 1101 12kV circuit outcome pending as of the publish date of this report.

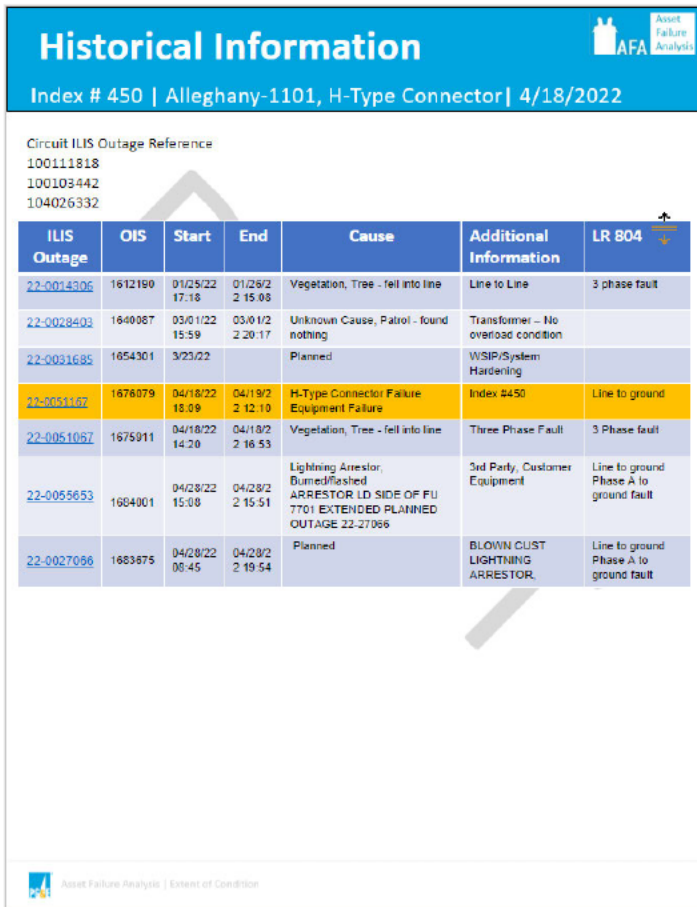
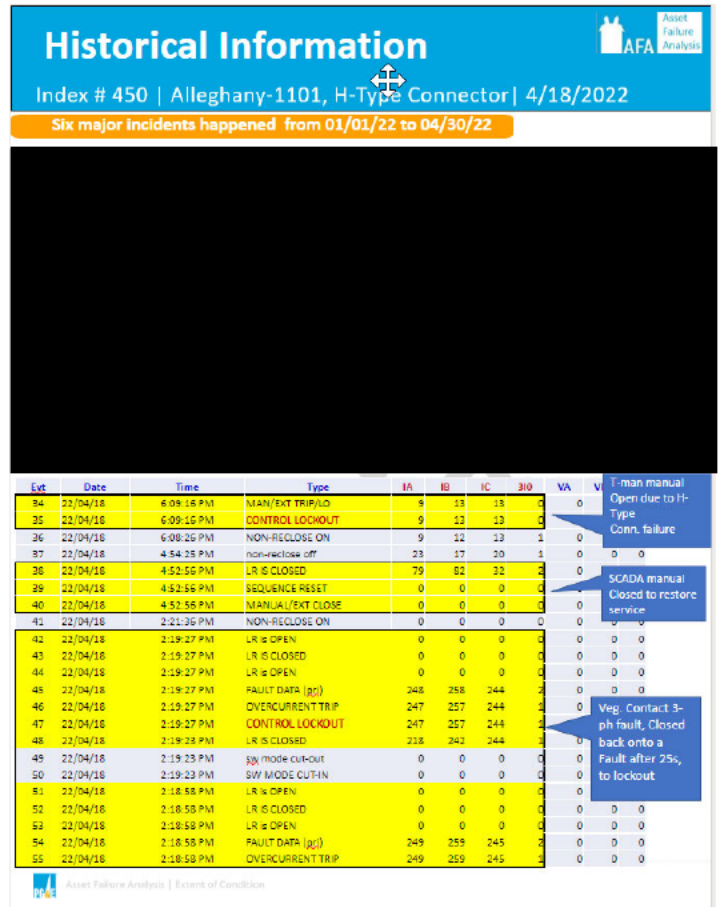
3 high fire threat district (HFTD), prompting AFA to recommend a Safety Condition Assessment Review (SCAR) of the area. AFA also created a timeline of relevant events (See Figure 14) as well as a historical information (See Figure 15) for the Alleghany circuit, demonstrating the voltage conditions prior to the incident as well as after. The SCAR analysis is still pending as of the publish date of this report.

Figure 13 AFA Historical Information pertaining to the incident.
