**Event
Analysis
Report**

Murphys – Property Damage

EIR No.: EI200909A

Date of Event: September 09, 2020

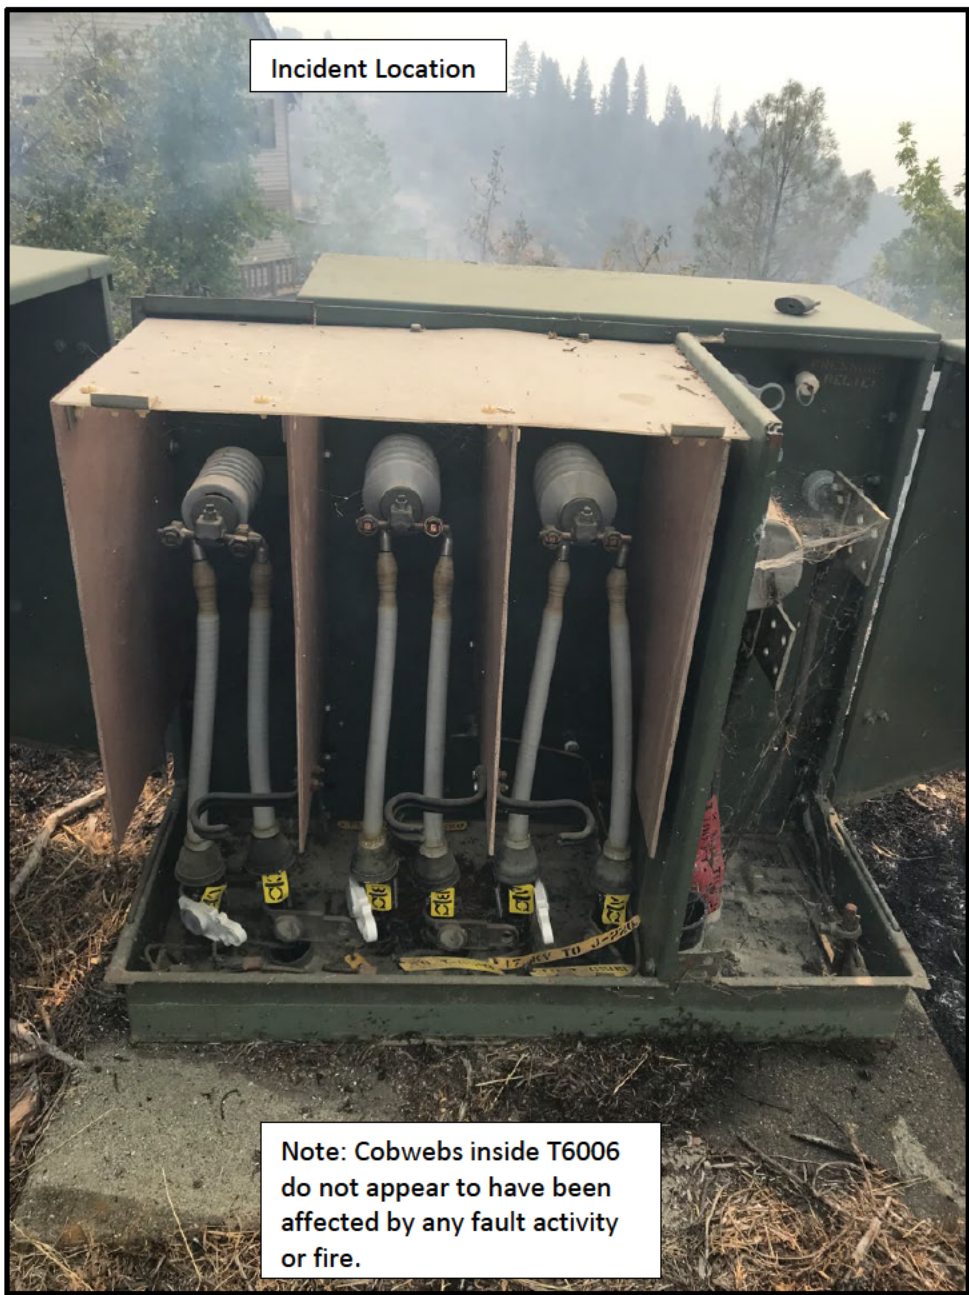
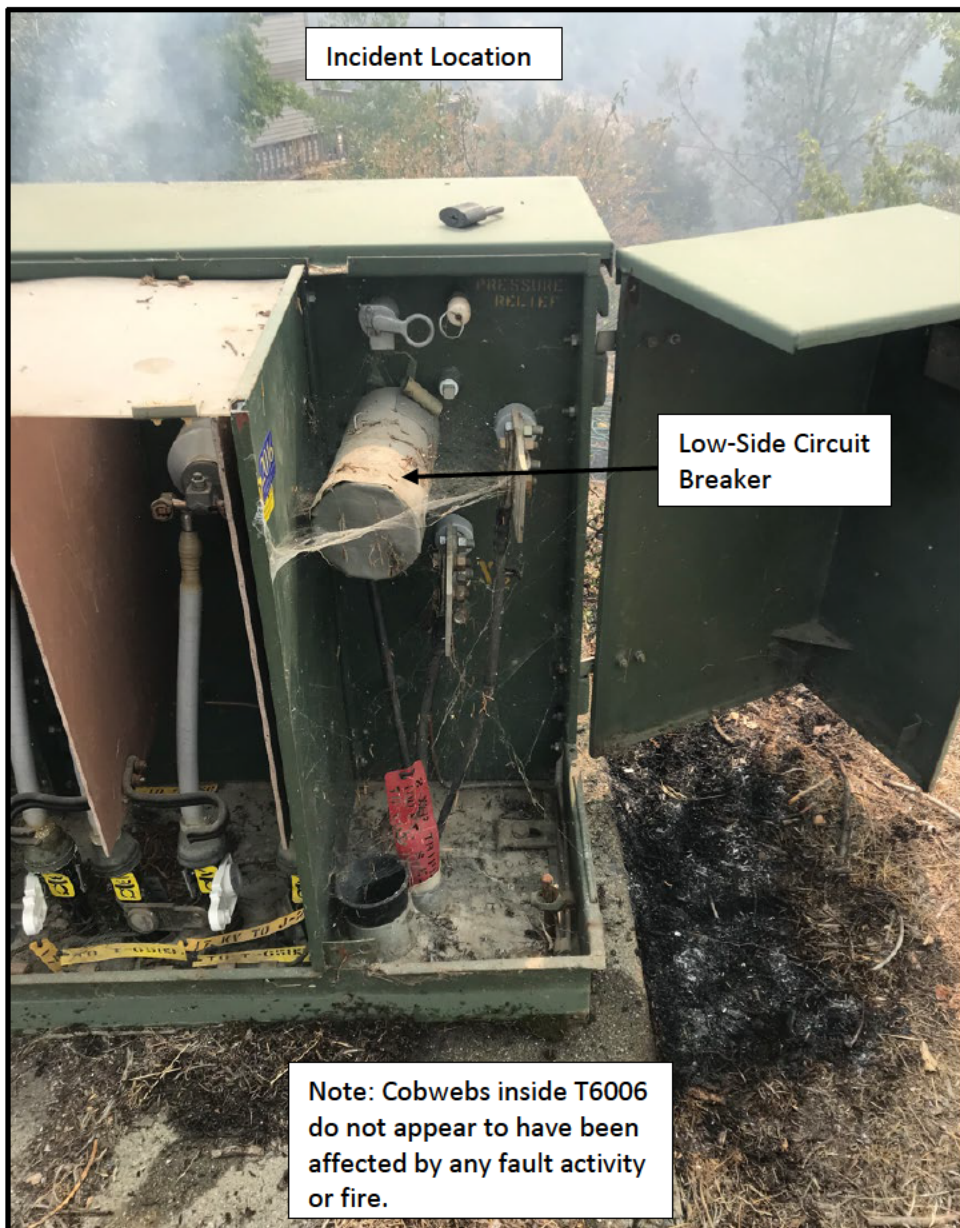
Additionally, T6006 remained in service after the incident without any required repairs (subsequently replaced as a result of the planned reliability project by 2021), which is also evidence that suggests the specific transformer was operating without any known equipment

issues. Moreover, no visible damage is seen in the post-incident troubleshooter images of T6006 below (Figures 4-5).

Figure 4: 09/09/20 PG&E troubleshooter image obtained post-incident of Transformer T6006

Figure 5: 09/09/20 PG&E troubleshooter image obtained post-incident of Transformer T6006

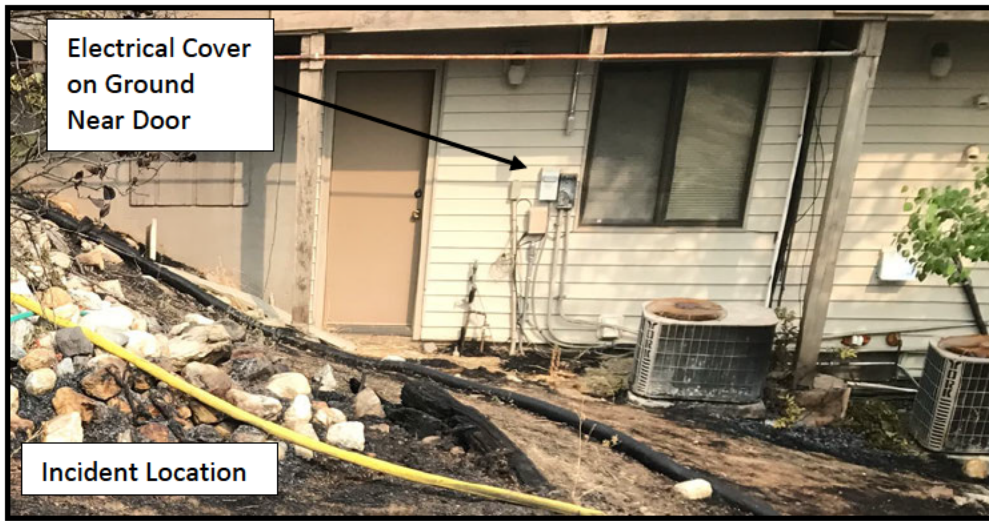
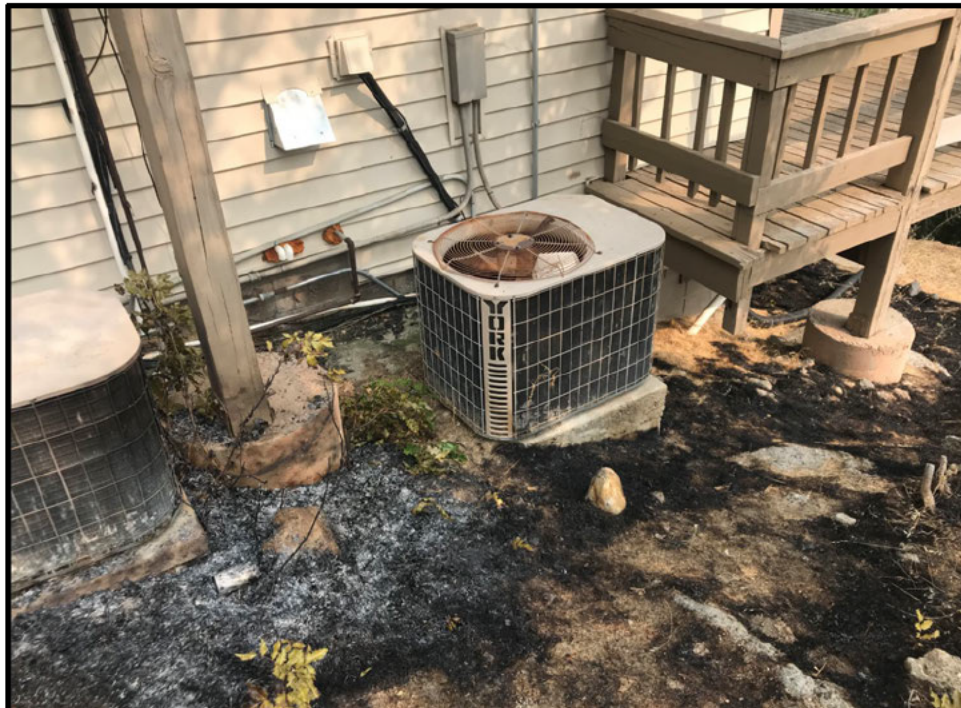
- Customer AC condenser issue resulting in AC circuit breaker to allegedly trip per fire department report (See Figures 6-7).
- AC unit manufacturing issue.

Figure 6: 09/09/22 PG&E troubleshooter image obtained post-incident of AC units at Incident Location

Figure 7: 09/09/22 PG&E troubleshooter image obtained post-incident of AC units at Incident Location

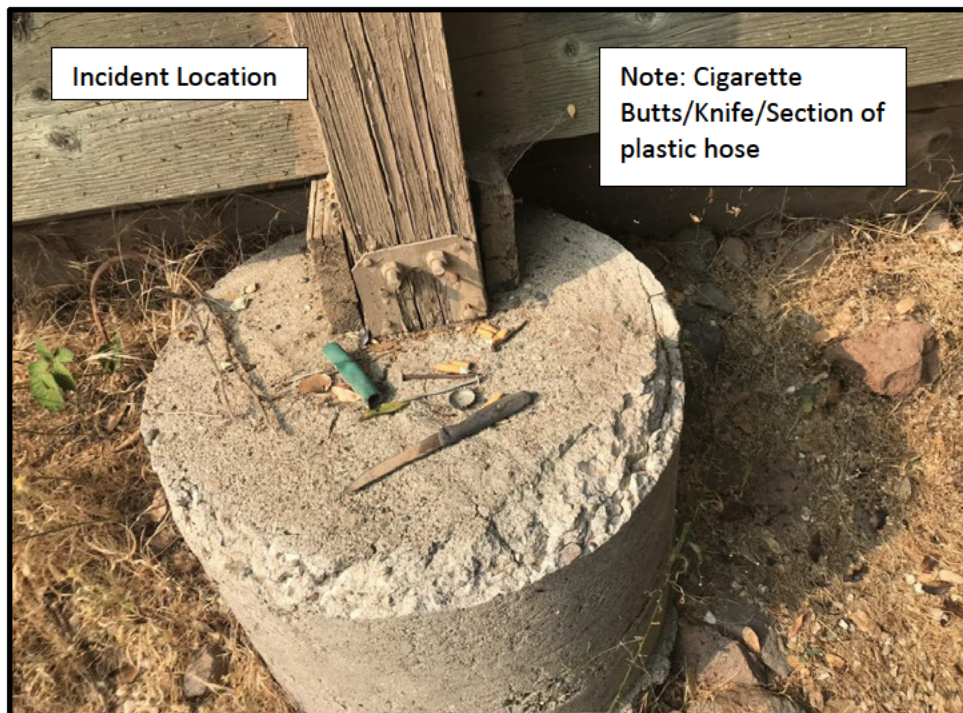
- If the AC unit feeder breaker opened (as was stated in the fire department report), it is indicative of a downstream fault affecting that particular customer circuit, outside of PG&E's control.
- Customer generator malfunction³⁵
 - A responding troubleshooter observed a portable generator in use but is not able to attest as to how it was connected electrically (i.e., in parallel) to the customer-side of the circuit (See Section 6.7 – Fire Department Report Analysis).
 - Unknown if a transfer switch was installed, and/or if there was a malfunction.
- Unknown if any electrical tampering occurred or arson related (Figures 8-9).

Figure 8: 09/09/22 PG&E troubleshooter image obtained post-incident of a knife, a hose section and burnt cigarette butts.

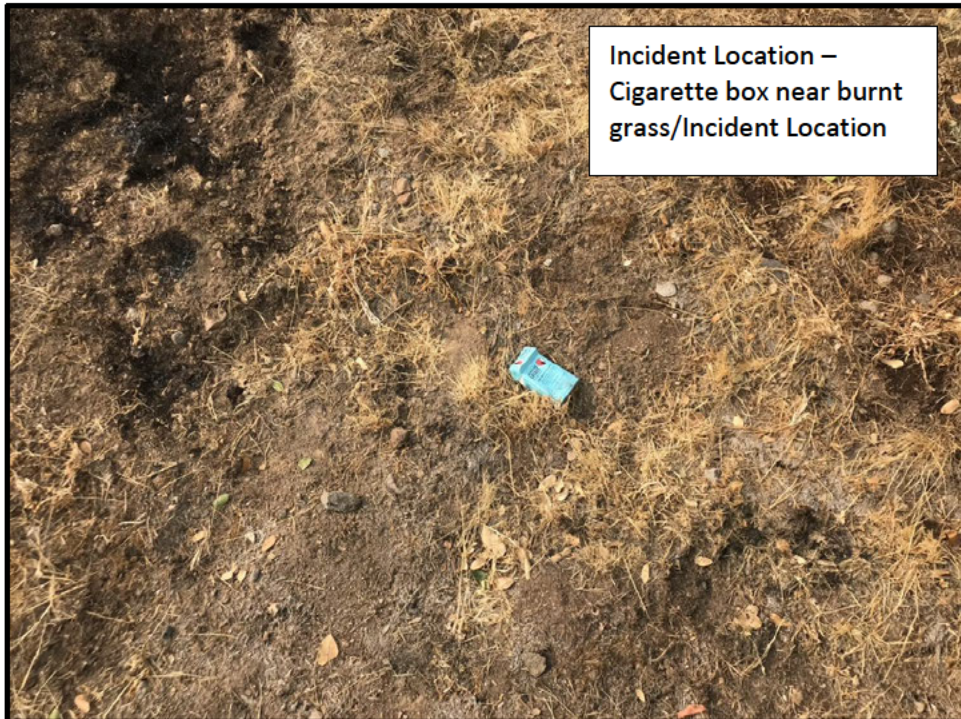
Figure 9: 09/09/22 PG&E troubleshooter image obtained post-incident of cigarette box near fire footprint – Incident Location.

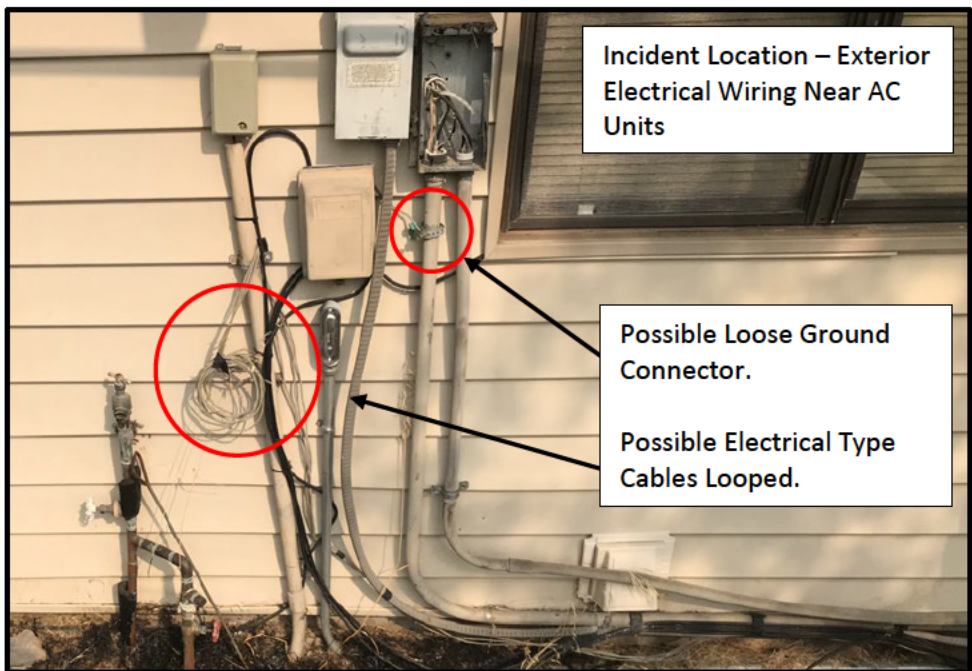
- Unknown if customer-grounding/electrical issue existed (Figures 10-11). Note: Possible loose ground connector attached to metal conduit under electrical box without cover, and looped possible electrical type wire on the exterior of the residential structure at the Incident Location³⁶:

Figure 10: 09/09/22 PG&E troubleshooter image electrical panels/wiring– Incident Location

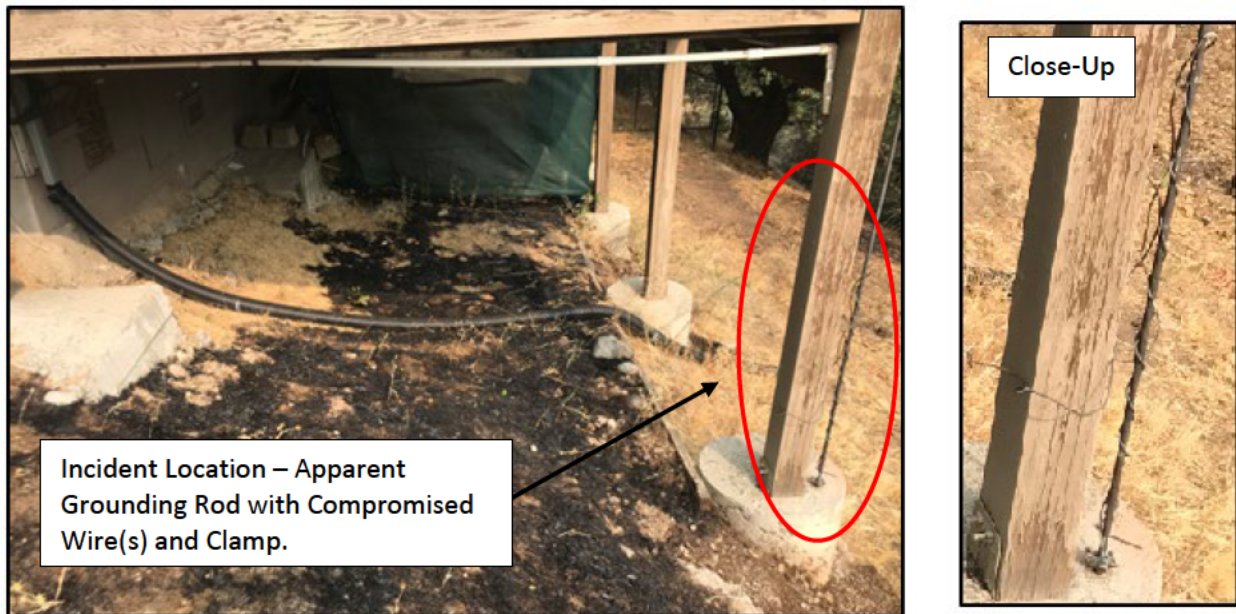
Figure 11: 09/09/22 PG&E troubleshooter Image – Apparent Grounding Rod with Possible Broken Wire - Incident Location

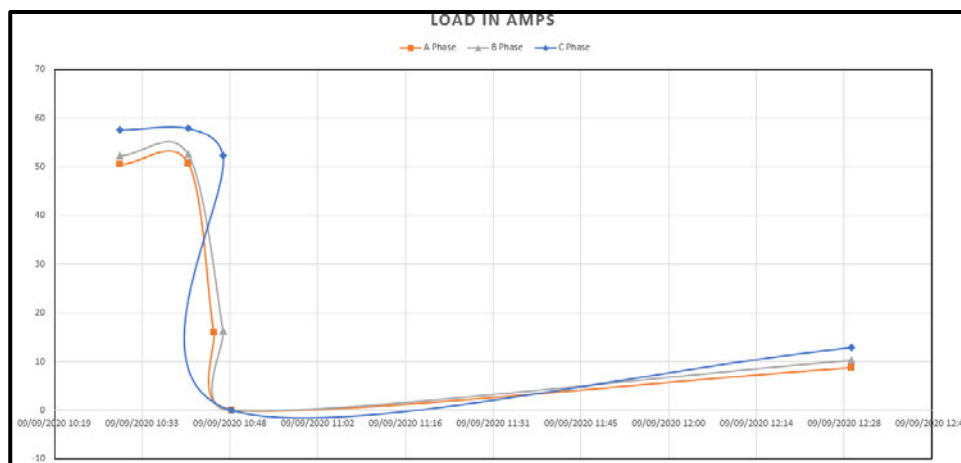
September 09, 2020 SCADA loading data from LR 7144 indicated no overloading conditions existed from 1030 hours to 1230 hours, which includes the reported fire's start time (See Figure 14 below).

Figure 14: LR 1744 Loading Profile on September 09, 2020.
