Event Analysis Report

Woodland – Property Damage

EIR No.: EI220611A

Date of Event: June 11, 2022

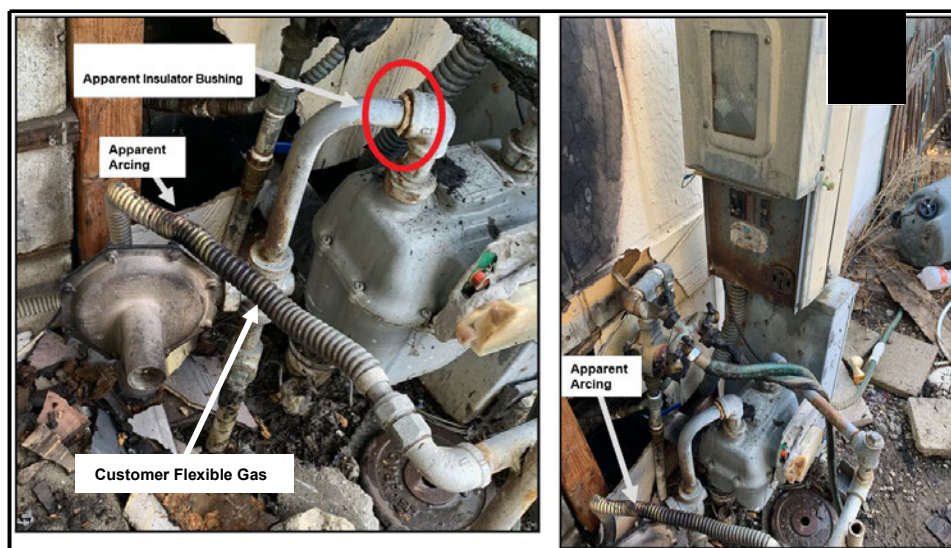
Figure 4: 06/11/22 GSR images showing visual insulator bushing - Incident Location #1

Visual observations of GSR images from both Incident Locations indicate the presence of insulator bushings associated to $\frac{3}{4}$ " steel 90-degree pipe fittings at both Incident Locations. Insulators are used to electrically isolate PG&E facilities from customer piping to enable cathodic protection of metallic facilities.⁴¹ We do not physically bond gas meter set equipment to the electrical system ground during any meter set installation or maintenance work.⁴² The customer flexible gas lines were observed within an inch or less (possibly touching) to PG&E's gas regulators. This potentially circumvented PG&E's gas insulating fitting functionality and created a condition which resulted in electrical arcing. The condition of customer owned house lines at both Incident Locations is unknown. PG&E also does not know if the customer flexible gas lines were grounded/bonded electrically on the customer's side, beyond PG&E's $\frac{3}{4}$ " 90-degree insulating fittings, as this is beyond our area of responsibility.
