Event Analysis Report

Bakersfield - Media

EIR No.: EI181120A

Date of Event: November 20, 2018

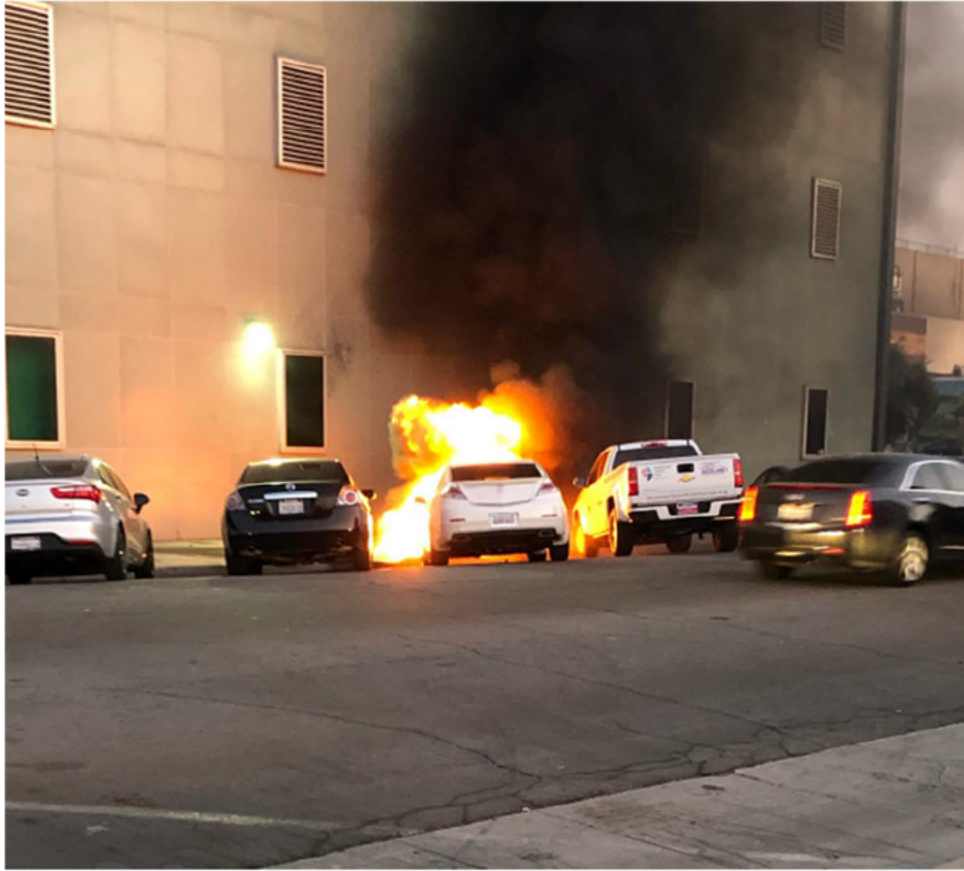
On November 20, 2018, at 1745 hours, a PG&E restoration supervisor arrived at the Incident Location and observed the Bakersfield Fire Department and three news agencies on site. Upon checking in with the fire captain, it was explained that they had heard an explosion and arrived to find a small fire near Vault 39. The fire was extinguished prior to the restoration supervisor's arrival on site. The restoration supervisor made the scene safe with cones around the perimeter of the vault until a PG&E troubleman arrived. Upon arrival, the PG&E troubleman observed oil in Vault 39 on Switch SW 5059/5061/5062, on the surrounding transformers in Vault 39, and on the sidewalk. A private vehicle parked near Vault 39 also sustained damage from the fire.

Figure 1: Fire in Vault 39, 20th and Eye Street, Bakersfield, 11/20/2018. Source: Media

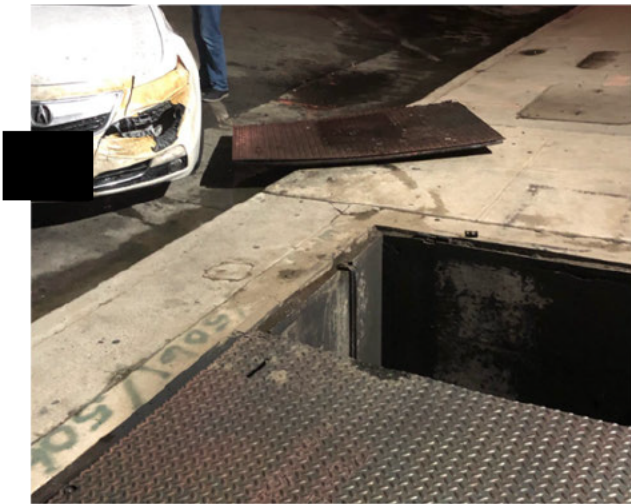
Figure 2: Vault 39 lid and damaged vehicle, 20th and Eye Street, Bakersfield, 11/20/2018. Source: PG&E

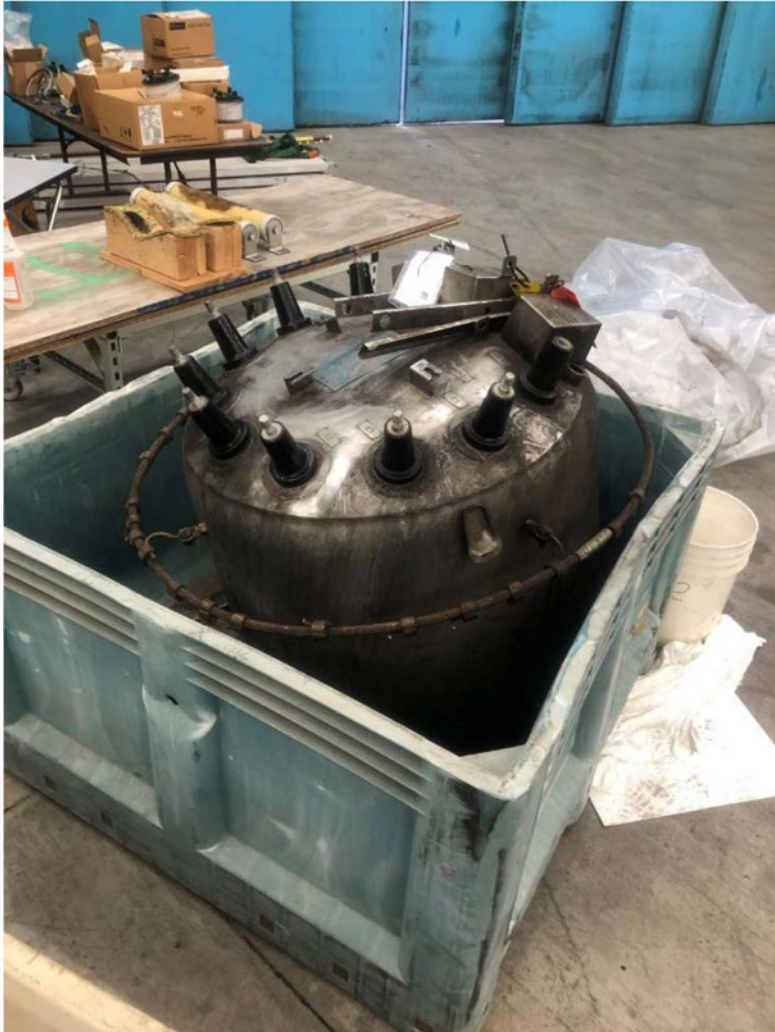
Figure 3: Fire damage evident on tank; burned oil, soot. Switch handles appear to be intact and in the closed position, grounding ring intact and connected to tank.

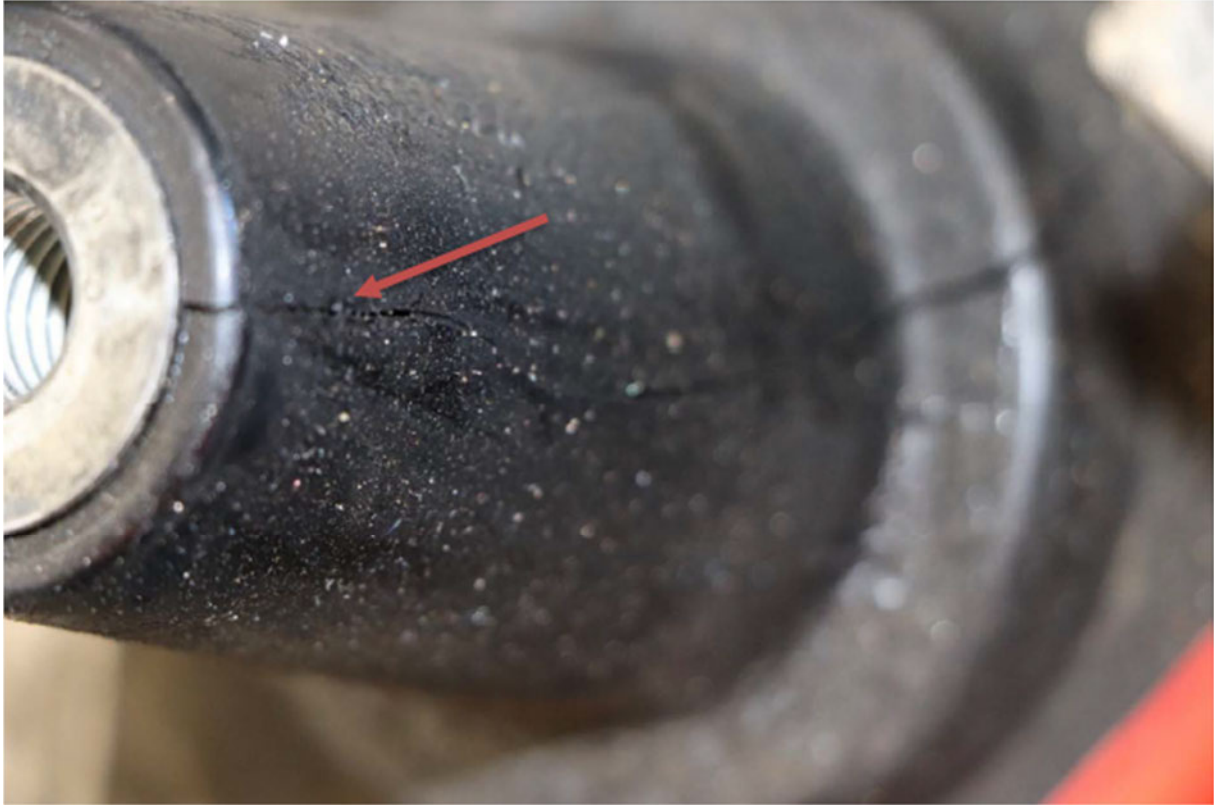
Figure 4: Cracked L1 bushing

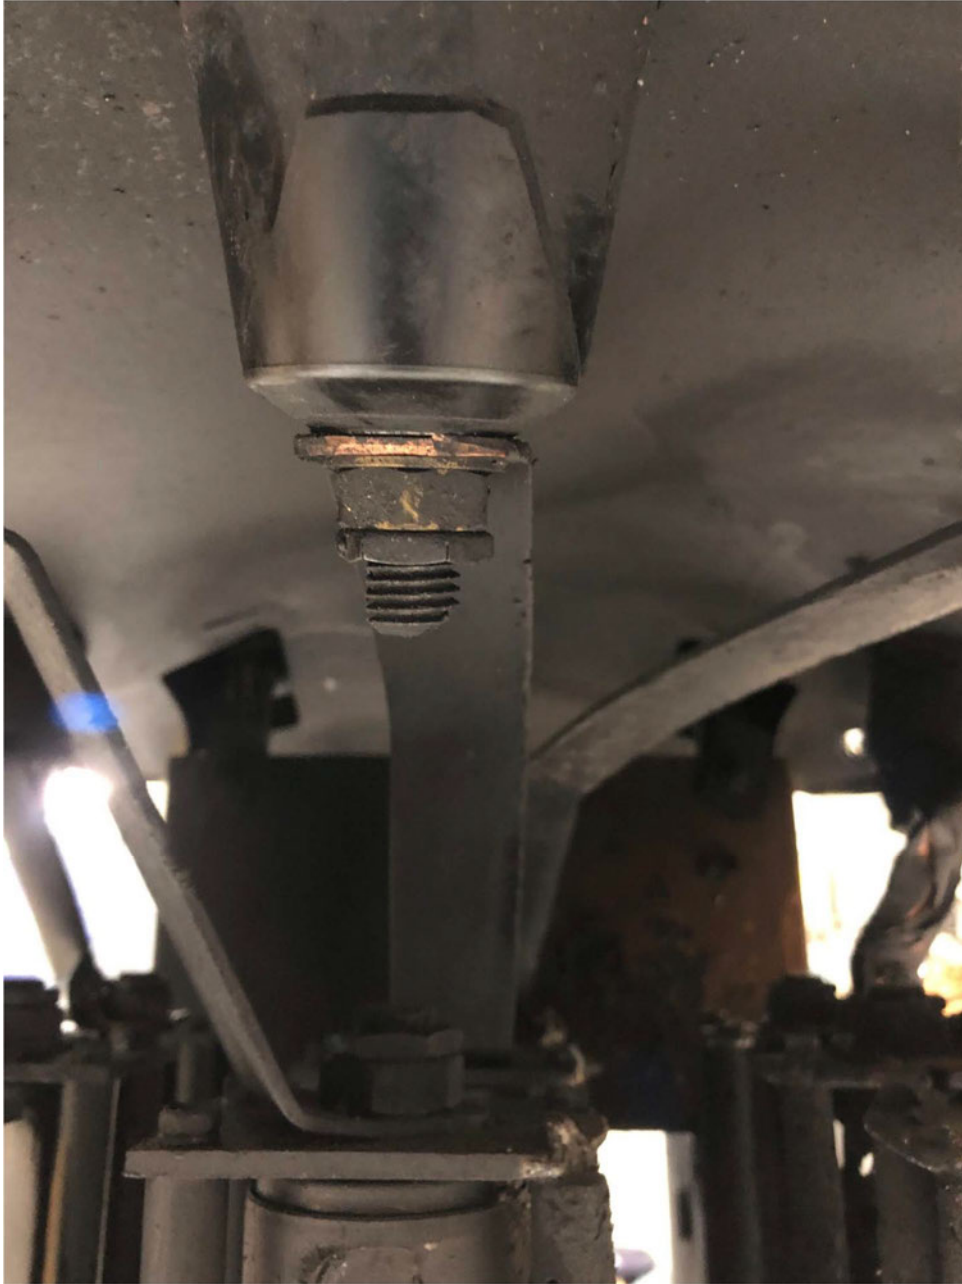
Figure 5: Cracked T2 bushing

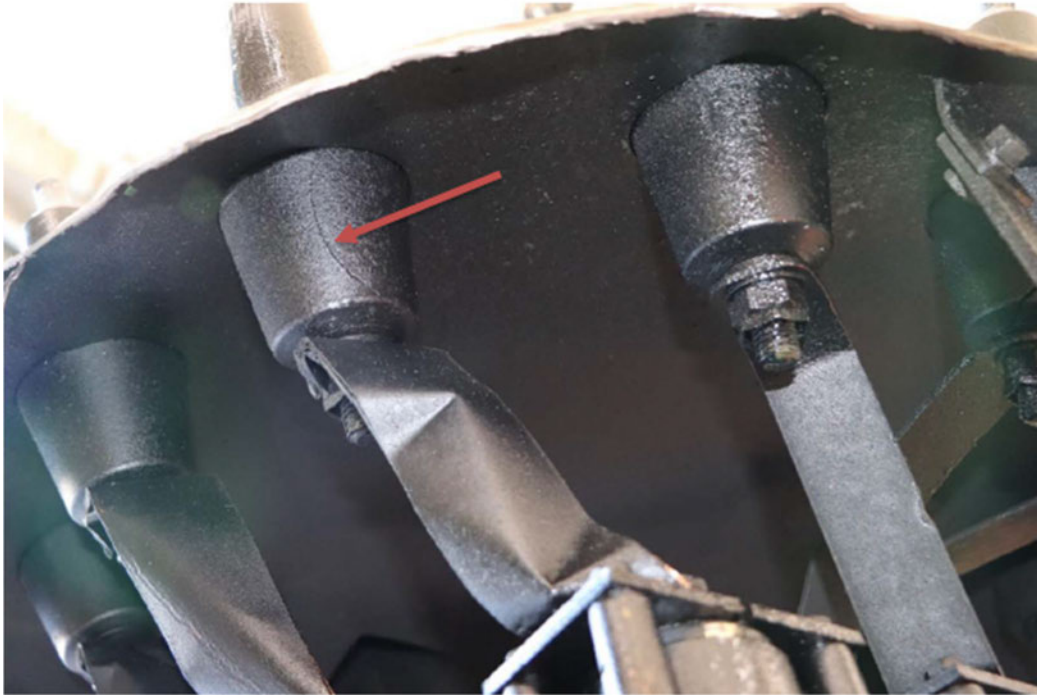
Figure 6: Cracked R2 bushing

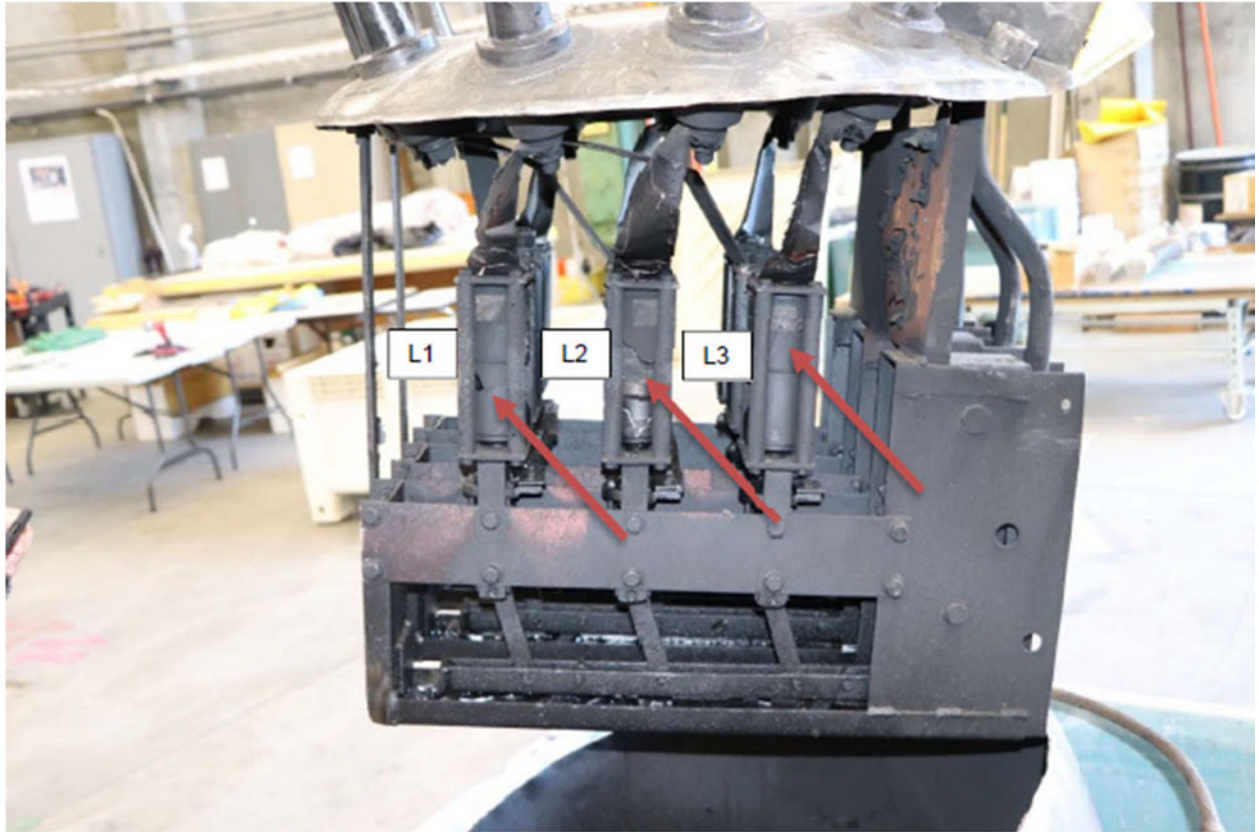
PG&E's Applied Technology Sciences ("ATS") conducted an external visual inspection and teardown for internal inspection of the failed switch to help determine if there were any issues with the switch. The inspection determined that four of the nine internal VI ceramic bodies were cracked and both internal and external portions of bushings were cracked. Because the switch was examined after a catastrophic failure, it's possible that much of the damage was a result of the failure, and not the cause of the failure. The cracked bodies of the VIs allowed oil to enter

the vacuum envelope. Oil in the vacuum envelope does not have sufficient insulating properties to prevent the arc from extinguishing, resulting in the VI's catastrophic failure. The cause of the cracked VIs was not identified due to the damage from the initial failure and subsequent fire.¹⁴ The CPUC was present for the teardown and inspection of the switch.

Figure 7: Internal mechanism, fire damage, cracked vacuum interrupters (VIs)

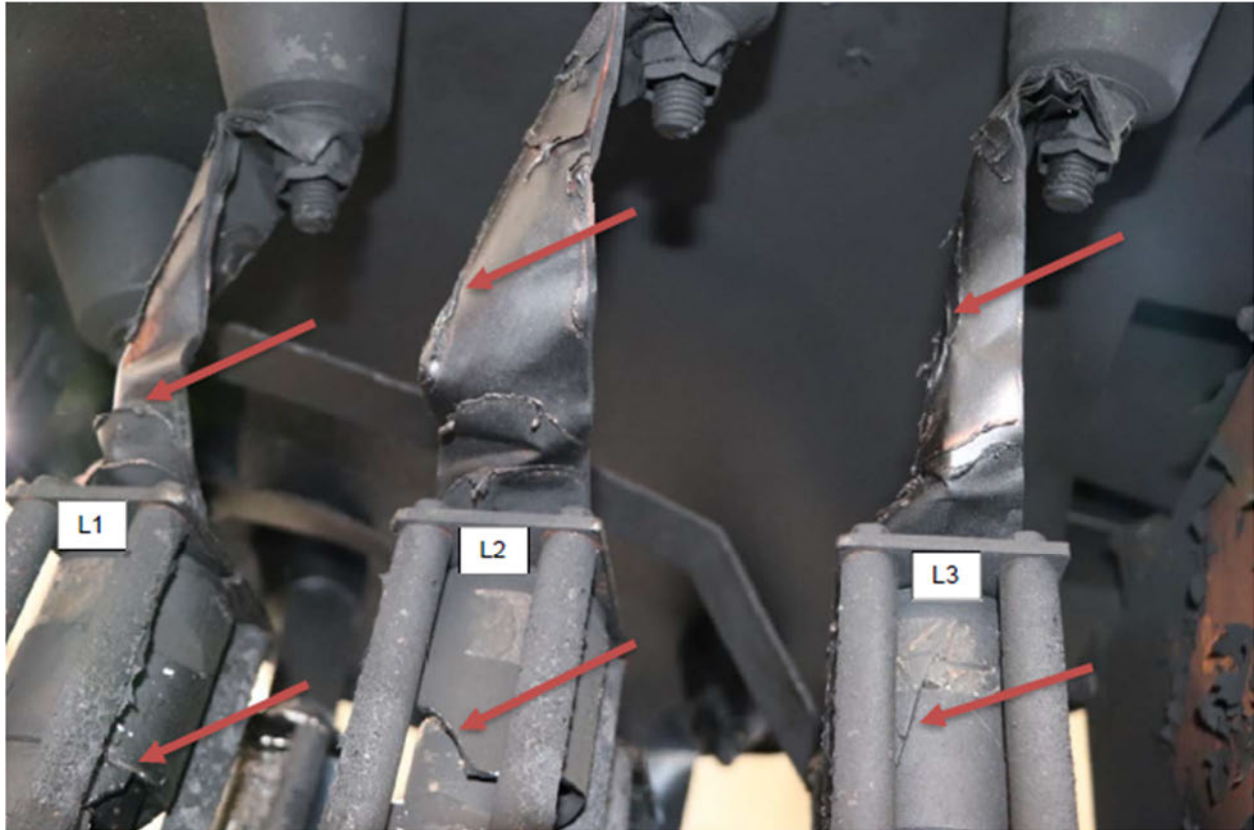
Figure 8: Cracked vacuum interrupters, evidence of arcing and melted parts on connections inside the tank
