# ***Event Analysis Report***

***Event Name:*** *Walnut Creek - Media*

***PG&E Reference Number:*** *EI190518A (CAP: [117297655](#))*

***Date of Event:*** *May 18, 2019*

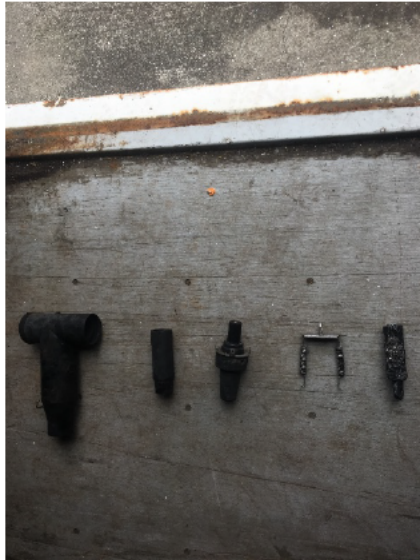
PG&E collected the damaged switch and one elbow connector (which includes a T-body, T-body adapter, bushing, elbow, and connector) into evidence.

*Figure 1-Parts of the damaged connector  
(collected as evidence)*

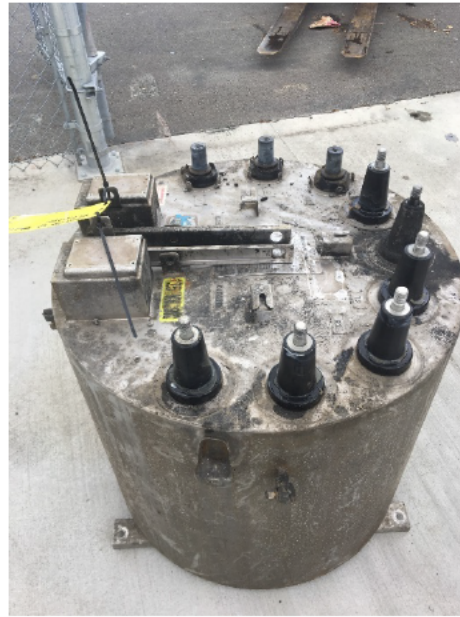
*Figure 2-Figure 6 - SW-14931 -  
removed from the vault*

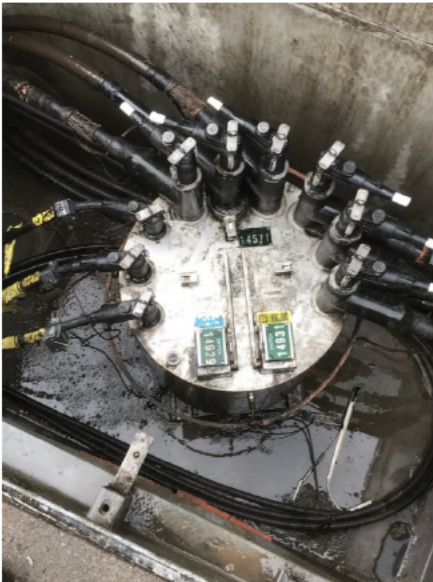
Based on the data uncovered during the investigation, follow up interviews with field personnel, and the ATS failure analysis (Report # 006-19.12 Rev. 1), the direct cause of the equipment explosion and resulting outage was the failure of the downstream external cable elbow connector of the T2 bushing. This resulted in a line-to-ground fault on the B-phase. This fault created the burning and arcing damage observed on and around the T2 bushing and tank (as seen in the images below).

*SW-14931 and connectors (view of the top)*

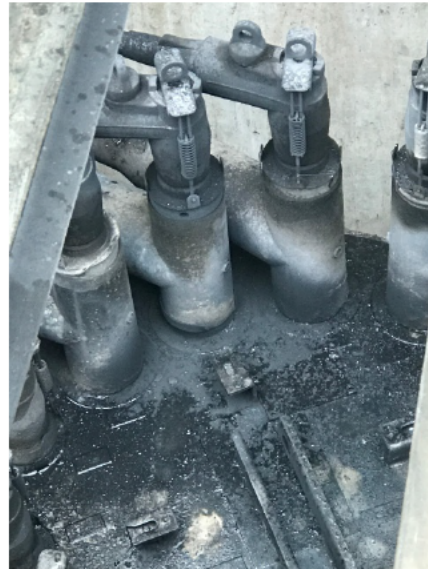
*Burn mark on SW-14931 and the connectors - close-up view*

The oil analysis, electrical testing, and visual inspection of the internal components did not reveal any defects or problems inside the switch. Based on this forensic data, it is reasonable to conclude the cable and elbow connection was the location of the fault. The downstream external cable was not damaged and was not replaced as a result of this incident.

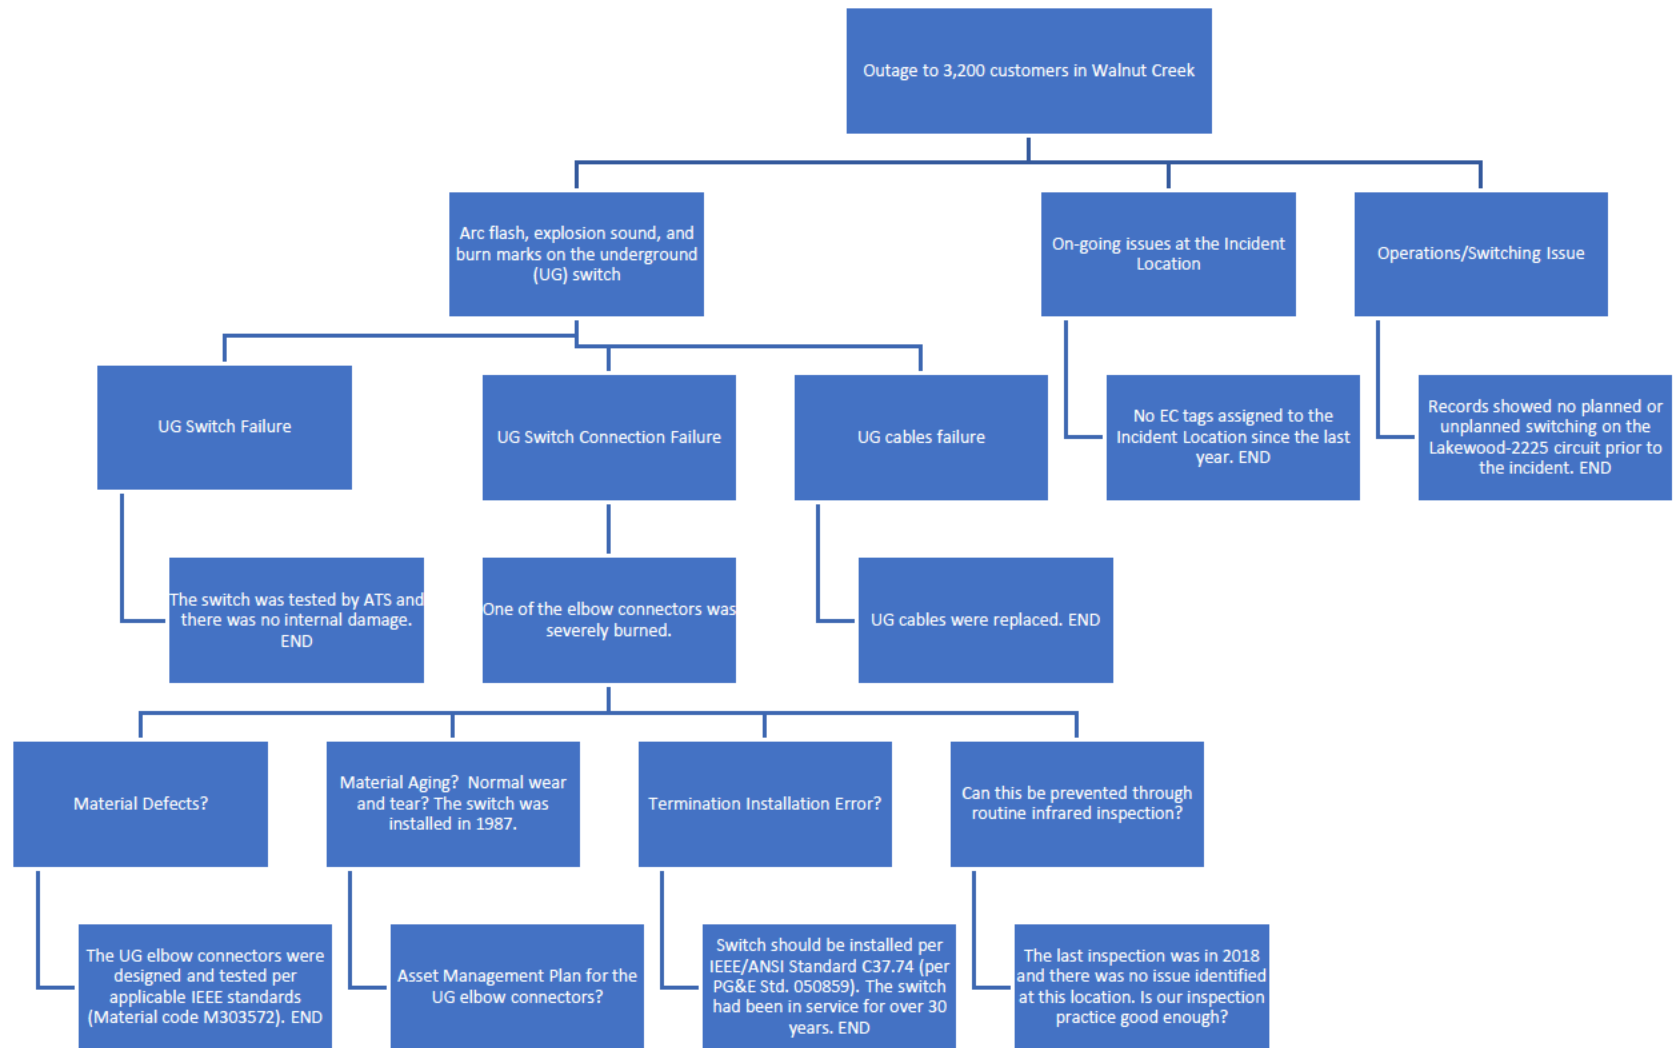
The Direct Cause of this event is an external T-body connector termination, as outline in the ATS report. The failure caused an outage and resulted in a loud noise and smoke from the underground equipment.

A contributing cause was a lack of comprehensive documentation of equipment failures – including the failures of UG elbow connectors. A more comprehensive list of failures could help the proactive identification of signs of an impending failure.

Below is a factor tree examining possible causes and contributing causes:
