# Event Analysis Report

## San Francisco – Media

EIR No.: EI200212A

Date of Event: February 12, 2020

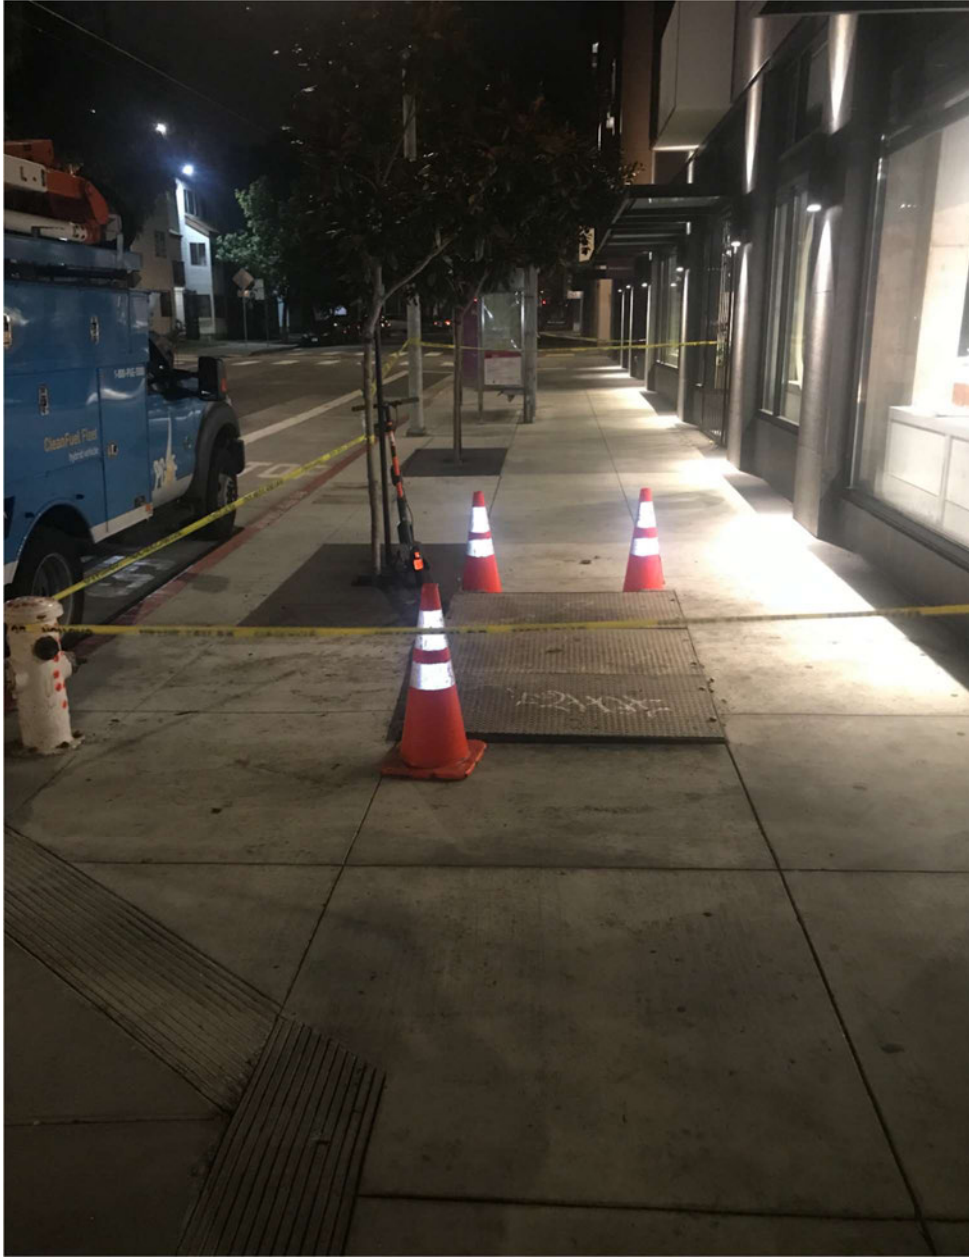
When the responding cableman and a supervisor arrived at the intersection of Laguna Street and Hayes Street in San Francisco ( “Incident Location”), they observed the San Francisco Fire Department (“SFFD”) on site and smoke coming from a manhole (later identified as the primary subsurface enclosure GW5086 #5 box). The cableman reported seeing an enclosure with the frame up out of the ground. The enclosure appeared to house a connection point with no switch. SFFD roped off the area and the cableman performed switching operations to re-energize customers. The cableman observed Man On Line (“MOL”) tags on the same circuit. The supervisor noted that there was ongoing construction on the SF X circuit, so the Incident Location was being back fed from the SF Y circuit.<sup>1</sup>

Figure 1: The location of the fire. Taken February 12, 2020

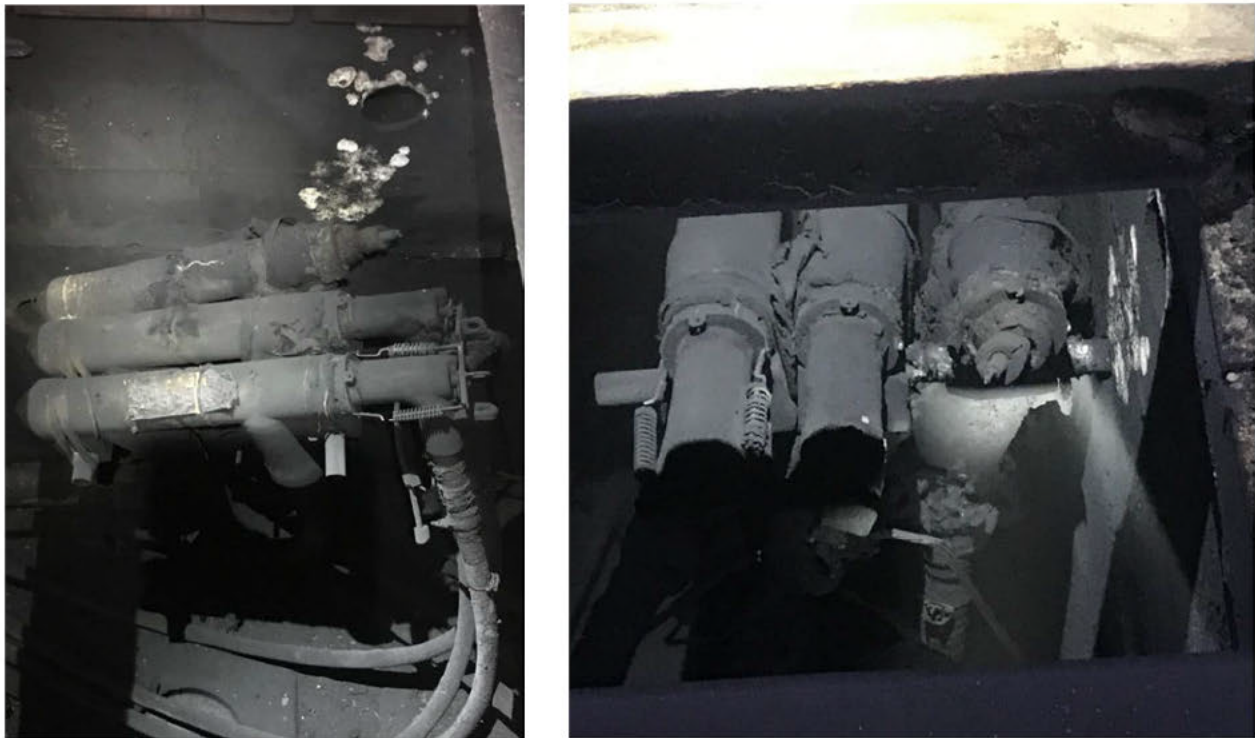
Figure 2: Condition of the damaged equipment on the night of the incident.

Visual inspection showed that the phase A reducing tap plug suffered insulation degradation that led to a ground fault. A review of the relay event data further showed that there were two ground fault events during the incident. See the ATS Report provided to the CPUC on June 16, 2020 for further details.

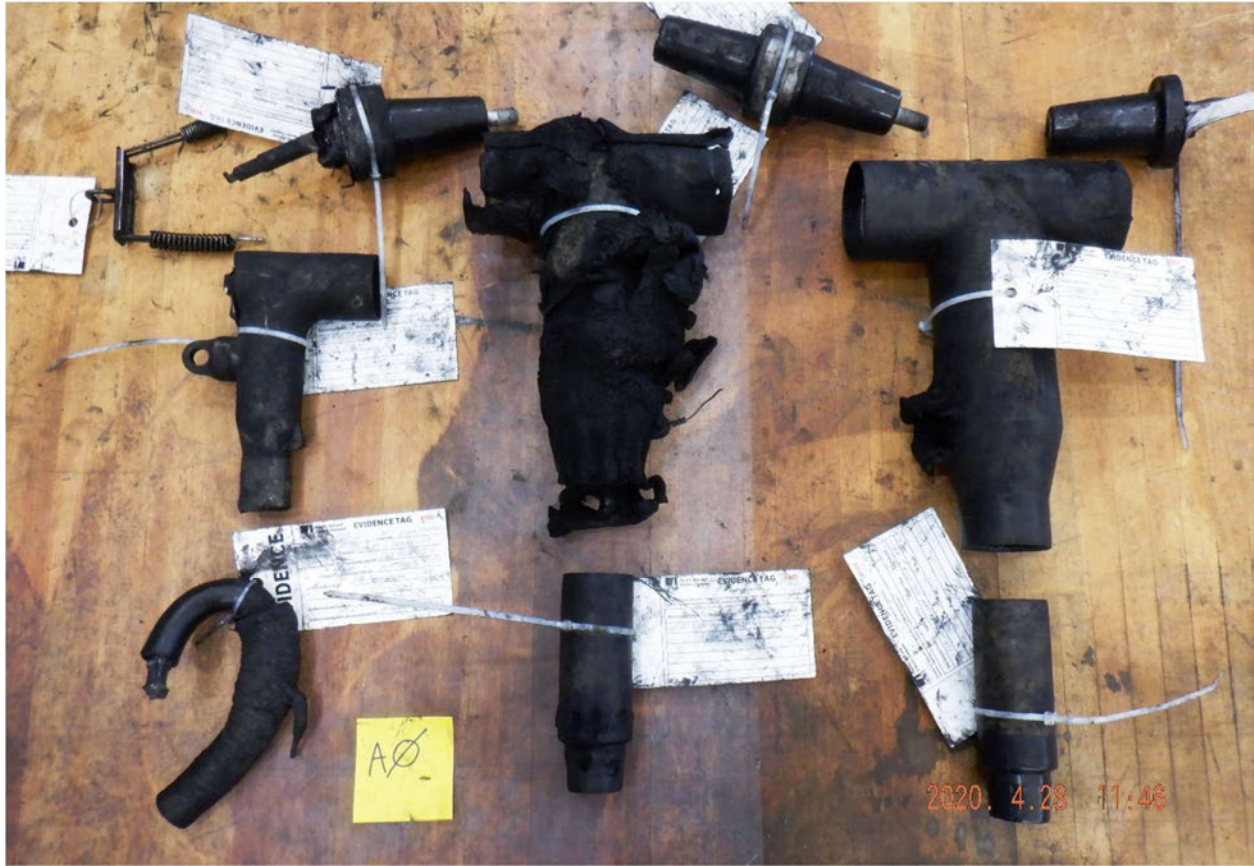
PG&E collected the T-body junction points, the elbow attachments, and associated hardware into evidence. Note that the responders and crew first believed that only two of the elbows had been recovered. Upon examination, ATS found the damaged remains of the third elbow (shown in Figure 3) amongst the evidence.

Figure 3: The evidence collected from A phase. The failed tap plug and elbow are shown on the left.

Based on the failure analysis provided by ATS, EII concluded that this event was caused by equipment failure of the A Phase 600/200A reducer elbow. A Hazard Barrier Analysis was performed and identified no corrective actions.
