Event Analysis Report

Bakersfield Incident – Property Damage

EIR No.: EI200724B

Date of Event: July 24, 2020

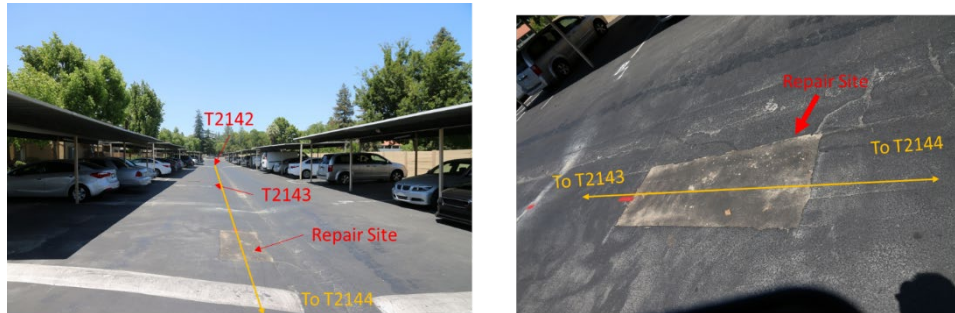
Figure 4: Repair site between transformers T2143 and T2144 on the southeast driveway of the [REDACTED]. The area was repaired on or after July 22 and before July 24, 2020. Photo taken on August 4, 2020.

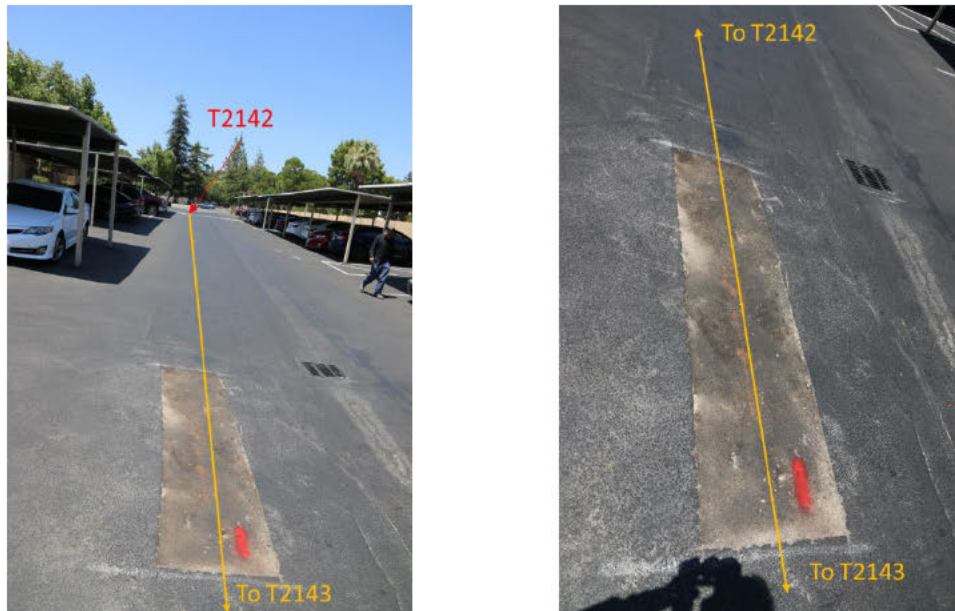
- C1: Ineffective guidance and controls on repair-replacement decisions for underground distribution equipment experiencing repeated failures. This most likely resulted in the underground Cable Section #1 being repaired instead of replaced prior to July 24, 2020. Had the underground Cable Section #1 been replaced in accordance with current maintenance practices, it is unlikely the cable would have subsequently failed on July 24, 2020.

Figure 5: Repair site between transformers T2142 and 6525/T2143 (Cable Section #1) on the southeast driveway of [REDACTED]. Photo taken on August 4, 2020.

- PG&E isolated the damaged primary underground cable section and successfully restored service to all 4,100 impacted customers.
- PG&E replaced Cable Section #1 between transformers T2142 and T2143 (Cable Section #1) on 9/2/20.⁵ The failed cable Section #1 was abandoned in place.⁶

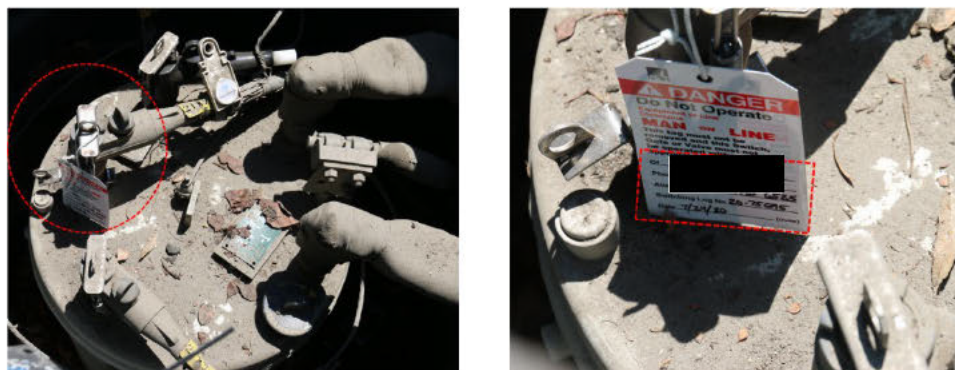
Figure 7: The primary cable toward switch 6525 at the transformer T2142 is lifted and tagged out. Photo taken on August 4, 2020.

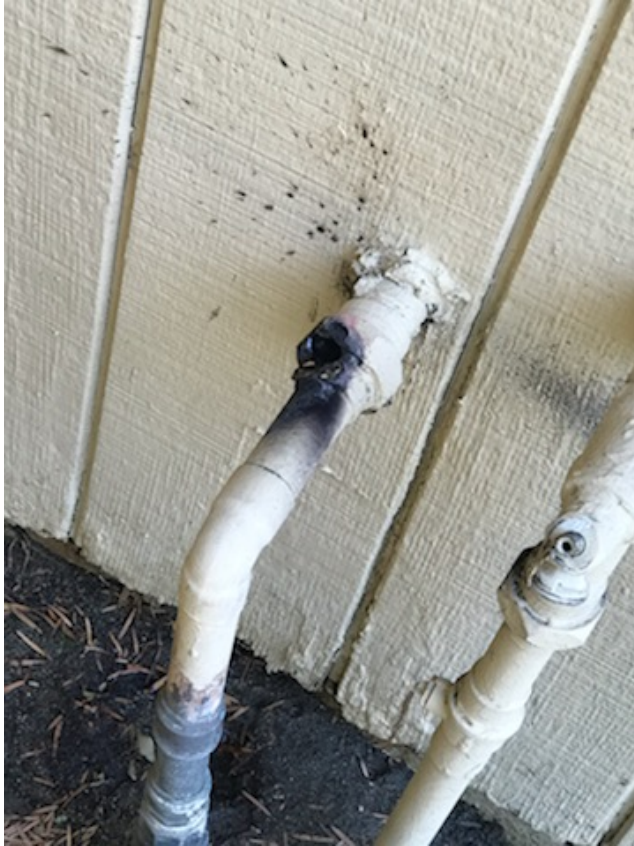
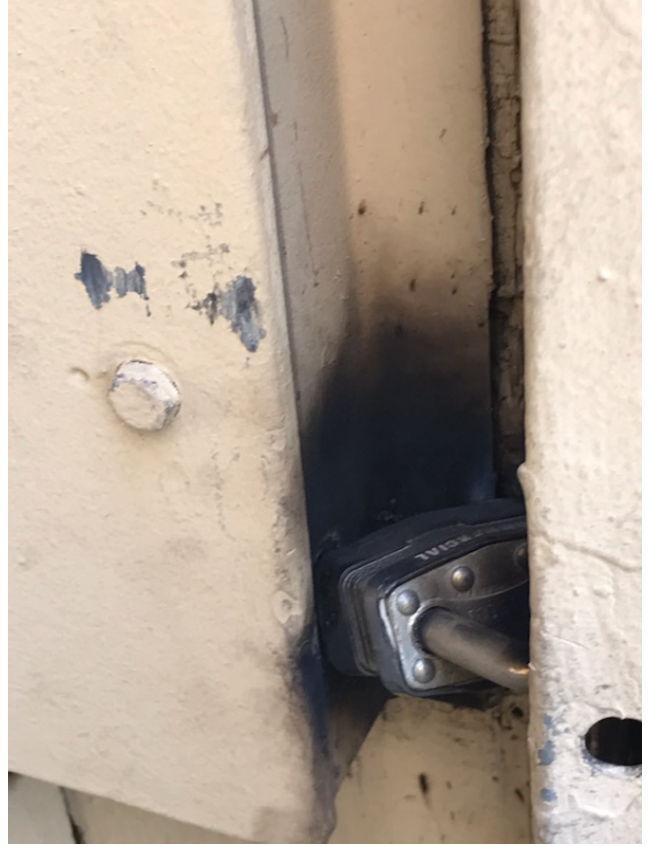
- Damage on the low-voltage customer side was observed after the incident on July 24, 2020 at the water pipes and communication boxes. Figure 7 shows some high-temperature damage on the low voltage side after the incident on July 24, 2020.

Figure 8: Damaged equipment on the customer side. Photo taken on August 4, 2020.

2. After being contacted by the Restoration Supervisor, PG&E area Superintendent for Kern Division secured electrical and plumbing contractors to inspect and repair affected electrical wiring and plumbing on the customer side.

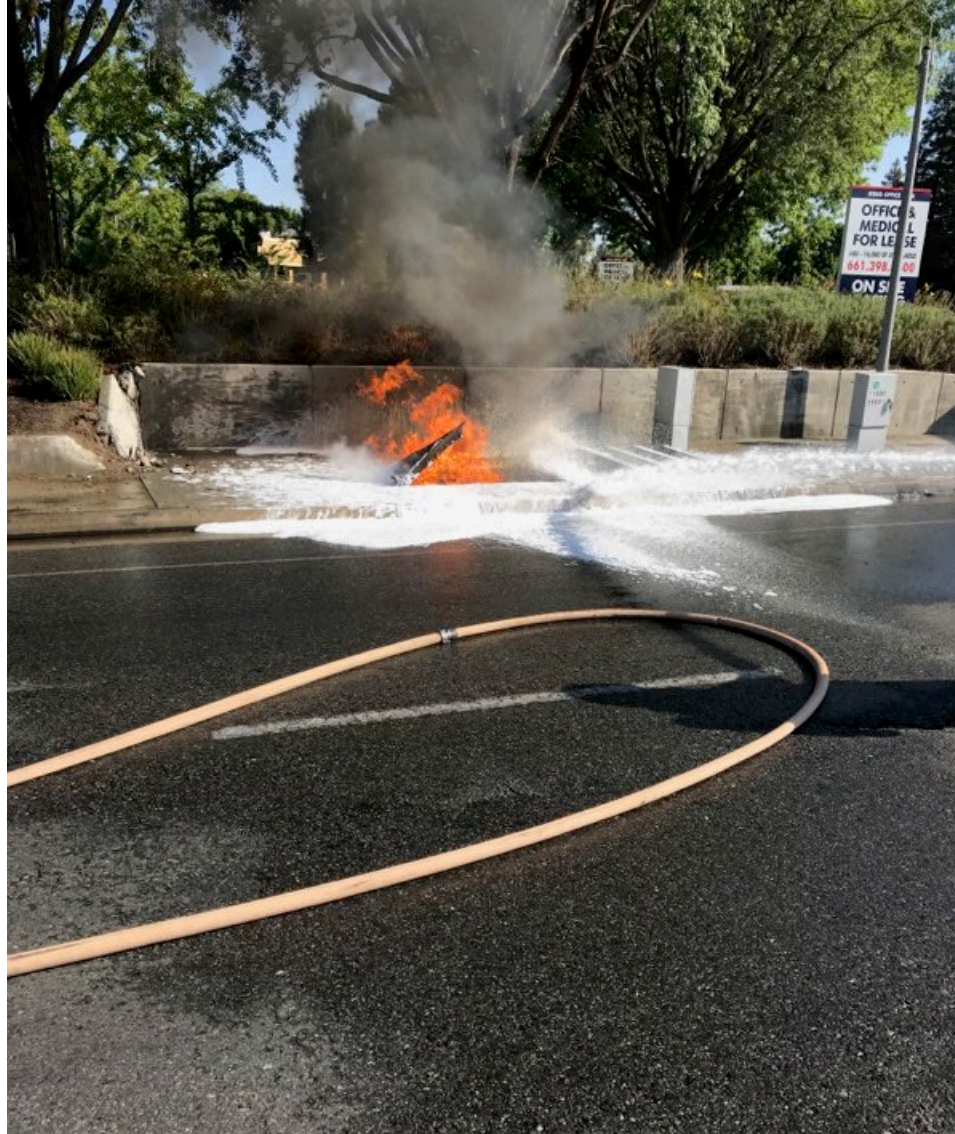
- The failed 3-way switch was in an underground vault at the corner of the Ming Avenue and New Stine Road. This switch failed catastrophically on July 25, 2020 and caused a fire at the underground vault (see Figure 8). Figure 9 shows the 3-way switch location during the site inspection on August 4, 2020.

Figure 9: Fire at the underground vault housing the 3-way switch. Photo taken on July 25, 2020.

- PG&E replaced the subject Switch (3-way primary switch), its associated SCADA device, and the damaged cables.
- PG&E used mobile generator units to supply temporary power to customers while the repairs were being performed.

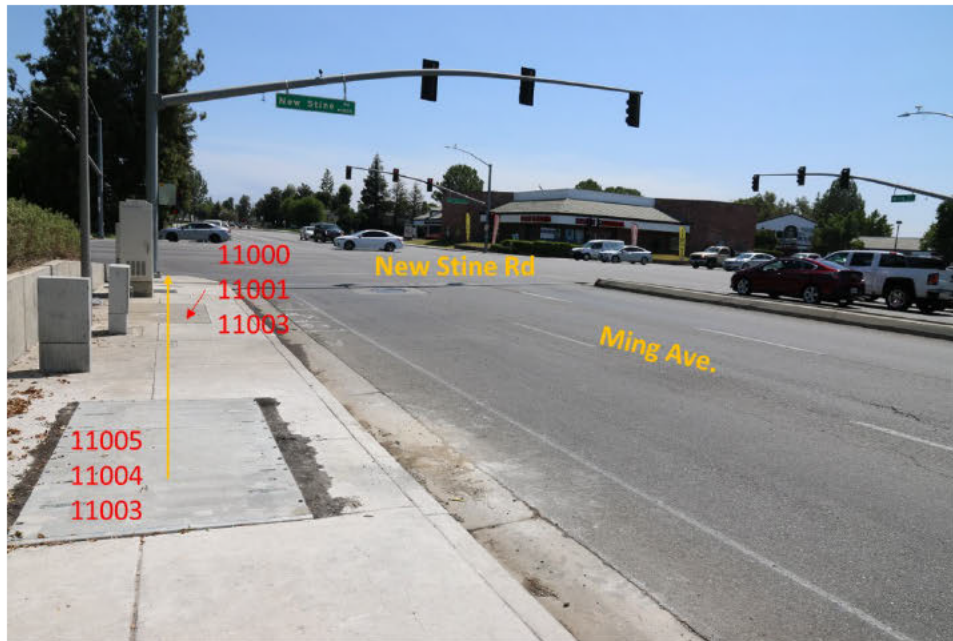
Figure 10: Location of the 3-way switches – the switch failed catastrophically on July 25, 2020. Photo taken on August 4, 2020.

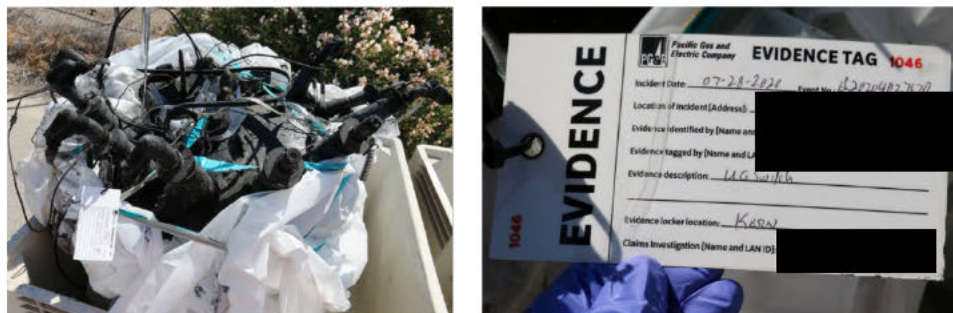
Figure 11: The failed 3-way switch (11003, 11004, 11005) kept in evidence locker. Photo taken on August 4, 2020.

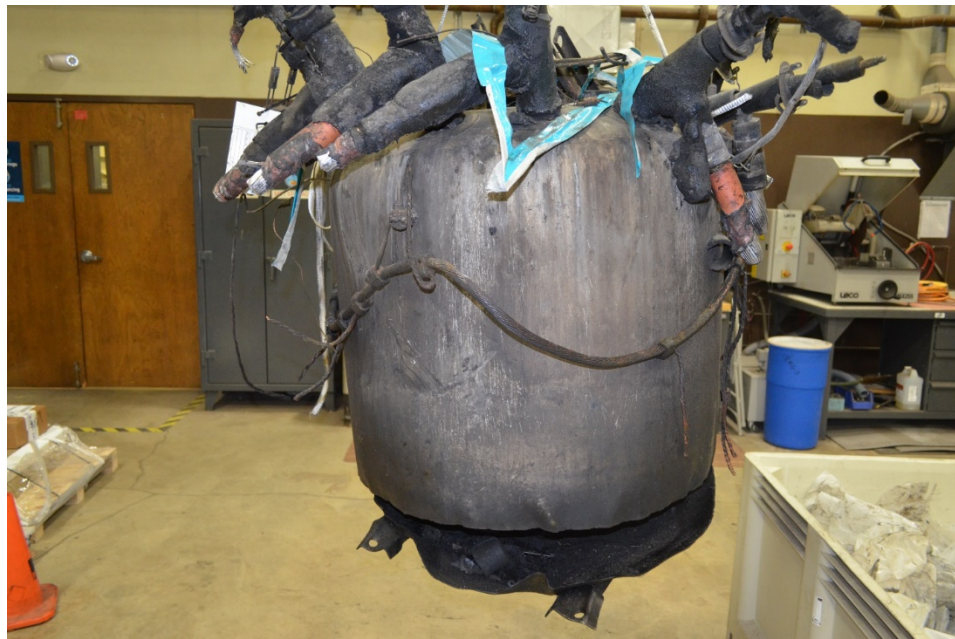
The 3-way switch that failed was recovered and preserved as evidence. The switch was transferred to the PG&E's Applied Technology Services ("ATS") facility in San Ramon for further investigations. ATS evidence inspection revealed damaged vacuum interrupters inside the failed switch. The specific cause failure was not identified "due to the damage from the initial failure and subsequent fire."⁴⁰ The PG&E's ATS report detailing the results of the failure analysis of the switch is included in Attachment 9.

Figure 12: The failed 3-way switch in PG&E's Applied Technology Services Facility in San Ramon, CA. Photo taken on October 7, 2020.

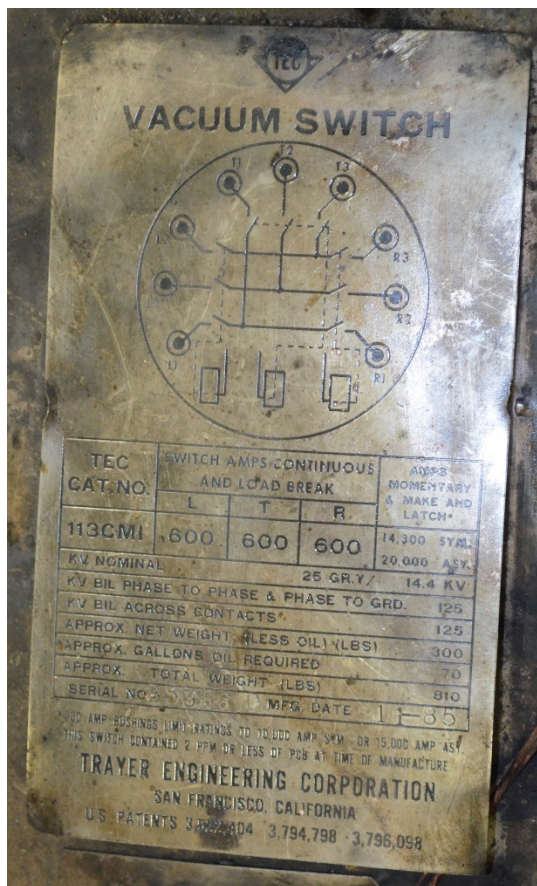
Figure 13: Nameplate of the failed 3-way switch.

3. The age of the subject 3-way switch was more than the average age of similar assets and most likely contributed to the failure of the switch on July 25, 2020. The average age of the PG&E 600 A vacuum-in-oil switches is 19 years.³¹ The subject 3-way primary switch was manufactured in 1985 based on its nameplate information.

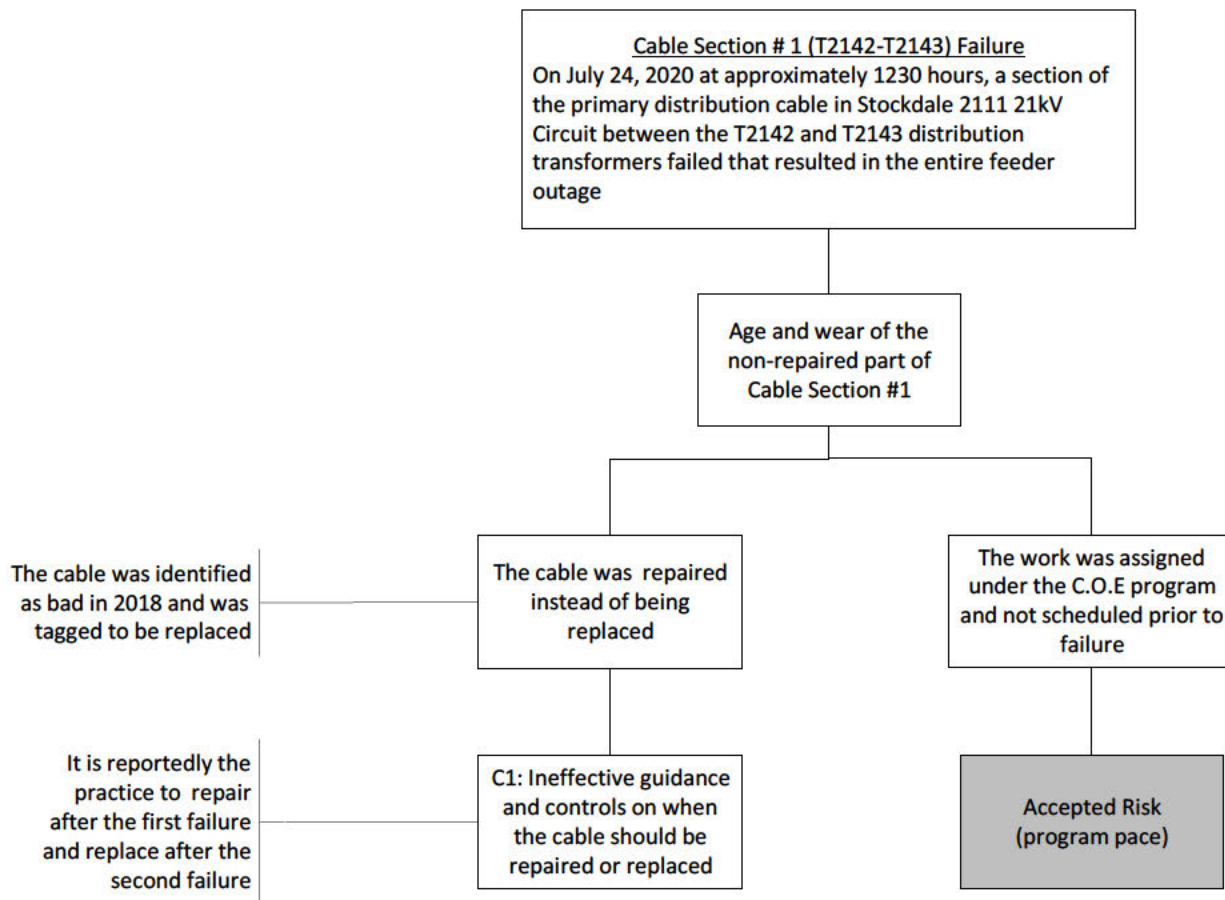
- C1. Guidelines and controls on repair-replacement decisions for equipment experiencing repeated failures were ineffective.** Cable Section #1 had failed previously in 2016 and in 2018 and there was an existing repair tag on that section recommending replacement under the Critical Operating Equipment (C.O.E.) program since 2018. The cable section was ultimately repaired (not replaced) on July 22, 2020; although, PG&E’s guidelines of underground cable failures required repairing the first failure but replacing the cable after a subsequent failure on the same conductor. although the 2018 failure had recommended replacement, the repair crew had the option to replace the cable (perhaps not realizing that the cable had experienced prior failures). Had the cable been replaced on July 22, 2020 instead of being repaired, it is highly likely that the July 24, 2020 failure could have been avoided.

Figure 14: Causal evaluation chart - Incident #1 (July 24, 2020)

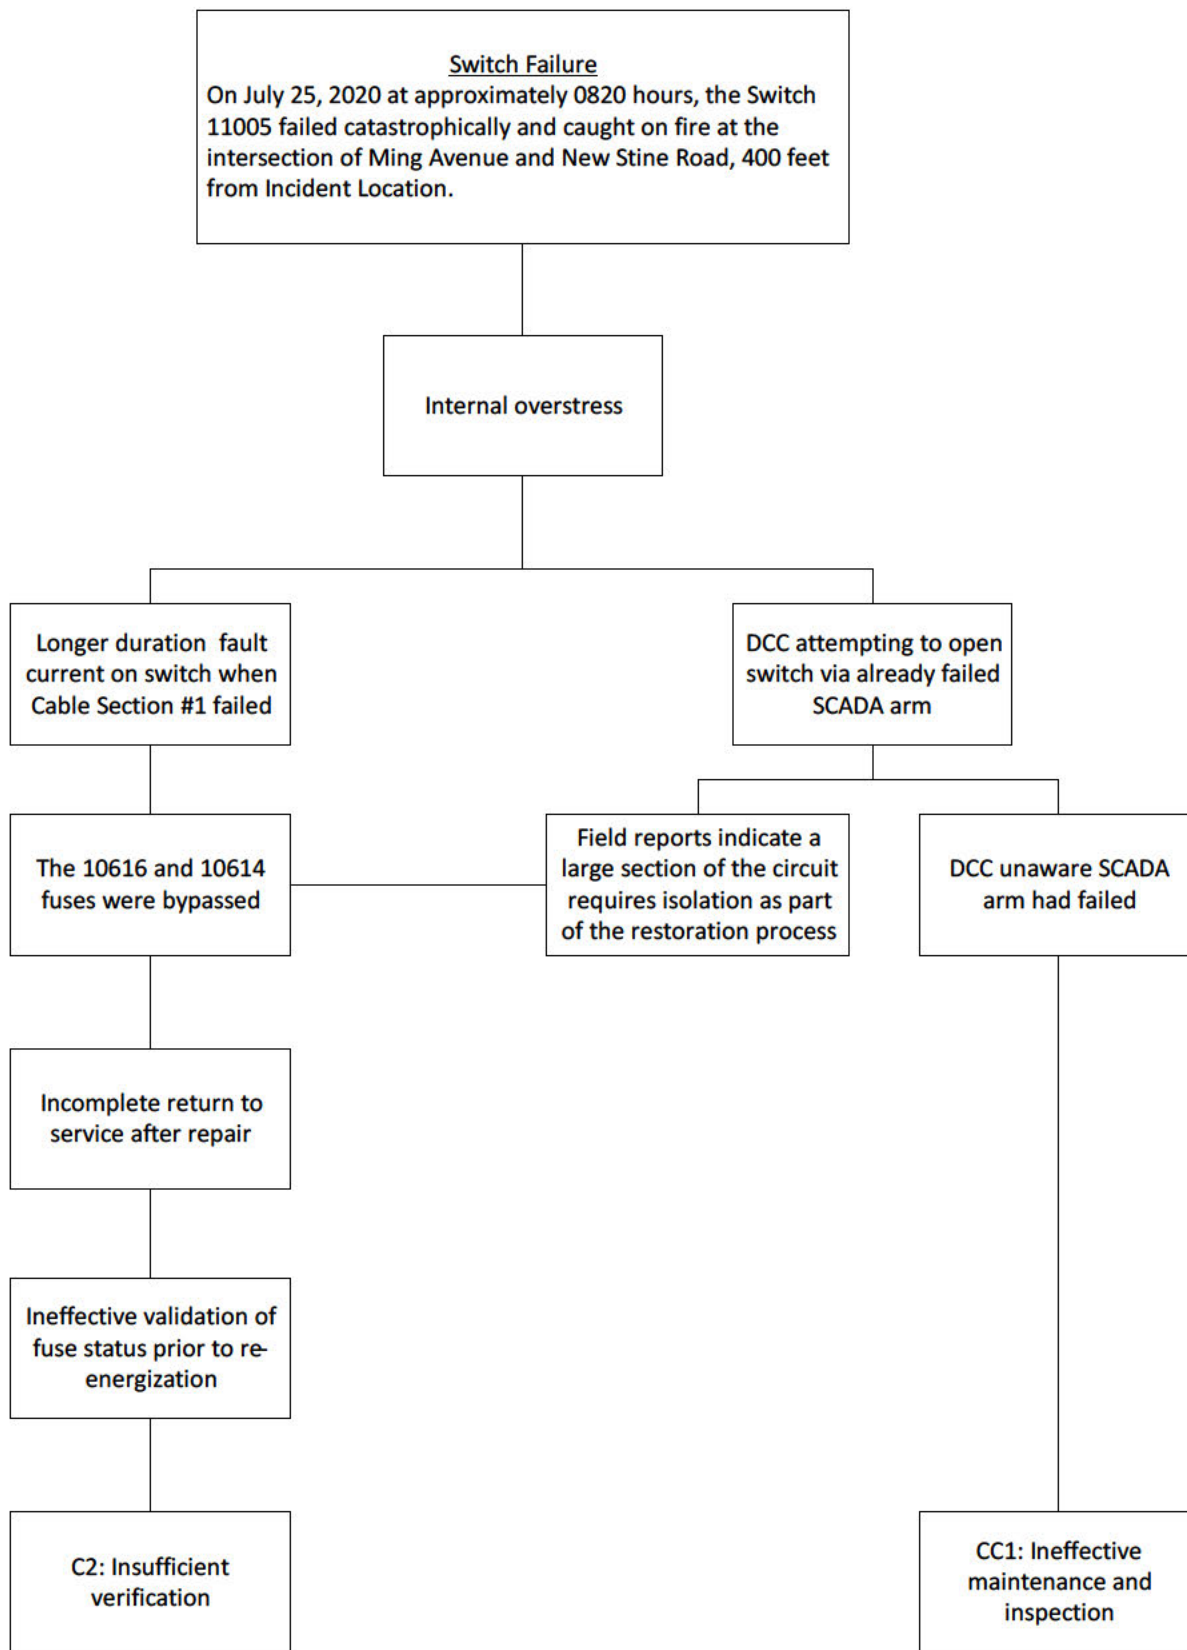
- C2. Insufficient verification post repair system configuration** resulted in fuses 10616 and 10614 to remain bypassed after their replacement following the failure of the Cable Section #2 on July 22, 2020. This likely caused a longer duration fault current during the failure of the Cable Section #1 on July 24, 2020, as well as excess stress on the 3-way primary switch that eventually failed on July 25, 2020.⁴⁶ In addition to having a longer duration fault, the fault extent resulting from bypassed fuses prompted the Distribution Control Center to attempt to remotely open the 3-way primary switch via the SCADA

operating mechanism which unbeknownst to them, had already failed; thereby likely adding additional stress onto the switch and its ultimate catastrophic failure.

Figure 15: Causal evaluation chart - Incident #2 (July 25, 2020)
