Event Analysis Report

Los Olivos – Property Damage

EIR No.: EI210606A

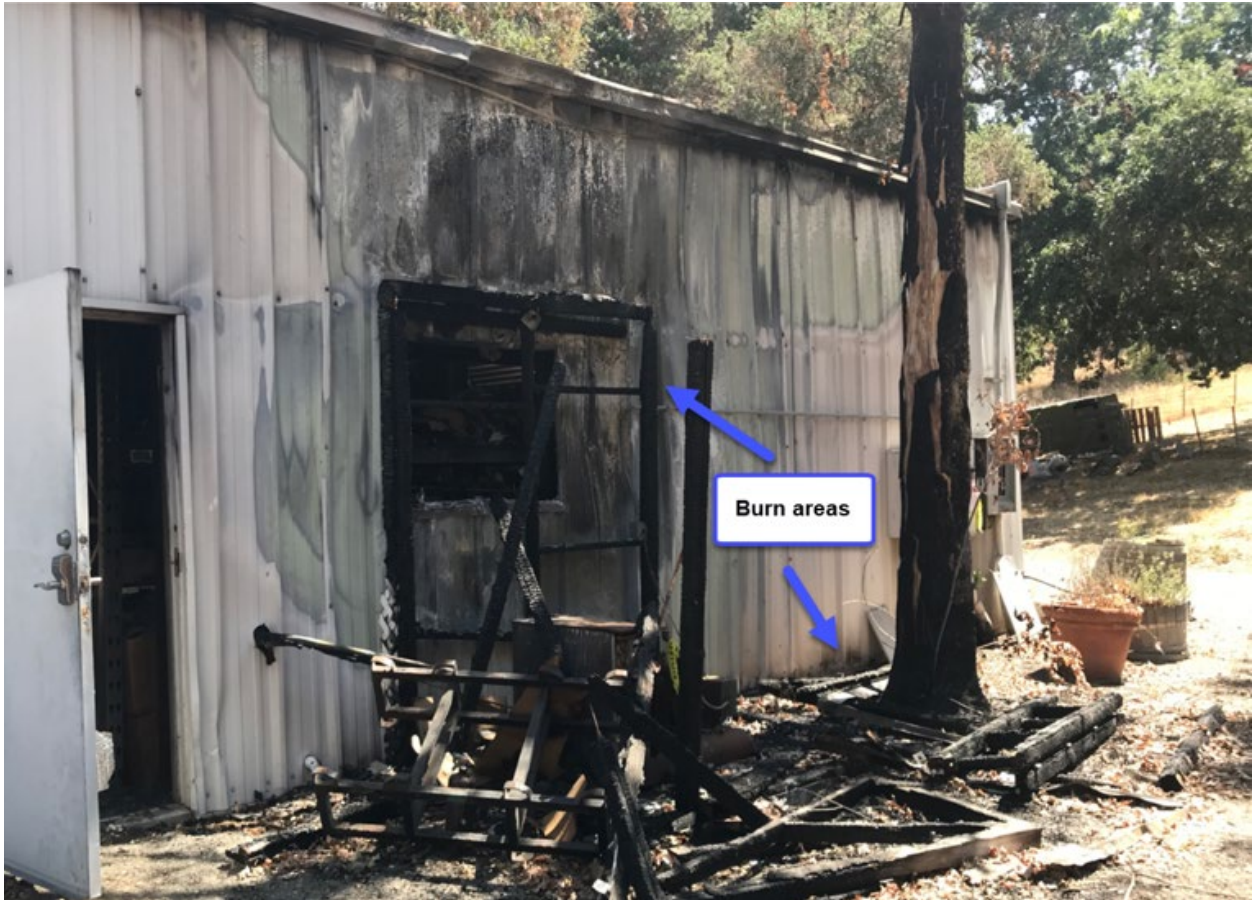
- Extensive fire patterns viewed on the exterior of the building near the Air Conditioning (“AC”) unit servicing the structure which the customer stated had been under repairs recently. This AC unit is at least six feet away from the customer’s electric panel.¹

Figure 2: Exterior of Incident Location - charred area adjacent to AC unit and down along perimeter base of building. Customer panel on right side of building. Photo taken during site visit on July 19, 2021.

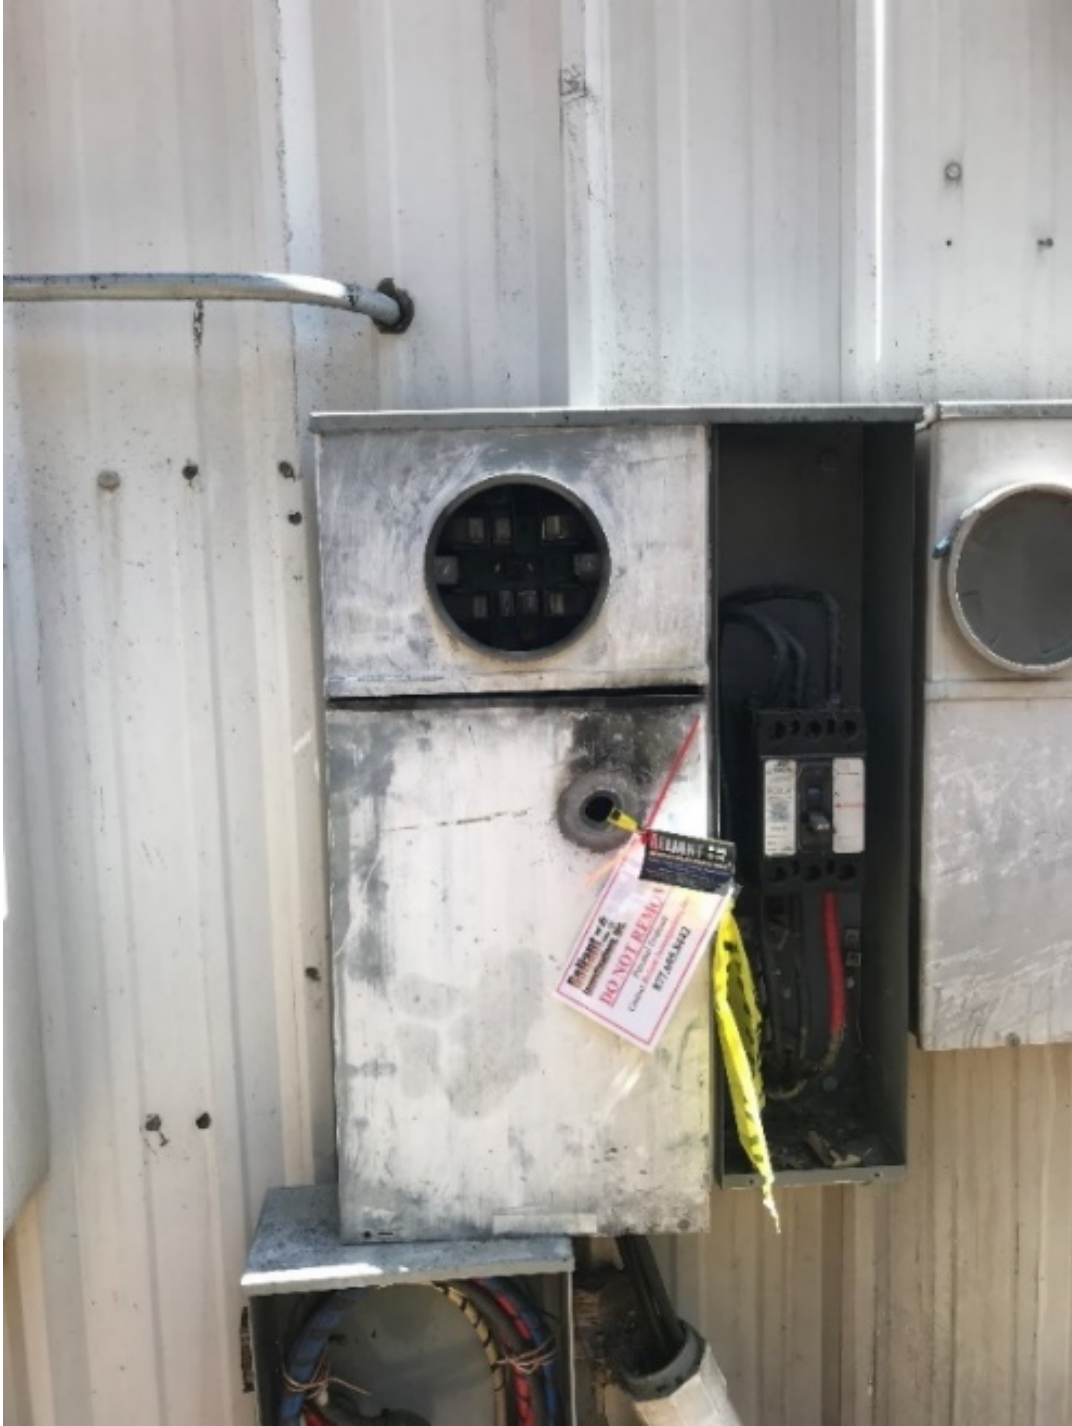
Figure 3: Customer panel. Photo taken during site visit on July 19, 2021.

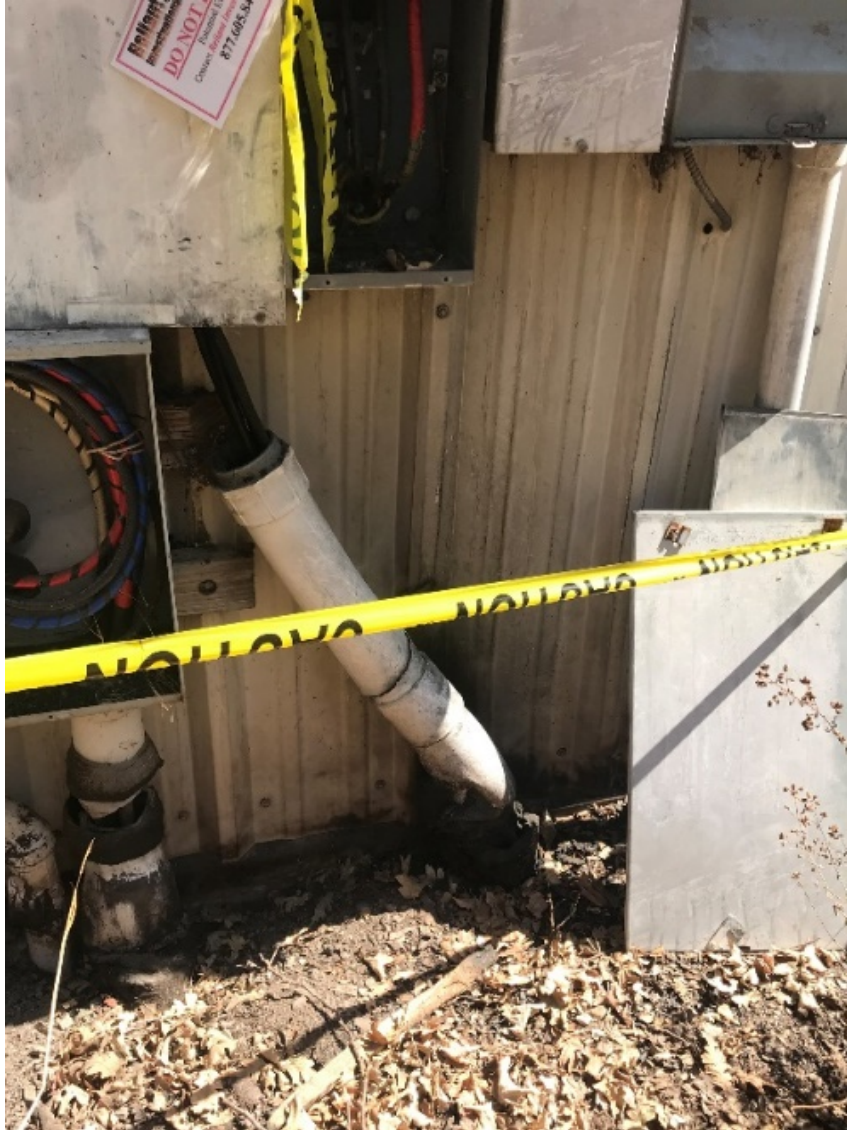
Figure 4: Service conduit–base melted from heat of fire. Photo taken during site visit on July 19, 2021.

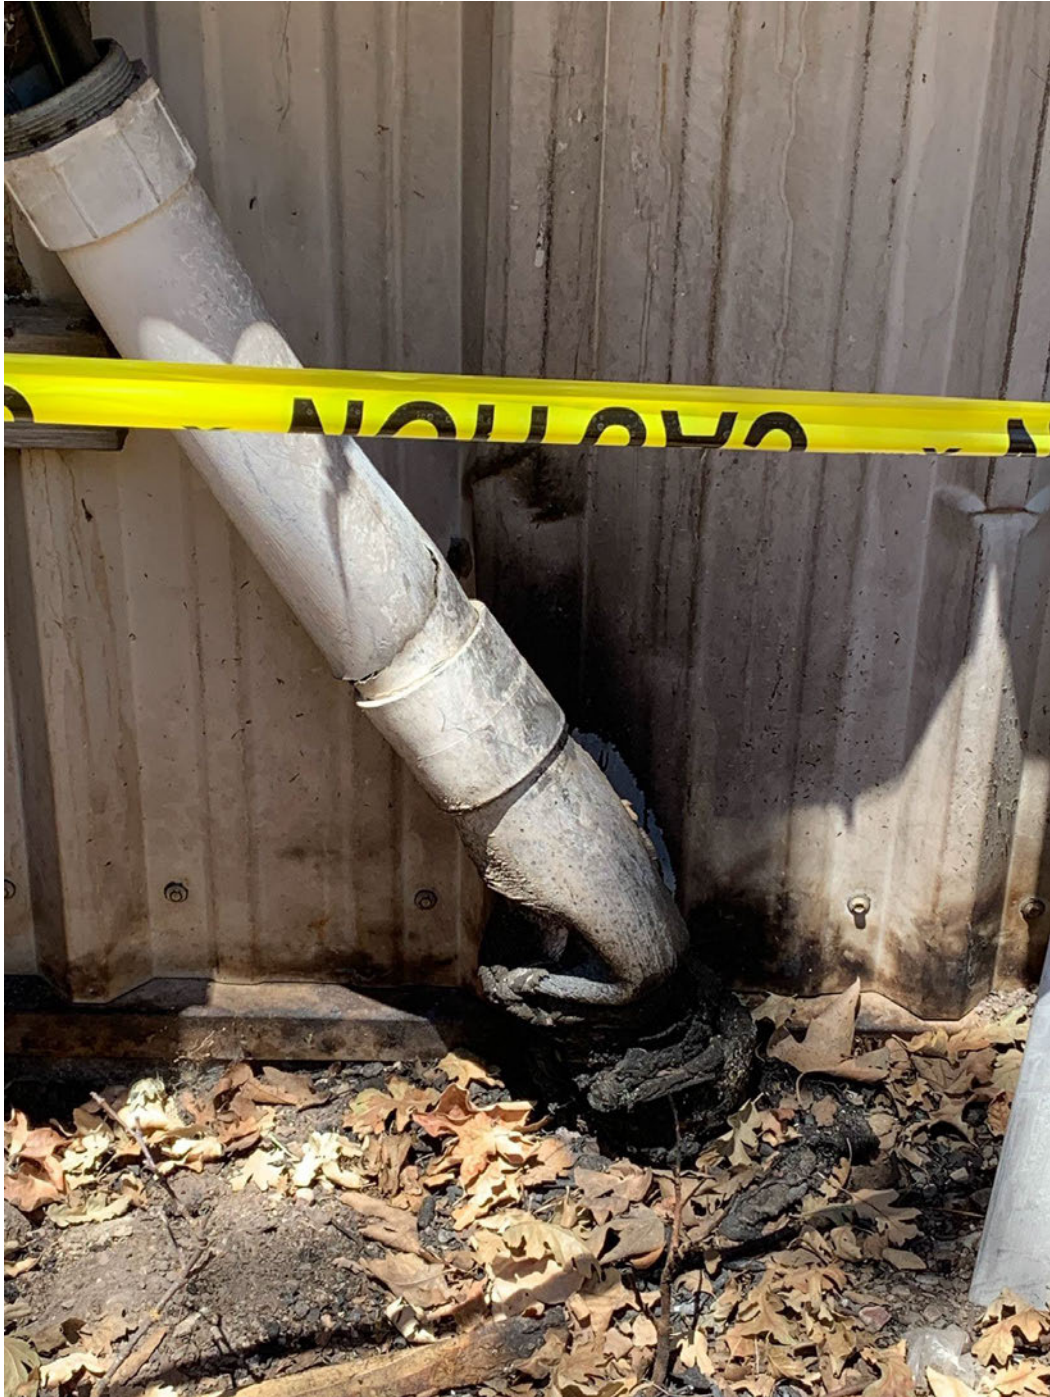
Figure 5: Crack on conduit exterior above joint. Photo taken by meter tech on July 1, 2021.

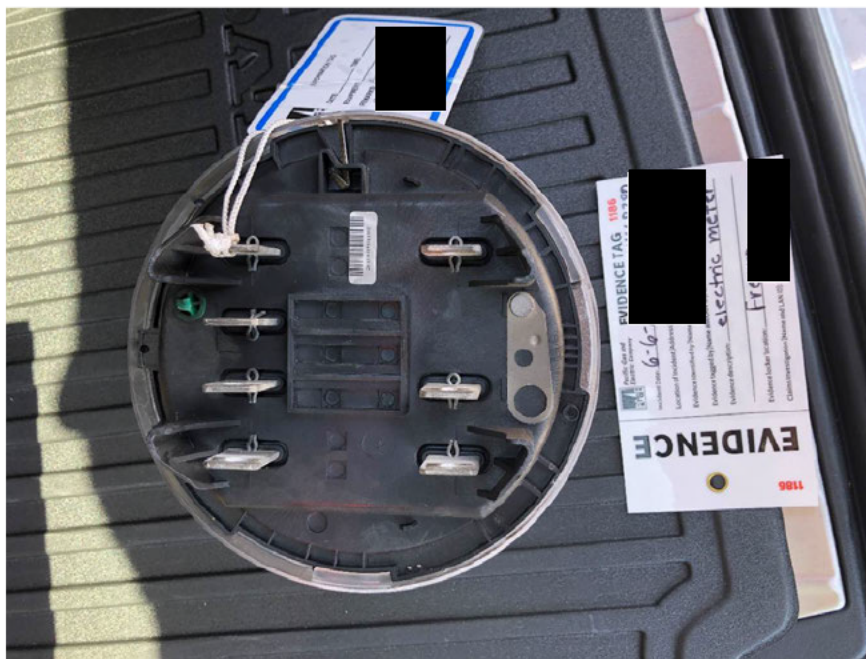
On July 19, 2021, PG&E EII and Law Claims took part in a joint scene inspection, requested by the property owner's insurance company's legal counsel. The site visit included an examination of the interior and exterior of the property's wine cold storage building. The Incident Location is a 3,000 square foot refrigerated wine storage building which contained pallets and cardboard boxes of wine in addition to an attached living quarters (Figure 1). The exterior of the Incident Location building showed the darkest area of charring in the vicinity of the area where the AC unit was housed (Figure 2). The customer's panel is several feet to the right of the AC, fed by underground service to a riser pole with a transformer. There were no external fire patterns above the electric panel (Figure 3); however, there was charring at the perimeter base of the building in that area which likely caused damage to the exterior base of the conduit (Figure 4). Additionally, the conduit had a visible crack just above the joint, which did not appear to be related to the fire (Figure 5). The PG&E SmartMeter displayed slight melting on the exterior surface and no visible damage to the associated prongs (Figures 6 and 7).

Figure 7: No damage to prongs of SmartMeter. Photo taken by Law Claims on June 25, 2021.

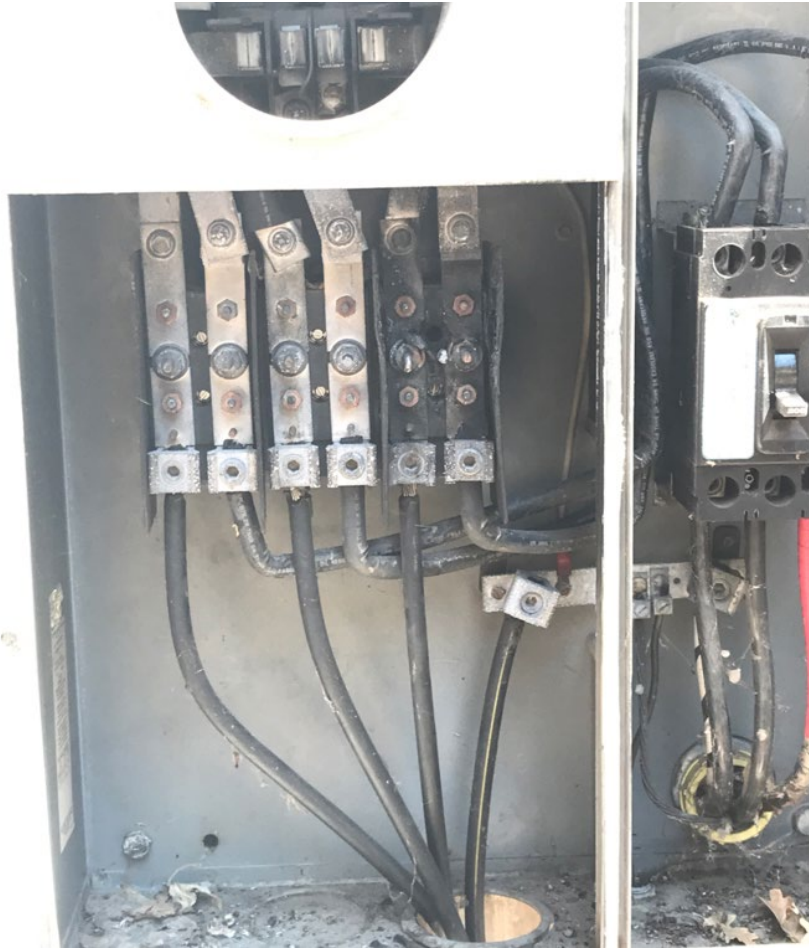
- The customer panel was not sealed at the bottom which allows for small animals/rodents to enter. Two frogs were found inside the panel which may have cause cross phasing and blew the “C” phase of the three-phase service.²
- The terminal block connections inside the customer panel near the unsealed opening showed damage consistent with arcing.³
- The areas indicated by the SBFDF fire report to be considered fire origin/cause of ignition come under the customer’s responsibility.⁴
- PG&E SmartMeter sustained minimal damage - slight melting on the exterior surface and no visible damage to the associated prongs on the connection side of the meter. Additionally, there were no exterior fire patterns above the electric meter.⁵
- There were no blown fuses or any damage to the transformer.

Upon opening the customer's panel, a terminal block with six connections underneath was viewed (Figure 8) with the connections on the right-side displaying damage. The damage appears to have been caused by arcing. Also visible was an open, unsealed area at the bottom of the panel which would allow for small animal entry – two burnt frogs were found at the base of the panel, leading to the theory that they may have caused cross phasing inside the area which would cause arcing to the terminal connections.

Figure 8: Terminal Block under meter – right side shows damage. Opening in bottom of panel is visible. Taken on site visit July 19, 2021.

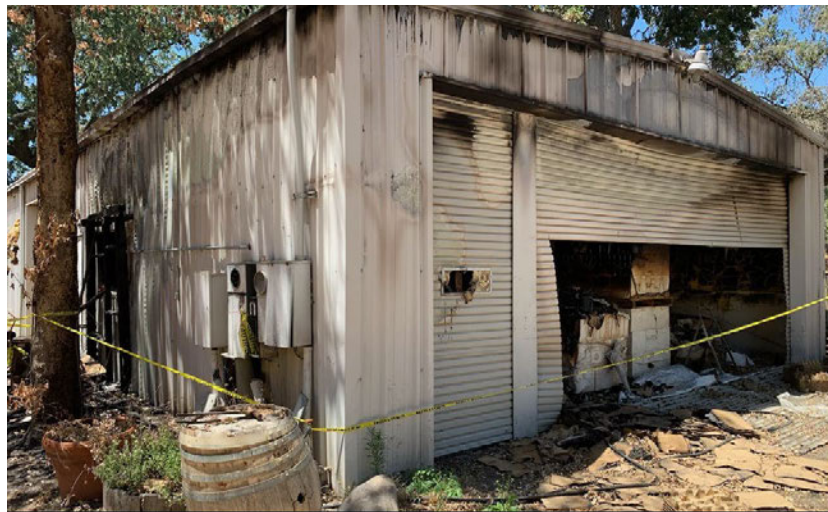
Figure 9: Roll up door accessed by first responders. Photo taken by meter tech on July 1, 2021.
