Event Analysis Report

Daly City – Property Damage

EIR No.: EI200621A

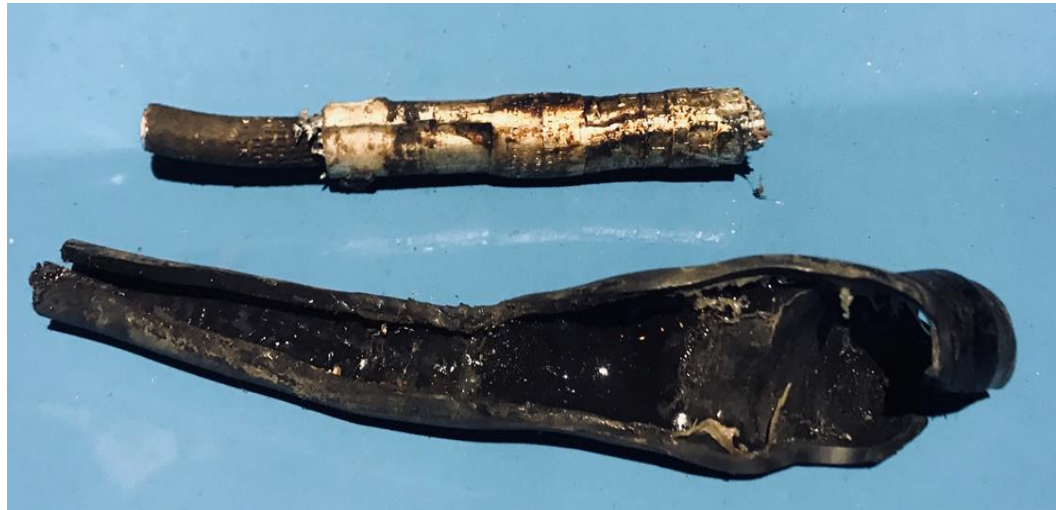
Photograph 1: Taken on June 22, 2020 of the secondary neutral splice with pin terminal connector (Top) and rubberized cover (Bottom) that was recovered by the troubleman

Based on the visual examination of the inside surface of the splice and the copper wire, it can be concluded that the splice failed by arcing as evidenced by melted globules on the copper wire. Whitish corrosion debris could be seen on the splice as well as the edge of the splice in this region of the damaged insulation. This corrosion was attributed due to liquid water and moisture ingress through the cracked insulation.

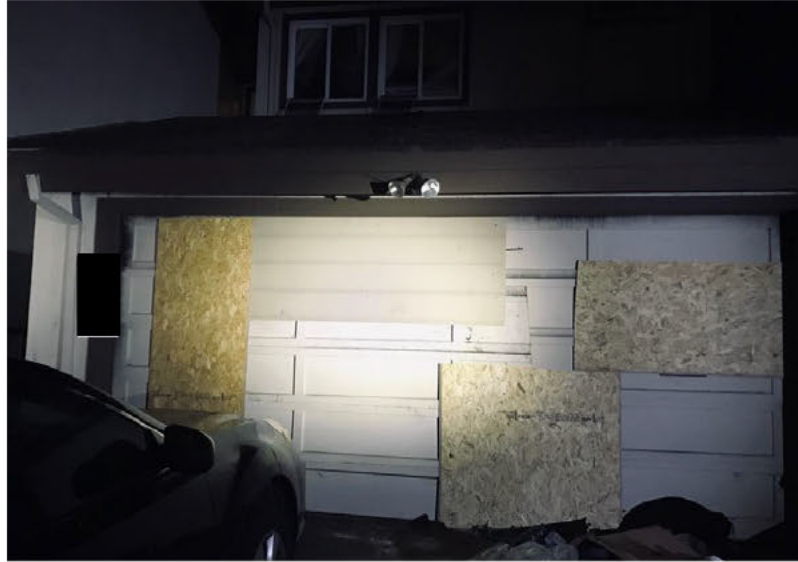
Photograph 2: Taken by the troubleman on June 21, 2020 of the outside of the Incident Location and boarded garage

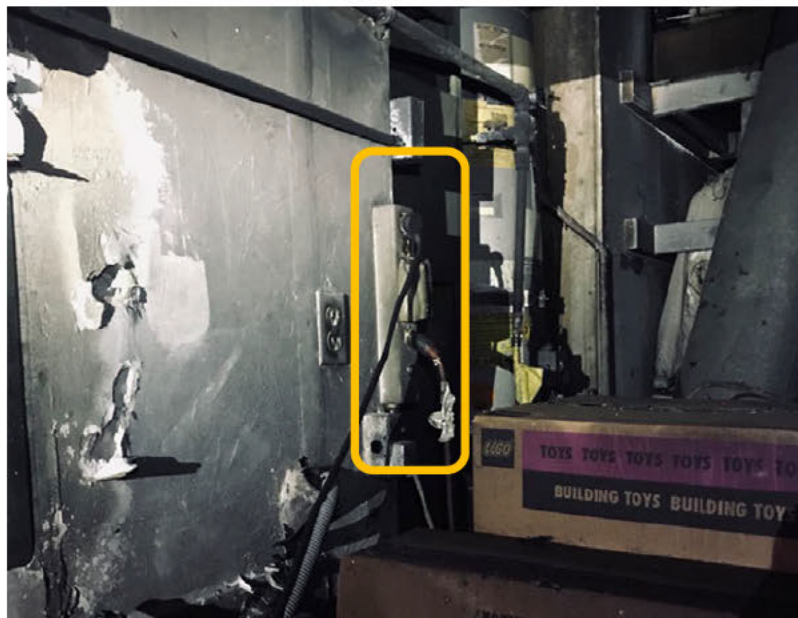
- Observation 1: On the date of the incident, NCFA observed that the fire was located inside the garage, near the garage main door leading to the home. The fire was concentrated on the back wall inside of the garage. The NCFA report indicates that the heat and subsequent fire appears to have ignited when clothes from atop a clothes dryer fell onto multiple tool batteries plugged into a power strip coupled with another power strip. The small fire charred the corner of the garage and damaged the contents inside the garage that produced a lot of heat and smoke. The source was from the customer's powered equipment that may have electrically failed and malfunctioned.

Photograph 3: Taken by the troubleman on June 21, 2020 inside of the garage that depicts the customer's 50v surge protector plugged into a second surge protector

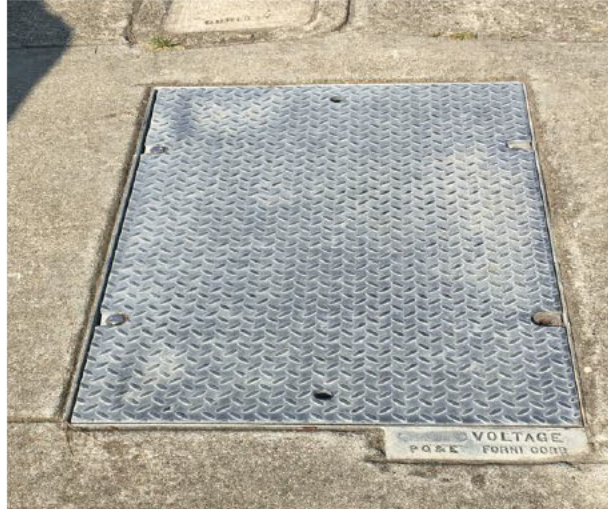
Photograph 4: Taken on October 4, 2021 of the secondary splice box lid

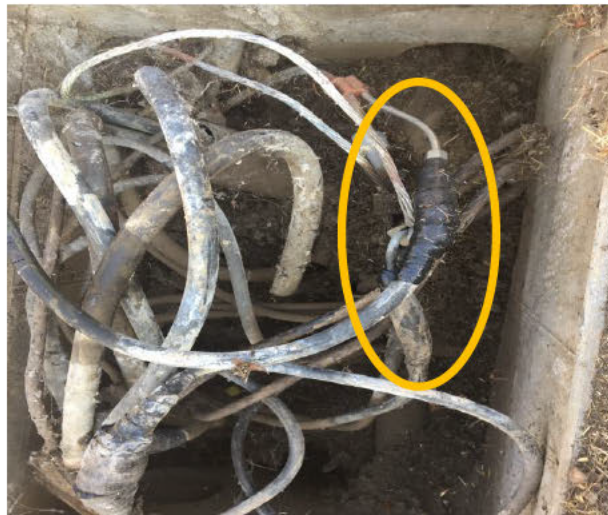
- Observation 3: On October 4, 2021 the EII investigator met with the PG&E restoration supervisor at the Incident Location and inspected the repair by the troubleman. There were no anomalies found.

Photo 5: Taken on October 4, 2021 of the neutral splice repair previously made by the troubleman
