NOV_CAC9_LU_20220804_1232

NOTICE OF VIOLATION

Energy Safety Inspection Report

Report Number: CAC9_LU_20220804_1232

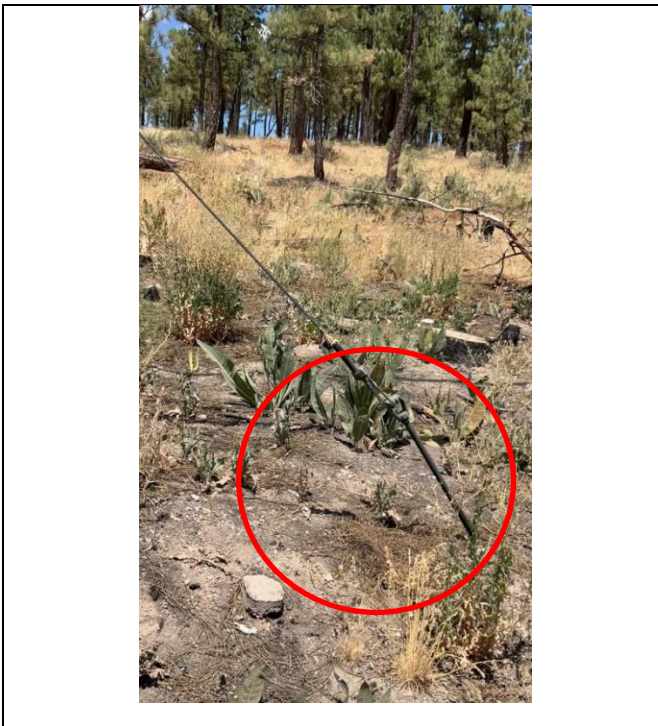
D2 Photos

Defect 2: Energy Safety found fire damage to the down guy wire and its hardware at the above referenced pole number 294723 (Lat/Long: 39.81342673405091, -120.462361682919), as shown in D2 photos on page A-2. The purpose of guy wires is to provide the necessary mechanical support of the pole, conductors, equipment, and balance the load. If the load on a pole is unbalanced, then the structure can become unstable and increase the likelihood of failure. By itself, this would warrant a Minor risk defect. However, in conjunction with Defect 1, Energy Safety considers this defect to be in the Severe risk category.

Item1GW1Img1: Guy anchor rod and strand vice pulled out of the ground

Energy Safety notified Liberty Utilities via phone on August 4, 2022, of the Severe defect listed above. Liberty Utilities responded on August 16, 2022. On August 24, 2022, Liberty Utilities notified Energy Safety that corrective actions were in progress. On September 21, 2022, Liberty notified Energy Safety via email reporting that the pole and guy wire has been replaced. Energy Safety accepts Liberty Utilities’ response and considers this defect closed.

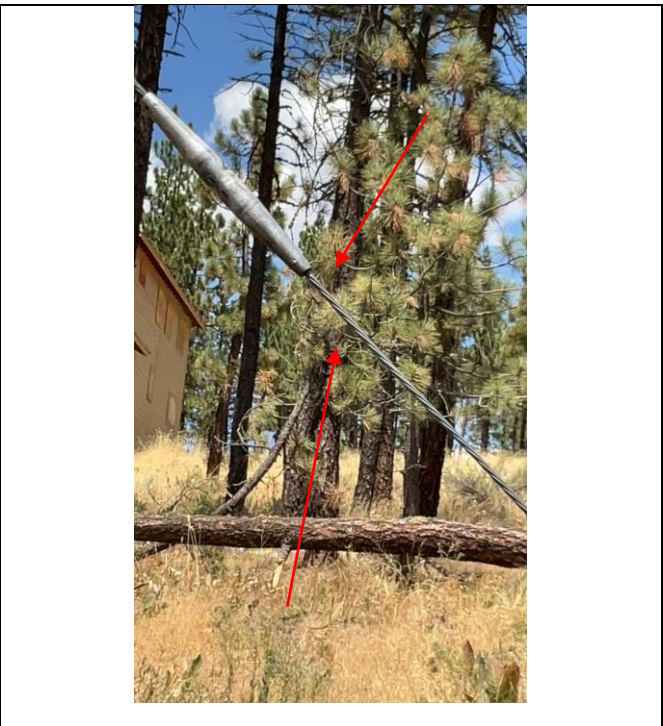
Item1GW1Img2: Evidence of Guy Wire having been exposed to fire

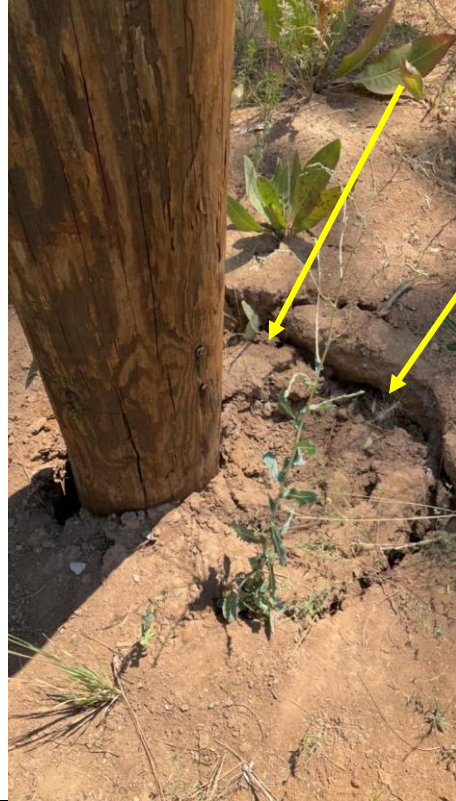
V1 Photos

Visual inspection of the base of the pole shows a hole in the earth at the base of the pole approximately three inches in diameter, and an area approximately one foot in diameter around the base that was not filled in or firmly piled up around the base of the pole. See V1 photo on page A-6. Failure to adhere to pole setting protocols may decrease the stability of the pole, increasing the possibility of failure, which may lead to falling, leaning, and reduced clearances, thereby increasing ignition risk and endangering public safety. Energy Safety considers this violation for failure to adhere to protocol to be in the Moderate risk category.

Item5IA2Img1: Possible material movement at the base of the pole
