NOD\_CAC9\_LU\_20220804\_1232

## **NOTICE OF DEFECT**

# Energy Safety Inspection Report

Report Number: CAC9\_LU\_20220804\_1232

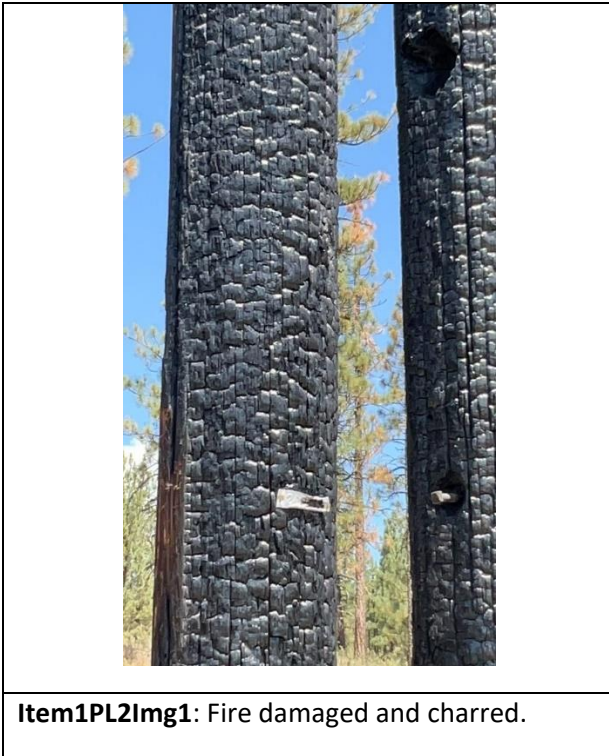
D1 Photo

**Defect 1:** Energy Safety observed that pole number 294723 (Lat/Long: 39.81342673405091, -120.46236168291999) shows severe fire damage and is completely charred from the ground to the top of the pole. Energy Safety considers this defect to be in the Severe risk category.

Defect 1: Energy Safety observed that pole number 294723 (Lat/Long: 39.81342673405091, -120.46236168291999) shows severe fire damage and is completely charred from the ground to the top of the pole, as shown in the D1 photo on page A-2. Poles are intended to support the structural and mechanical loads of the energized equipment on the pole. When a pole is charred from fire damage, it loses material strength and may no longer support the loads it was designed to hold. In such cases, the pole is unable to safely support overhead equipment, and may result in pole failure causing energized equipment on the pole to fall on the ground. Liberty Utilities’ Concatenated\_Standards.pdf document GEN02T 7.1 states, “Poles must be able to support the

horizontal loads caused by wind loading on the pole itself, plus the wind on the conductors/equipment supported by the pole.”<sup>4</sup> Further, General Order 95 (GO 95) states, “Poles must be of sound timber.”<sup>5</sup> Energy Safety found this pole is not of sound timber increasing the chance of pole failure and thereby increasing Liberty Utilities’ ignition and wildfire risk. Energy Safety considers this defect to be in the Severe risk category.

Energy Safety notified Liberty Utilities by phone on August 4, 2022, of the Severe defect listed above. Liberty Utilities responded on August 16, 2022. On August 24, 2022, Liberty Utilities notified Energy Safety that corrective actions were in progress. On September 21, 2022, Liberty Utilities notified Energy Safety by email reporting that the pole has been replaced. Energy Safety accepts Liberty Utilities’ response and considers this defect closed.

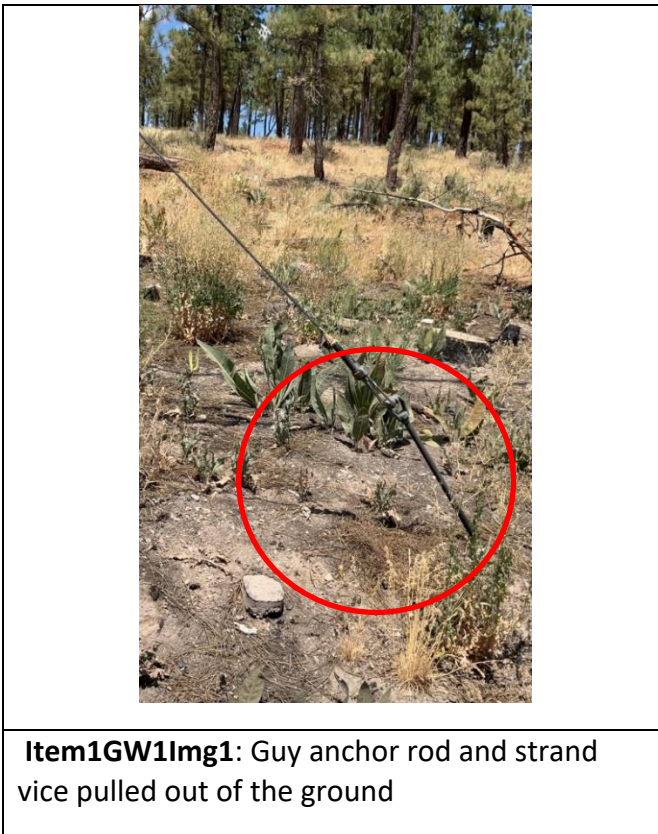
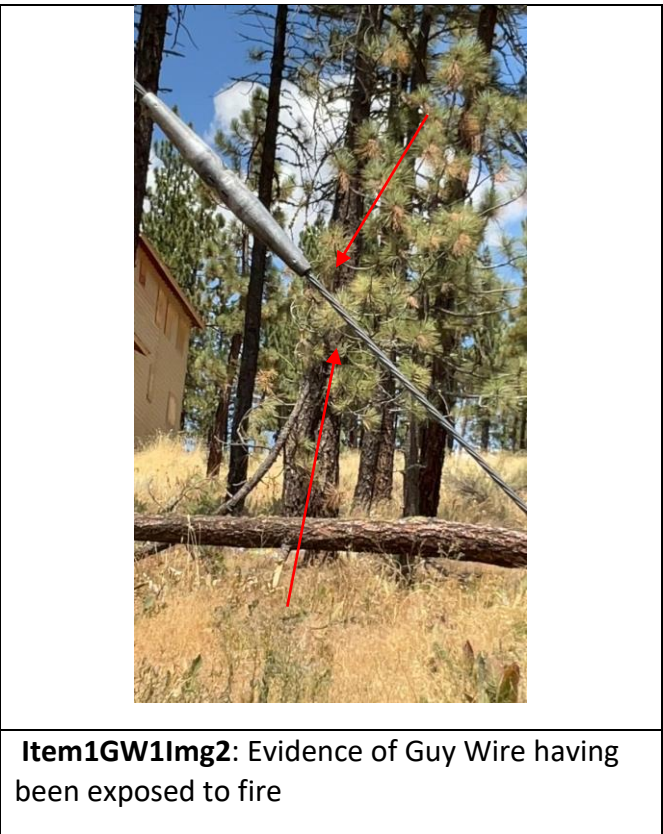
D2 Photos

**Defect 2:** Energy Safety observed fire damage to the down guy wire and its associated hardware at pole number 294723 (Lat/Long: 39.81342673405091, -120.462361682919). By itself, this would warrant a Minor risk defect. However, in conjunction with Defect 1, Energy Safety considers this defect to be in the Severe risk category.

Defect 2: Energy Safety found fire damage to the down guy wire and its hardware at the above referenced pole number 294723 (Lat/Long: 39.81342673405091, -120.462361682919), as shown in D2 photos on page A-2. The purpose of guy wires is to provide the necessary mechanical support of the pole, conductors, equipment, and balance the load. If the load on a pole is unbalanced, then the structure can become unstable and increase the likelihood of failure. By itself, this would warrant a Minor risk defect. However, in conjunction with Defect 1, Energy Safety considers this defect to be in the Severe risk category.

Energy Safety notified Liberty Utilities via phone on August 4, 2022, of the Severe defect listed above. Liberty Utilities responded on August 16, 2022. On August 24, 2022, Liberty Utilities notified Energy Safety that corrective actions were in progress. On September 21, 2022, Liberty notified Energy Safety via email reporting that the pole and guy wire has been replaced. Energy Safety accepts Liberty Utilities’ response and considers this defect closed.

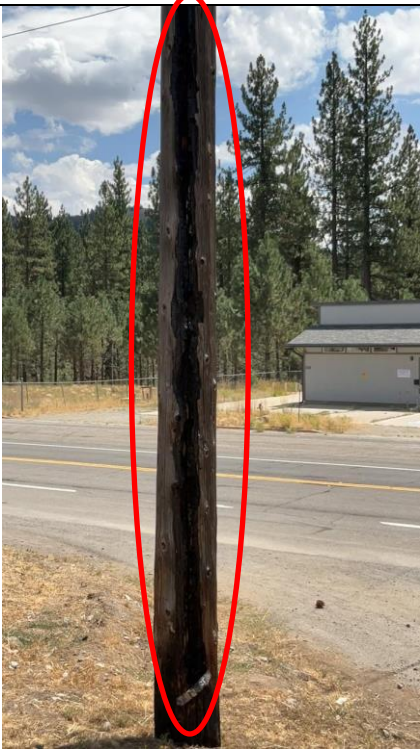
**Defect 3:** Energy Safety observed a burn crater traversing the center of pole number 70936 (Lat/Long: 39.81348906530345, -120.462249268081). Energy Safety considers this defect to be in the Severe risk category.

Defect 3: Energy Safety observed a burn crater through the center of the pole, spanning the entire length of pole number 70936 (Lat/Long: 39.81348906530345, -120.462249268081), as shown in D3 photos on page A-4. Poles are intended to support the structural and mechanical loads of the energized equipment on the pole. When a pole is hollowed from fire damage, it may lose material strength and can no longer support the same loads it was originally designed for. In such cases, the pole is unable to safely support overhead equipment, and may result in pole failure causing energized equipment on the pole to fall on the ground, increasing ignition risk. Liberty Utilities' Concatenated\_Standards.pdf document GEN02T 7.1 states, "Poles must be able to support the horizontal loads caused by wind loading on the pole itself, plus the wind on the conductors/equipment supported by the pole."<sup>3</sup> Further, GO 95 states, "Poles must be of sound timber."<sup>4</sup> Energy Safety found this pole may not be of sound timber increasing the chance of pole failure and thereby increasing Liberty Utilities' ignition and wildfire risk.. Energy Safety considers this defect to be in the Severe risk category.

Item3PL2Img1: Fire damaged

Energy Safety notified Liberty Utilities via phone on August 4, 2022, of the Severe defect listed above. Liberty Utilities responded on August 16, 2022. On August 24, 2022, Liberty Utilities notified Energy Safety that corrective actions were in progress. On September 21, 2022, Liberty Utilities notified Energy Safety via email reporting that the pole has been replaced. Energy Safety accepts Liberty Utilities' response and considers this defect closed.

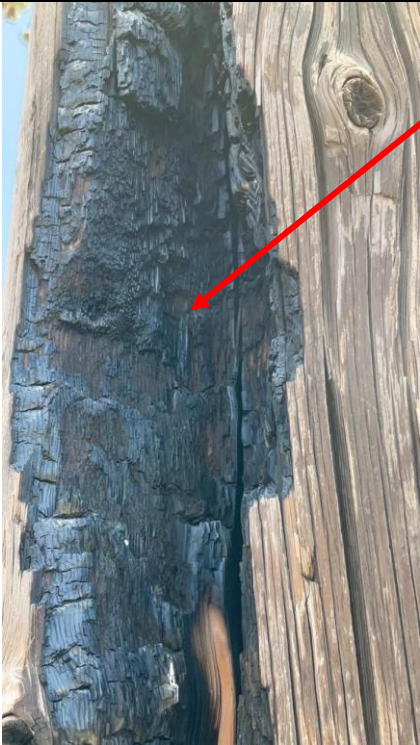
Item3PL2Img2: Fire hollowed out pole

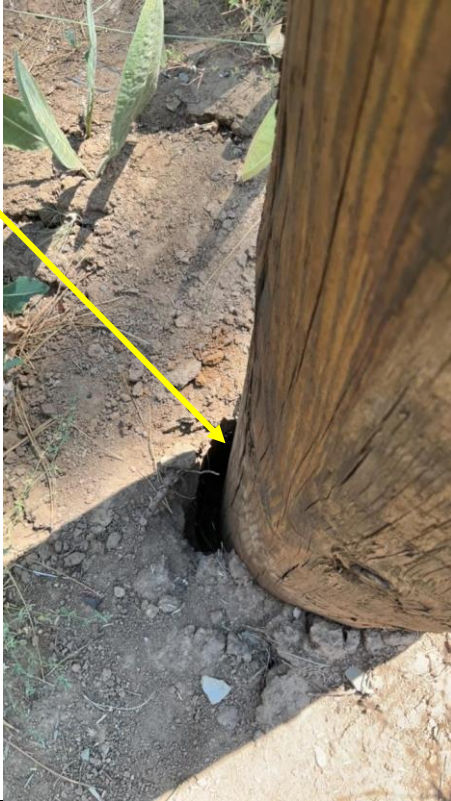
Visual inspection of the base of the pole shows a hole in the earth at the base of the pole approximately three inches in diameter, and an area approximately one foot in diameter around the base that was not filled in or firmly piled up around the base of the pole. See V1 photo on page A-6. Failure to adhere to pole setting protocols may decrease the stability of the pole, increasing the possibility of failure, which may lead to falling, leaning, and reduced clearances, thereby increasing ignition risk and endangering public safety. Energy Safety considers this violation for failure to adhere to protocol to be in the Moderate risk category.

**Item5IA2Img2:** Hole at the base of pole that was not filled in or firmly set

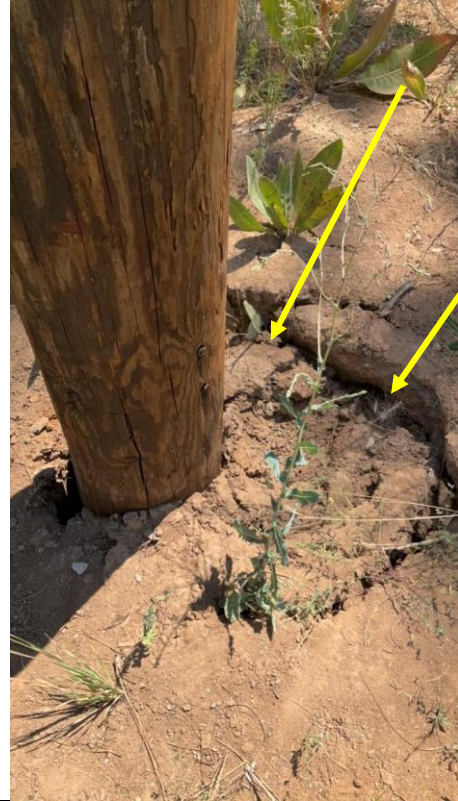
**Item5IA2Img1:** Possible material movement at the base of the pole
