## NOTICE OF VIOLATION

On November 28, 2023, Energy Safety conducted an inspection of Pacific Gas and Electric Company's WMP initiatives in the vicinity of the city of Willits, California. The inspection report is enclosed herewith. Energy Safety found the following violation(s):

# INSPECTION REPORT

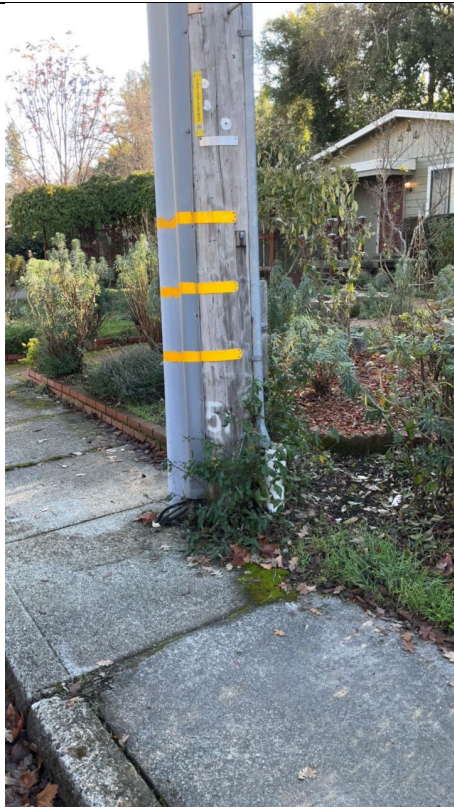
<p>Item6GImg1: Pole ID</p>	<p>Item6GImg2: Overall pole</p>

On pole number 121372843 at 127 Mill Creek Dr, Willits, CA, 95490, USA, 39.414468934293, - 123.361763449499, the inspector observed that pole clearing was not completed per protocol. The inspector's observation is documented in Violation 2 photographs, which are attachments to this report. Photo numbers Item6GIimg1, Item6GIimg2, Item6IA1img1, and Item6IA1img2 depict a non-exempt 3-foot tall, irrigated landscaping within the 10 ft firebreak radius.

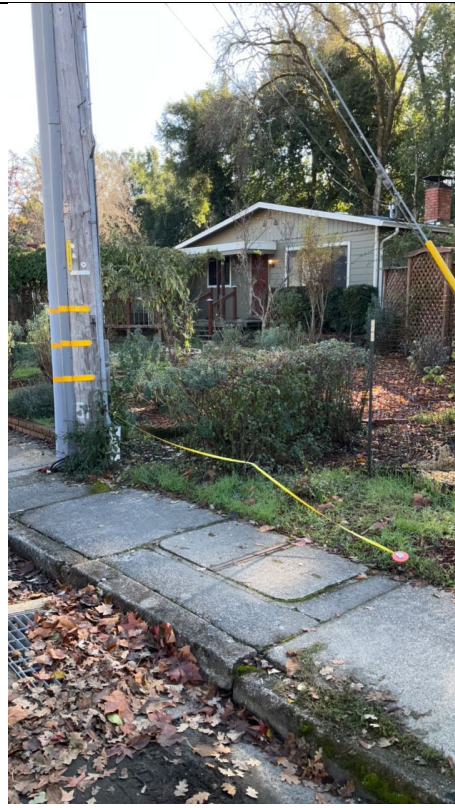
1. Pacific Gas and Electric Company's WMP clearance work was identified as complete at this location.
2. A vegetation exemption does not exist at this location.
3. The location of the pole is in a residential community next to a pedestrian sidewalk and street.
4. The vegetation is maintained by the owner.
5. The vegetation density is minimal.

**Item6IA1Img1:** Live vegetation within 10-foot radial clearance.

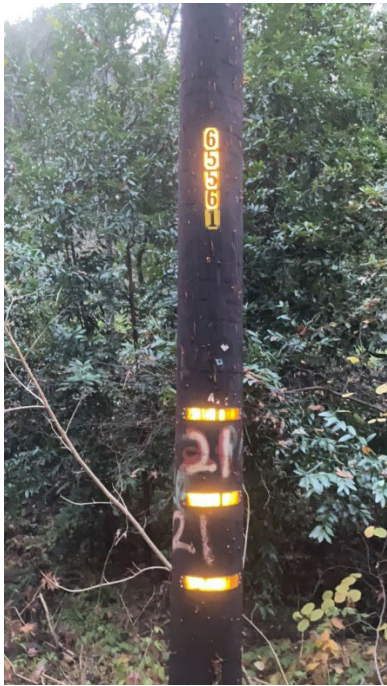
**Item14GIimg1:** Pole ID not present. The number 65561 is an unknown tag number.

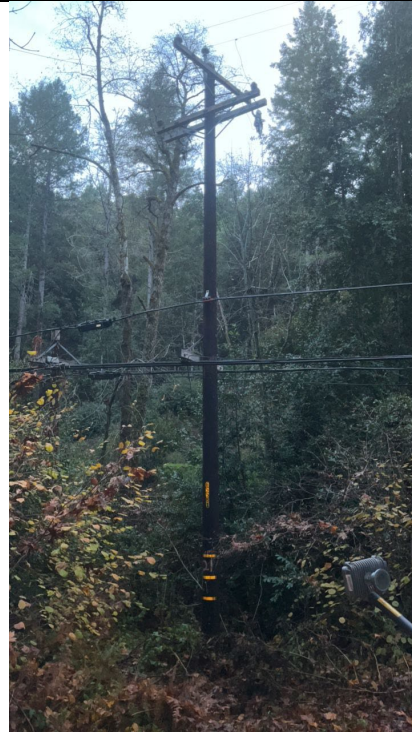
**Item14GIimg2:** Overall view of pole.

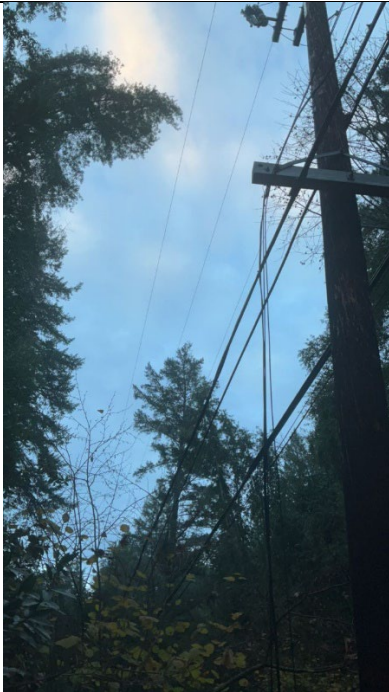
1. Pacific Gas and Electric Company's WMP clearance work was identified as complete at this location.
2. There is no evidence at the location indicating that pole brushing occurred.
3. Flammable vegetation was present within the 10 ft firebreak radius.
4. The vegetation density is moderate and is in contact with the pole.

**Item14GIimg3:** Top view of pole showing heavy vegetation.

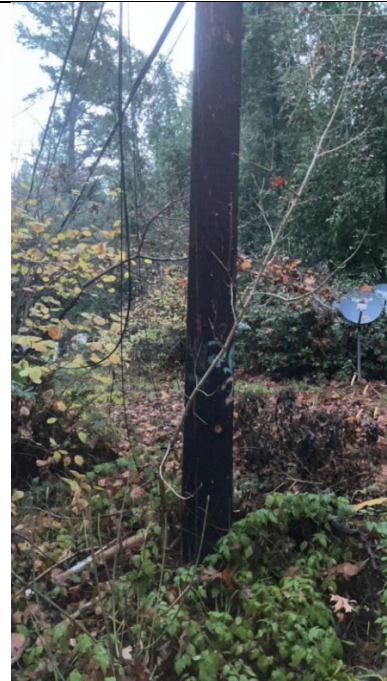
**Item14IA1img1:** Sapling resprout at base of pole.

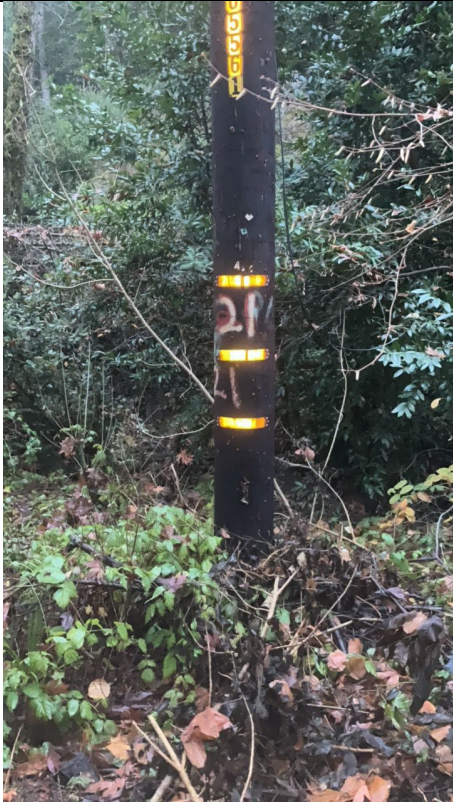
On an unnumbered pole at 29501 N Highway 101, Willits, CA, 95490, USA, 39.49699199735, - 123.366467972922, the inspector observed that pole clearing was not performed. The inspector's observation is documented in Violation 3 photographs, which are attachments to this report. Photo numbers Item14GIimg1, Item14GIimg2, Item14GIimg3, Item14IA1img1, Item14IA1img2, and Item14IA1img3 depict live vegetation and dead brush within the 10 ft firebreak radius.

**Item14IA1img2:** Live vegetation within the firebreak 10-foot radial clearance.

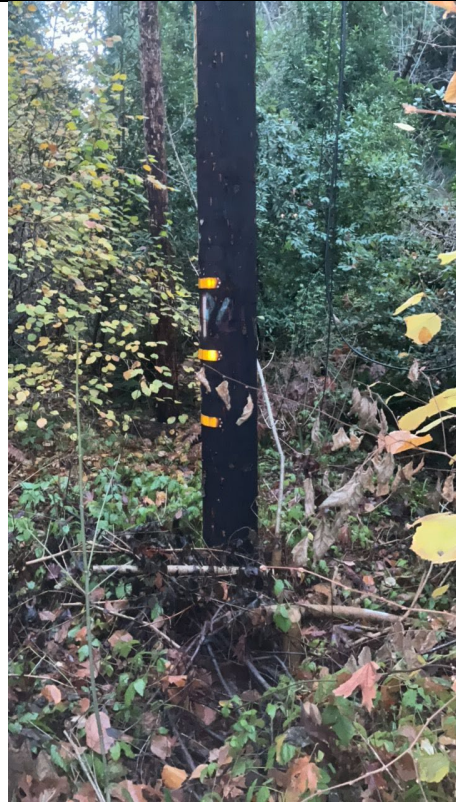
**Item14IA1img3:** Dead wood within the firebreak 10-foot radial clearance.
