## NOTICE OF VIOLATION

# INSPECTION REPORT

Electrical Corporation:	Liberty Utilities (LU)
Report Number:	LU_CAC18_20231025_0916
Inspector:	CAC18
WMP Year Inspected:	2023
Quarterly Data Report (QDR) Referenced:	Quarter 2 (Q2)
Inspection Selection:	Energy Safety viewed the contents of the Q2 QDR and performed an analysis that resulted in the selection of the WMP initiatives and locations referenced in this report.
Relevant WMP Initiative(s):	Clearance (2023 WMP initiative number 8.2.3.3)
Date of inspection:	October 25, 2023
City and/or County of Inspection:	South Lake Tahoe, El Dorado County
Inspection Purpose:	Assess the accuracy of Liberty Utilities' QDR data, completeness of its work, compliance with WMP requirements, and compliance with its protocols.

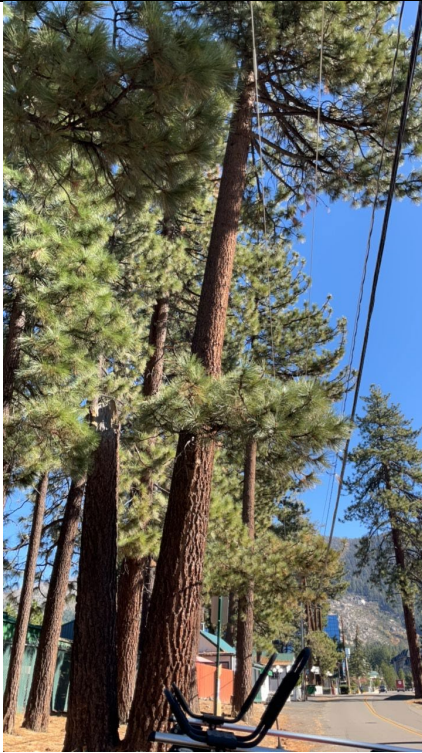
Near pole ID 275568 at 920 Stateline Ave, South Lake Tahoe, CA, 96150, USA, 38.9609062307708, -119.944810162602, the inspector observed two Jeffrey pines within Liberty Utilities' clearance distance of six feet. The inspector's observations are documented in Violation 1 photographs, which are attachments to this report. Photograph numbers Item1G1mg1, Item1G1mg2, Item1IA1mg1, and Item1IA1mg2 depict a Jeffrey pine approximately three feet from primary conductors. Photograph numbers Item1IA1mg3 and Item1IA1mg4 depict a Jeffrey pine that is approximately five feet from primary conductors. The radial clearance requirement from these primary conductors (12kV-25kV) is six feet, and Liberty Utilities failed to trim back to 12-15 feet, per Liberty Utilities' MAT shown in Table 8-23 above.

**Item1IA1img1:** Green Jeffrey pine approximately three feet from a primary conductor.

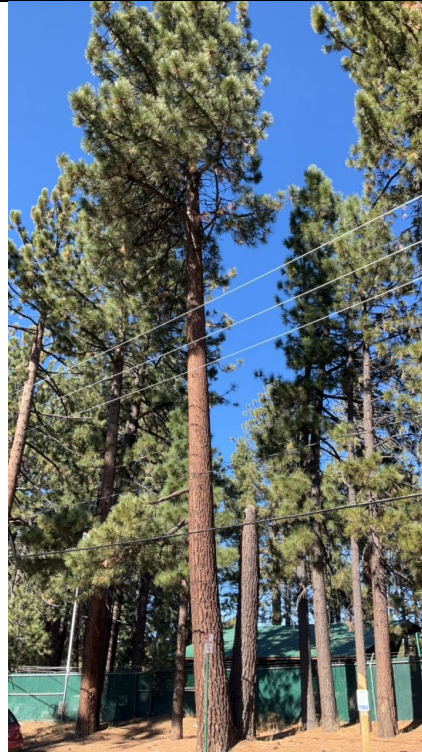
**Item1IA1img2:** Same Jeffrey pine as in image Item1IA1img1.

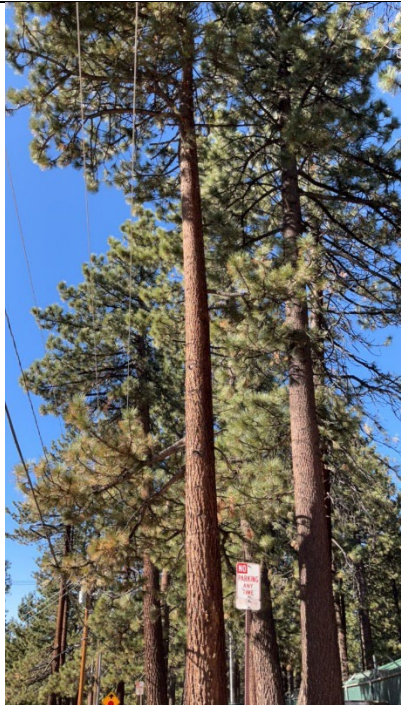
**Item1IA1img3:** Green Jeffrey pine approximately five feet from a primary conductor.

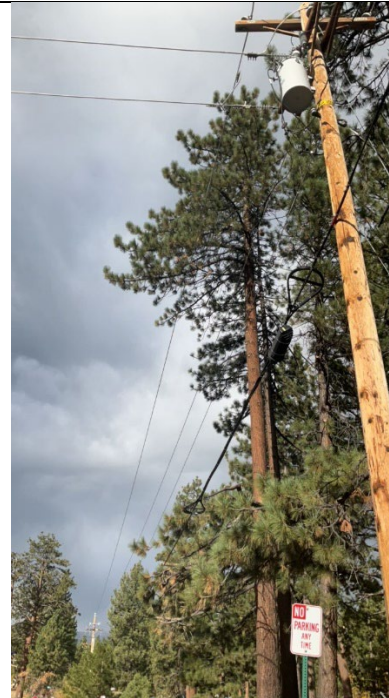
**Item1IA1img4:** Same tree as in image Item1IA1img3. Overall tree picture.
