March 22, 2024

## NOTICE OF VIOLATION

# INSPECTION REPORT

Electrical Corporation:	Liberty Utilities (LU)
Report Number:	LU_CAC18_20231102_1208
Inspector:	CAC18
WMP Year Inspected:	2023
Quarterly Data Report (QDR) Referenced:	Quarter 2 (Q2)
Inspection Selection:	Energy Safety viewed the contents of the Q2 QDR and performed an analysis that resulted in the selection of the WMP initiatives and locations referenced in this report.
Relevant WMP Initiative(s):	Clearance (2023 WMP initiative 8.2.3.3)
Date of inspection:	November 2, 2023
City and/or County of Inspection:	Coleville, Mono County
Inspection Purpose:	Assess the accuracy of Liberty Utilities’ QDR data, completeness of its work, compliance with WMP requirements, and compliance with its protocols.

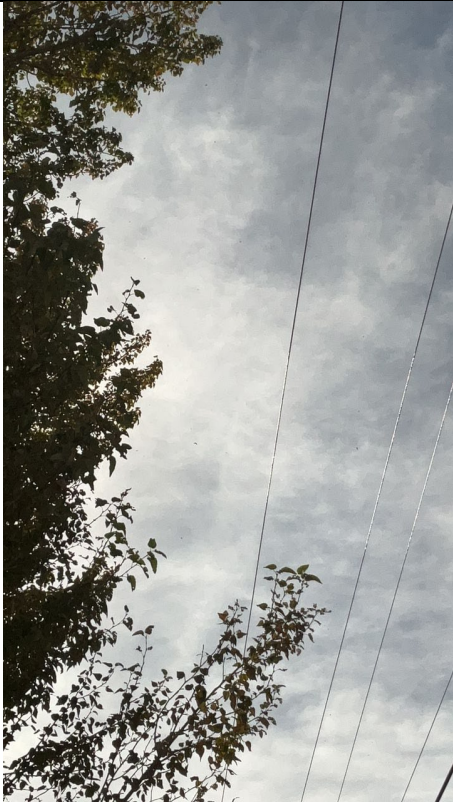
Near pole ID 128913 at 110520-111298 US Highway 395, Coleville, CA, 96107, USA, 38.5532305947518, -119.502482688142, the inspector observed cottonwood trees within Liberty Utilities' clearance distance of six feet. The inspector's observations are documented in Violation 1 photographs, which are attachments to this report. Photograph numbers Item2G1mg1, Item2G1mg2, Item2IA1mg1, and Item2IA1mg2 depict cottonwood trees approximately four to five feet from primary conductors. The radial clearance requirement from these primary conductors (12kV-25kV) is six feet, and Liberty Utilities failed to trim back to 12-15 feet, per Liberty Utilities' MAT shown in Table 8-23 above.

Energy Safety concludes that Violation 1 is Moderate because of these facts:

2. The cottonwood trees were within six feet of the primary conductors.
3. Liberty Utilities did not achieve vegetation clearance of between 12 and 15 feet from primary conductors.

**Item2IA1Img1:** View of cottonwood limbs approximately four to five ft from a primary conductor.

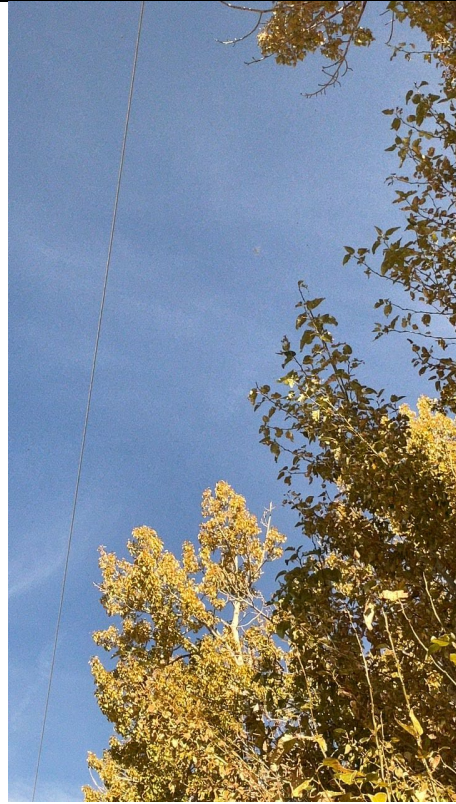
**Item2IA1Img2:** View of cottonwood limbs approximately four to five ft from a primary conductor.

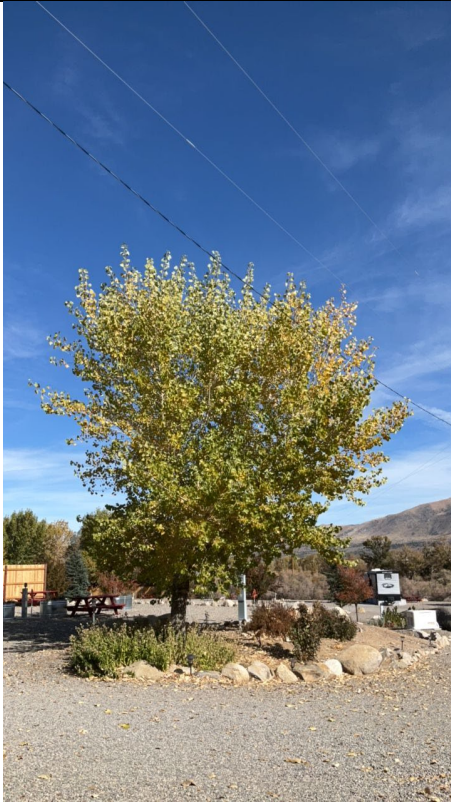
Near pole ID 260086 at 110065-110499 US Highway 395, Coleville, CA, 96107, USA, 38.5520217369178, -119.503151731416, the inspector observed a cottonwood tree within Liberty Utilities’ clearance distance of six feet. The inspector’s observations are documented in Violation 2 photographs, which are attachments to this report. Photograph numbers Item4G1mg1, Item4G1mg2, Item4IA11mg1, and Item4IA11mg2 depict a cottonwood tree within approximately six feet from primary conductors. The radial clearance requirement from these primary conductors (12kV-25kV) is six feet, and Liberty Utilities failed to trim back to 12-15 feet, per Liberty Utilities’ MAT shown in Table 8-23 above.

Energy Safety concludes that Violation 2 is Moderate because of these facts:

1. Liberty Utilities’ WMP clearance work was identified as complete at this location.
2. The cottonwood tree was within six feet of primary conductors.

- Liberty Utilities did not achieve vegetation clearance of between 12 and 15 feet from primary conductors.

**Item4IA1Img1:** View of cottonwood tree within six ft of a primary conductor.

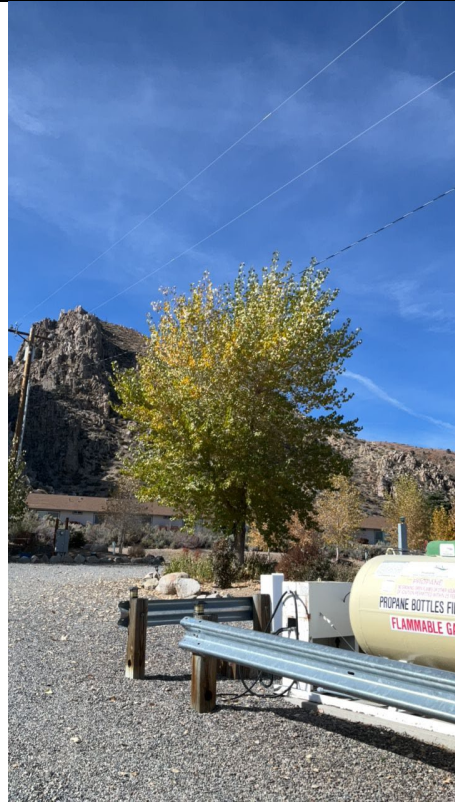
**Item4IA1Img2:** Secondary view of cottonwood tree within six ft of a primary conductor.

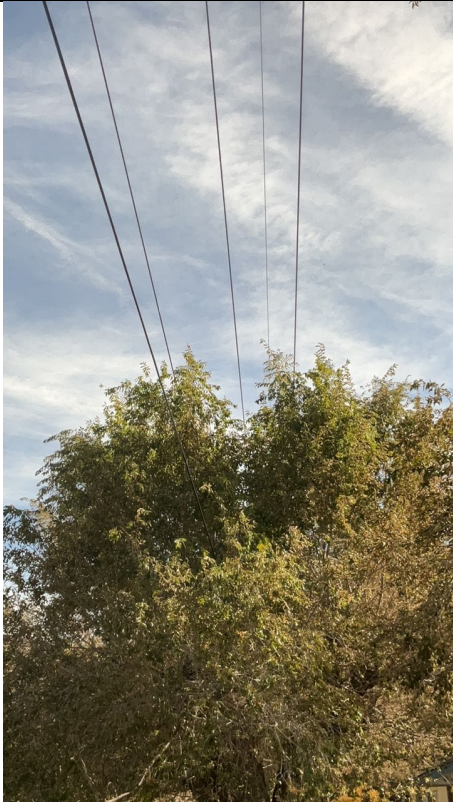
Near pole ID 293672 at Mile 108 US Highway 395, Coleville, CA, 96107, USA, 38.5196868593662, - 119.484202482983, the inspector observed an elm tree within Liberty Utilities’ clearance distance of six feet. The inspector’s observations are documented in Violation 3 photographs, which are attachments to this report. Photograph numbers Item5GIimg1, Item5GIimg2, Item5IA1img1, and Item5IA1img2 depict the elm tree approximately five feet from primary conductors. The radial clearance requirement from these primary conductors (12kV-25kV) is six feet, and Liberty Utilities failed to trim back to 12-15 feet, per Liberty Utilities’ MAT shown in Table 8-23 above.

Energy Safety concludes that Violation 3 is Moderate because of these facts:

- Liberty Utilities’ WMP clearance work was identified as complete at this location.
- The elm tree is within six feet of primary conductors.

3. Liberty Utilities did not achieve vegetation clearance of between 12 and 15 feet from primary conductors.

**Item5IA1Img1:** Front view of elm tree within five ft from a primary conductor.

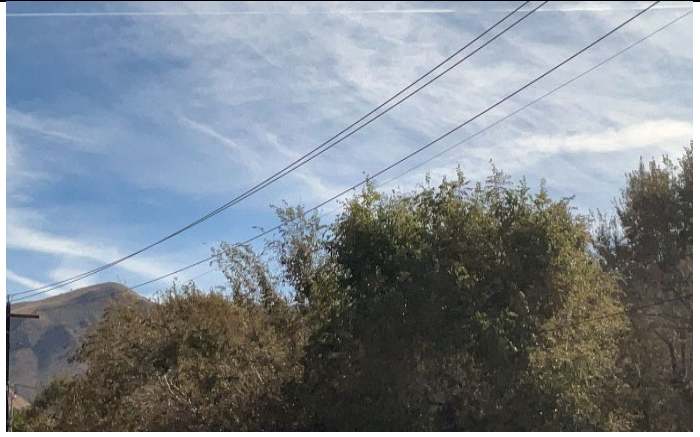
**Item5IA1Img2:** Side view of elm tree within five ft from a primary conductor.
