## NOTICE OF VIOLATION

# INSPECTION REPORT

Electrical Corporation:	Liberty Utilities (LU)
Report Number:	LU_CAC18_20231031_1007
Inspector:	CAC18
WMP Year Inspected:	2023
Quarterly Data Report (QDR) Referenced:	Quarter 2 (Q2)
Inspection Selection:	Energy Safety viewed the contents of the Q2 QDR and performed an analysis that resulted in the selection of the WMP initiatives and locations referenced in this report.
Relevant WMP Initiative(s):	Clearance (2023 WMP initiative number 8.2.3.3)
Date of inspection:	October 31, 2023
City and/or County of Inspection:	Coleville, Mono County
Inspection Purpose:	Assess the accuracy of Liberty Utilities' QDR data, completeness of its work, compliance with WMP requirements, and compliance with its protocols.

## Violation 1

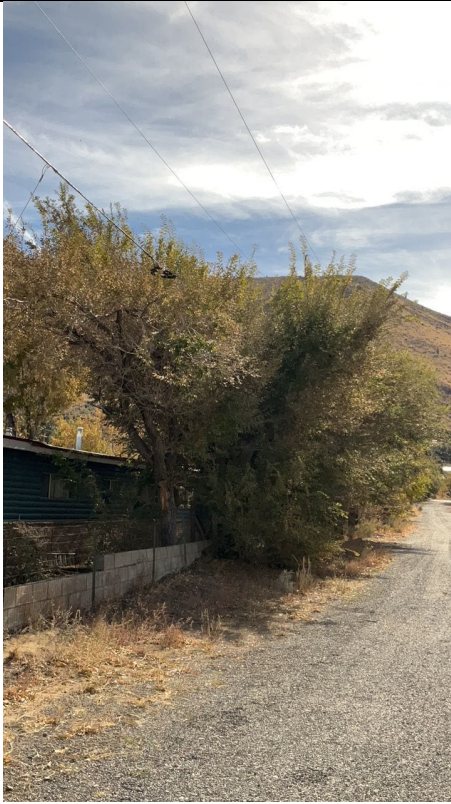
Near pole ID 158410 at 107045 US Highway 395, Coleville, CA, 96107, USA, 38.5128587072477, -119.470726209569, the inspector observed one elm tree approximately three feet and another elm tree approximately five feet below the primary conductors. The inspector's observations are documented in Violation 1 photographs, which are attachments to this report. Photograph numbers Item1GIimg1, Item1GIimg2, Item1GIimg3, Item1GIimg4, and Item1GIimg5 depict an elm tree approximately three feet under primary conductors and a second elm tree approximately five feet under primary conductors. The radial clearance requirement from these primary conductors (12kV-25kV) is six feet, and Liberty Utilities failed to trim back to 12-15 feet, per Liberty Utilities' MAT shown in Table 8-23 above.

**Item1Gimg3:** West view of elm trees underneath the primary conductor.

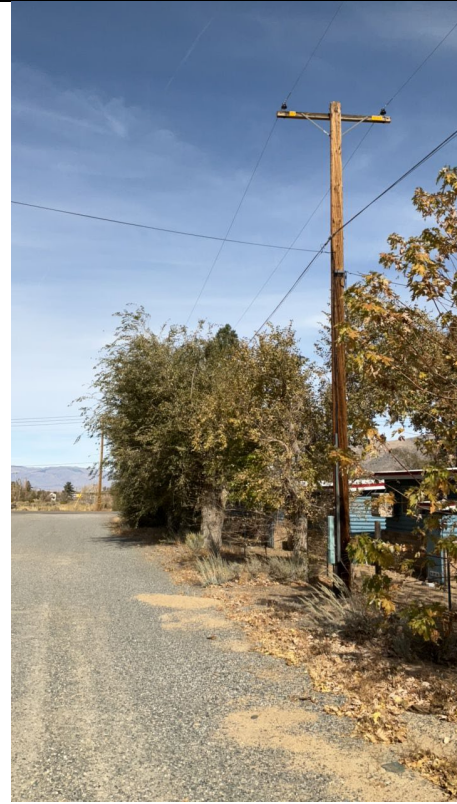
**Item1Gimg4:** East view of elm trees underneath the primary conductor.

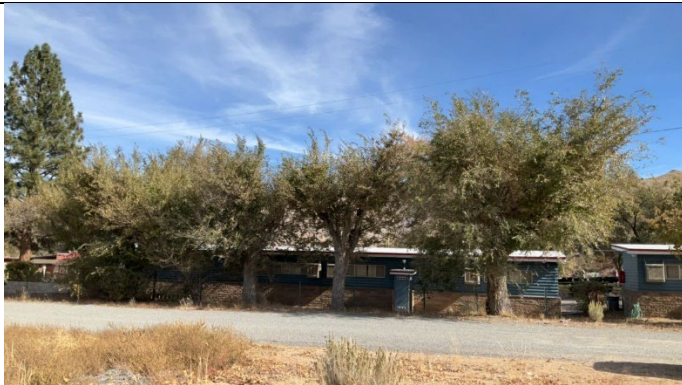
2. Two elm trees were within six feet of primary conductors.
3. Liberty Utilities did not achieve vegetation clearance of between 12 and 15 feet from primary conductors.

**Item1Gimg5:** Overview of clearances of the two elm trees growing underneath high voltage primary conductors. The two elm trees were measured at approximately three feet and five feet under primary conductors.
