NOTICE OF VIOLATION

On November 16, 2023, Energy Safety conducted an inspection of Liberty Utilities' WMP initiatives in the vicinity of the city of Tahoe Vista and Kings Beach, California. The inspection report is enclosed herewith. Energy Safety found the following violations:

INSPECTION REPORT

Electrical Corporation:	Liberty Utilities (LU)
Report Number:	LU_CAC17_20231116_0839
Inspector:	CAC17
WMP Year Inspected:	2022
Quarterly Data Report (QDR) Referenced:	Quarter 3 and Quarter 4 (Q3 and Q4)
Inspection Selection:	Energy Safety viewed the contents of the Q3 & Q4 QDR and performed an analysis that resulted in the selection of the WMP initiatives and locations referenced in this report.
Relevant WMP Initiatives:	Expulsion fuse replacement (WMP 7.3.3.7) Other corrective action/Tree attachments (WMP 7.3.3.12)
Date of inspection:	November 16, 2023
City and County of Inspection:	Tahoe Vista and Kings Beach, Placer County
Inspection Purpose:	Assess the accuracy of Liberty Utilities' QDR data, completeness of its work, compliance with WMP requirements, and compliance with its protocols.

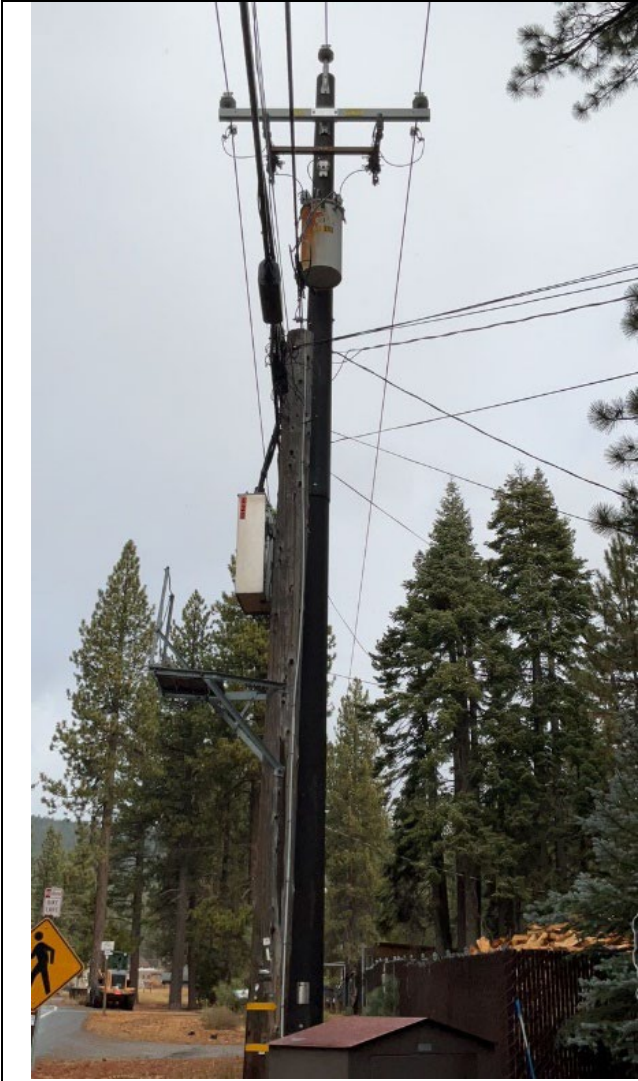
Item1GImg1: Overall pole.

On pole ID 292087 at 420 National Ave, Tahoe Vista, CA, 96148, USA, 39.2426041412934, -120.048456796215, the inspector observed a pair of expulsion fuses. The inspector's observation is documented in Violation 1 photographs, which are attachments to this report. Photo numbers Item1GImg1, Item1GImg2, Item1IA1Img1, and Item1IA1Img2 depict expulsion fuses instead of non-expulsion fuse alternatives.

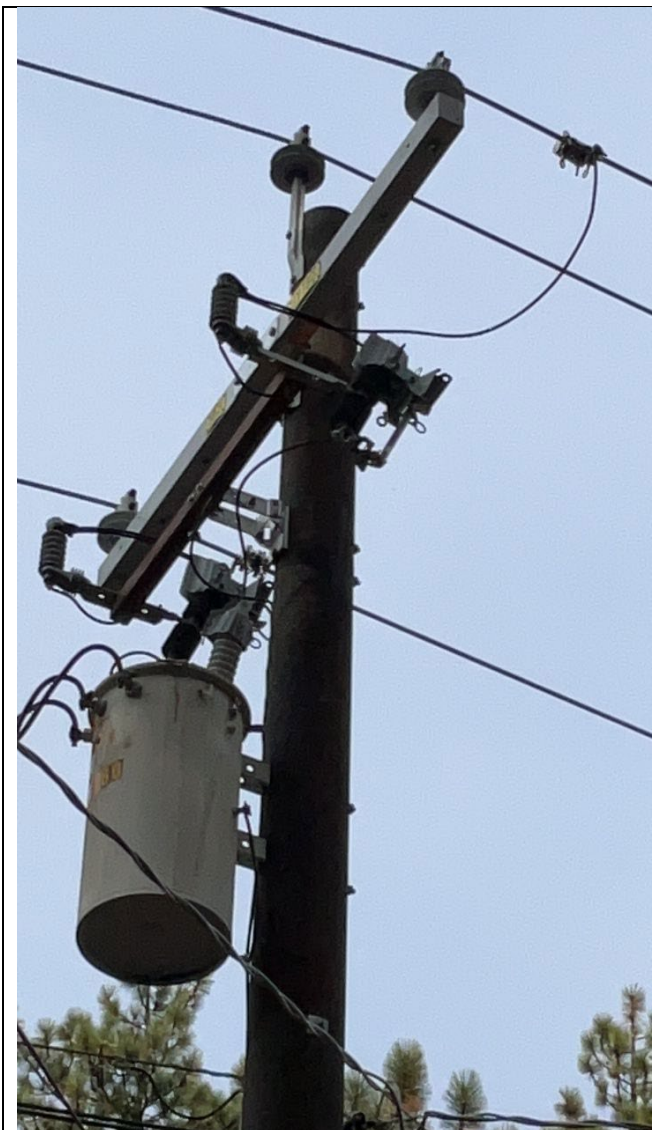
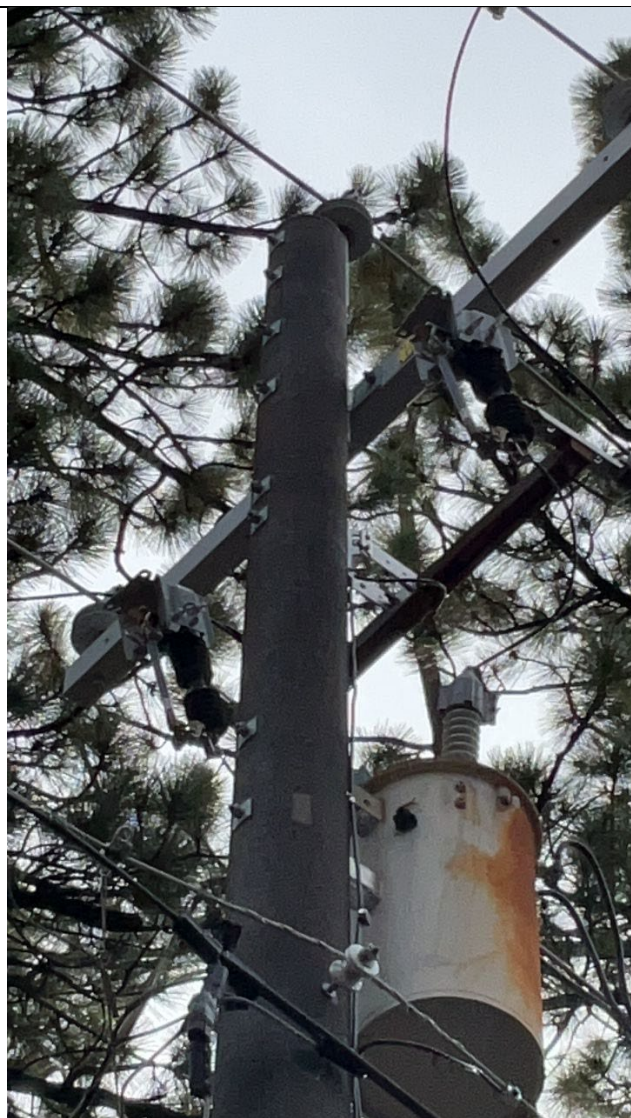
1. Liberty Utilities' WMP initiative number 7.3.3.7 - Expulsion Fuse Replacement work was reported as complete at this location.
2. Expulsion fuses were observed.
3. Non-expulsion fuses were not observed.

Item1IA1Img1: Close-up view of expulsion fuses.

Item1IA1Img2: Close-up view of expulsion fuses.

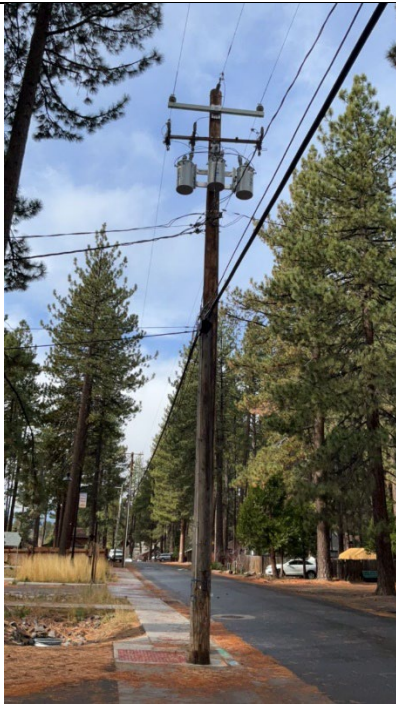
Item4GImg1: Overall pole.

On pole ID 292170 at 8270 Rainbow Ave, Kings Beach, CA, 96143, USA, 39.2384877574962, -120.027669287579, the inspector observed expulsion fuses. The inspector’s observation is documented in Violation 2 photographs, which are attachments to this report. Photo numbers Item4GIimg1, Item4GIimg2, Item4IA1img1, and Item4IA1img2 depict expulsion fuses instead of non-expulsion fuse alternatives.

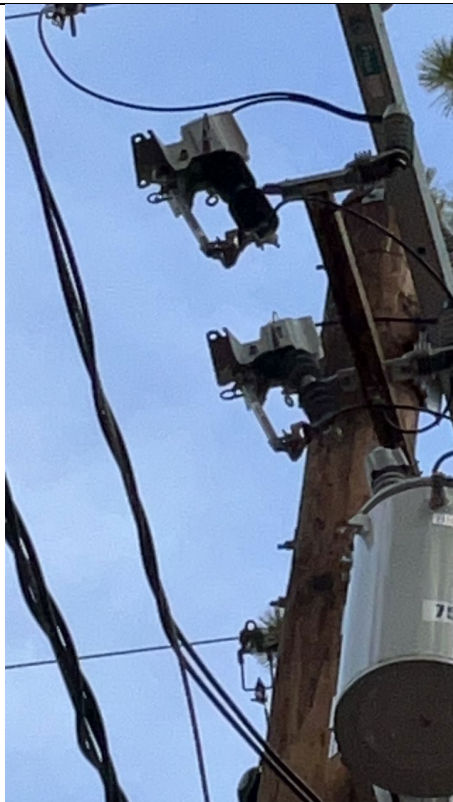
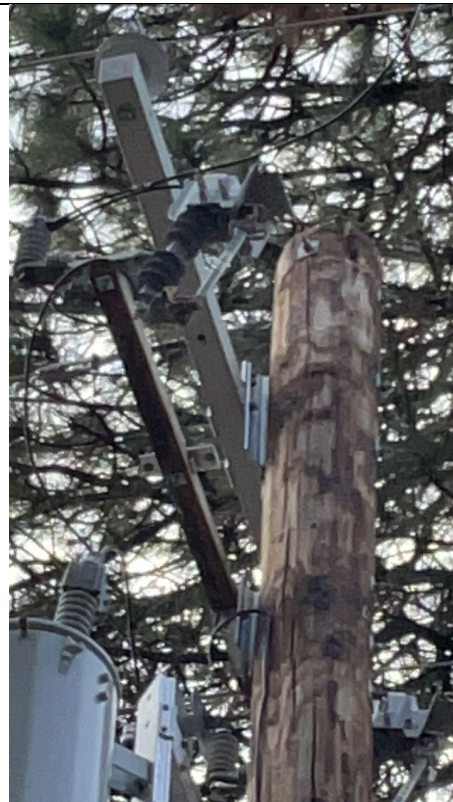
1. Liberty Utilities’ WMP initiative number 7.3.3.7 - Expulsion Fuse Replacement work was reported as complete at this location.
2. Expulsion fuses were observed.
3. Non-expulsion fuses were not observed.

Item4IA1Img1: Close-up view of expulsion fuses.

Item4IA1Img2: Close-up view of expulsion fuses.

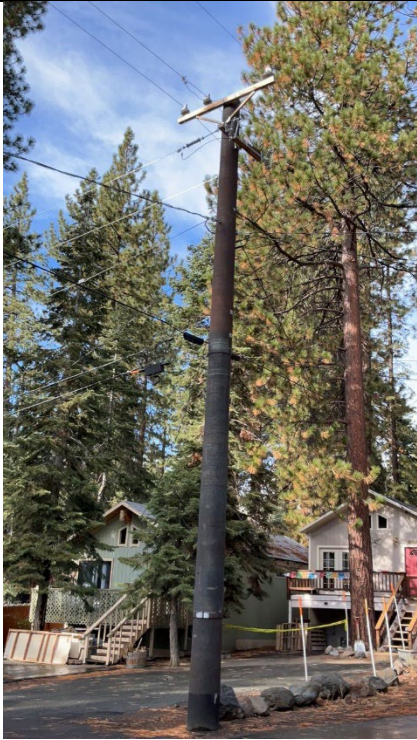
Item8GImg1: Overall pole.

On pole ID 291897 at 8899 Salmon Ave, Kings Beach, CA, 96143, USA, 39.2361242144599, -120.016292223114, the inspector observed a tree attachment. The inspector’s observation is documented in Violation 3 photographs, which are attachments to this report. Photo numbers Item8GIimg1, Item8GIimg2, and Item8GIimg3 depict a tree attachment where the attachment was reported as removed.

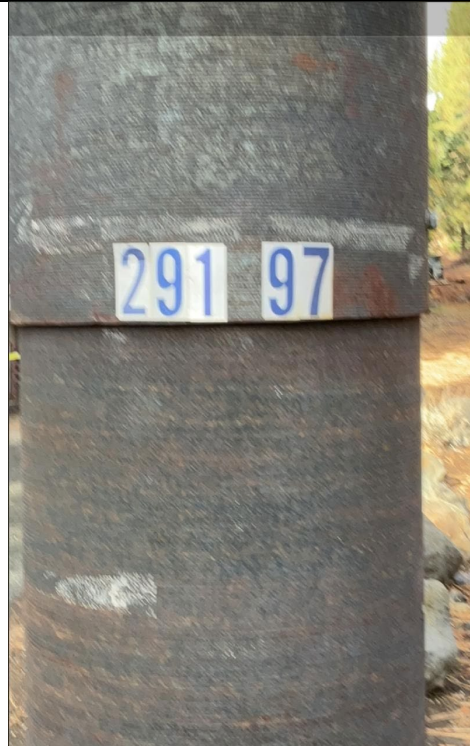
Item8GImg2: Pole ID (damaged).

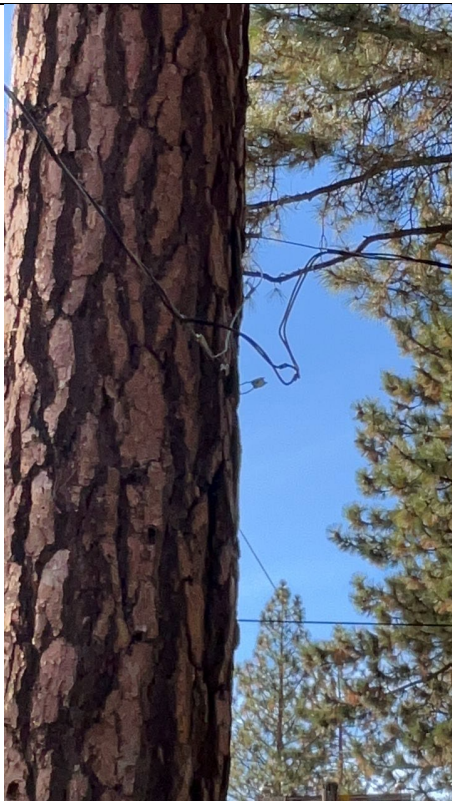
1. Liberty Utilities' WMP 7.3.3.12 - Other corrective action: Tree attachment work was identified as complete at this location.
2. Liberty Utilities failed to remove the tree attachment and reroute the service line using a new pole.

Item8GImg3: Close-up view of tree attachment.

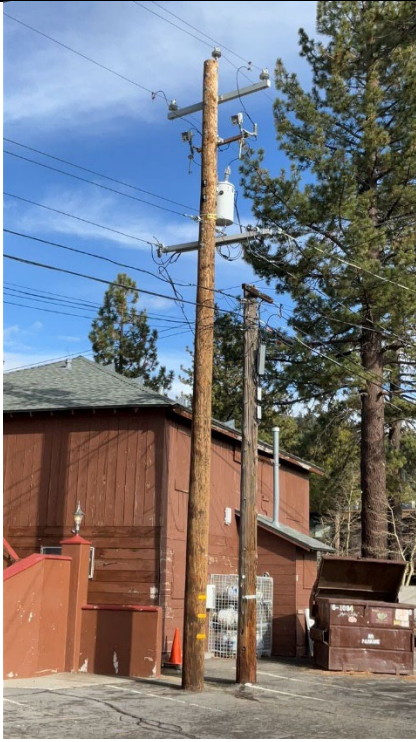
Item9GImg1: Overall pole.

On pole ID 292090 at 8216 Brockaway Vista Drive, Kings Beach, CA, 96143, USA, 39.2369406983482, -120.027923542717, the inspector observed expulsion fuses. The inspector's observation is documented in Violation 4 photographs, which are attachments to this report. Photo numbers Item9GImg1, Item9GImg2, and Item9GImg3 depict expulsion fuses instead of non-expulsion fuse alternatives.

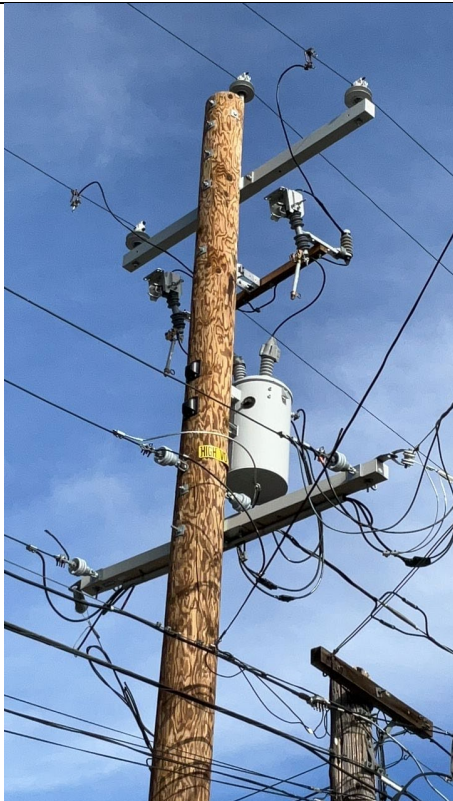
1. Liberty Utilities' WMP initiative number 7.3.3.7 - Expulsion Fuse Replacement work was reported as complete at this location.
2. Expulsion fuses were observed.
3. Non-expulsion fuses were not observed.

Item9GImg3: View of two expulsion fuses (open).

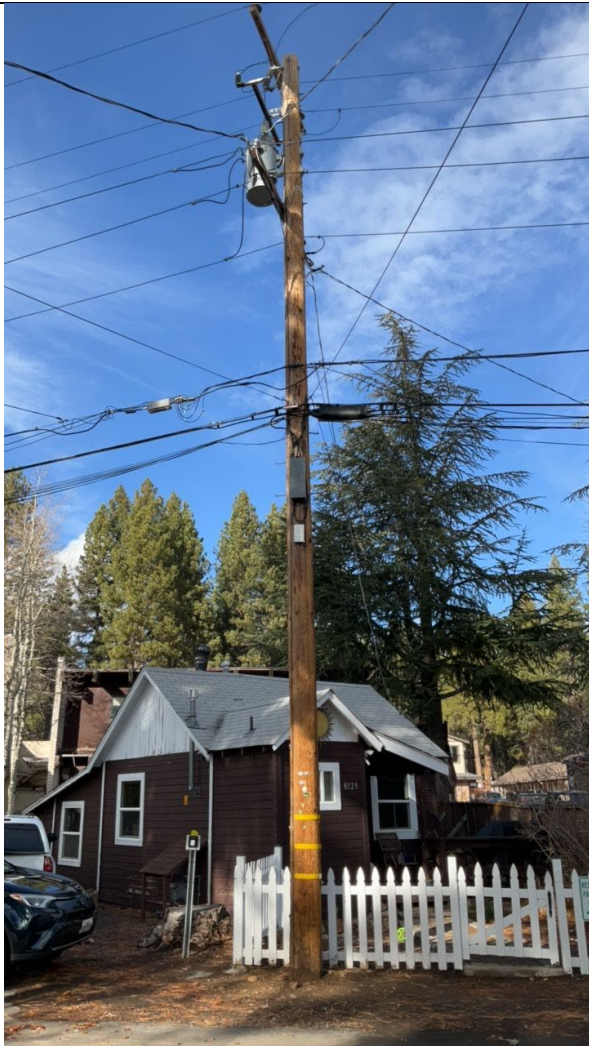
Item10GImg1: Overall pole.

On pole ID 290820 at 8106 N Lake Blvd, Kings Beach, CA, 96143, USA, 39.2371603131986, -120.028928803064, the inspector observed expulsion fuses. The inspector's observation is documented in Violation 5 photographs, which are attachments to this report. Photo numbers Item10GIimg1, Item10GIimg2, and Item10IAimg1 depict expulsion fuses instead of non-expulsion fuse alternatives.

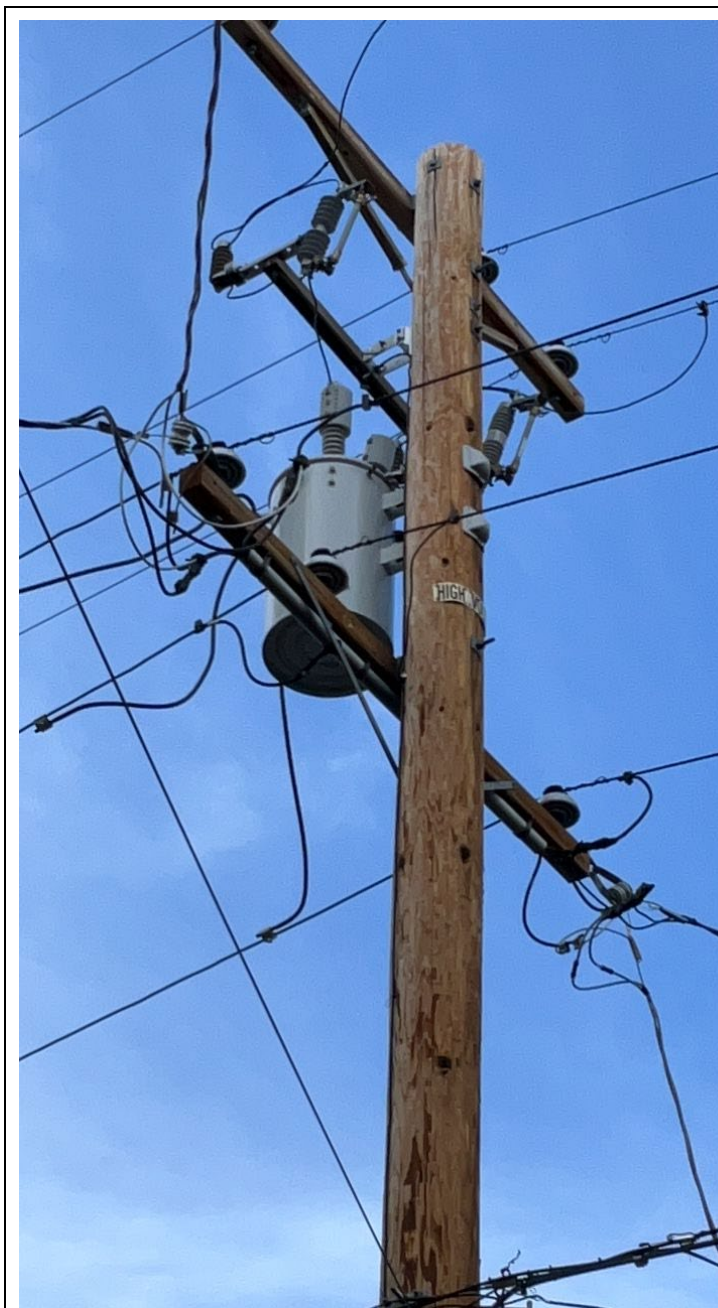
1. Liberty Utilities' WMP initiative number 7.3.3.7 - Expulsion Fuse Replacement work was reported as complete at this location.
2. Expulsion fuses were observed.
3. Non-expulsion fuses were not observed.

Item10IAimg1: View of two expulsion fuses.
