2024 Liberty Work Complete QC

QC of work complete

QC Assessment Date	April 1, 2024

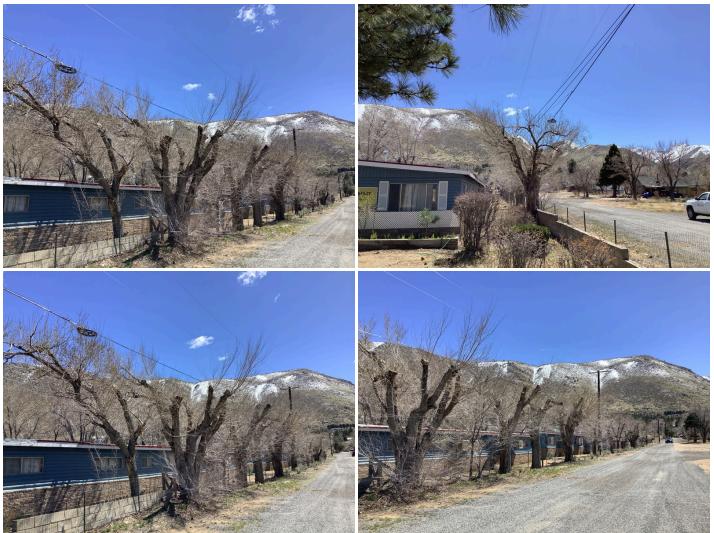
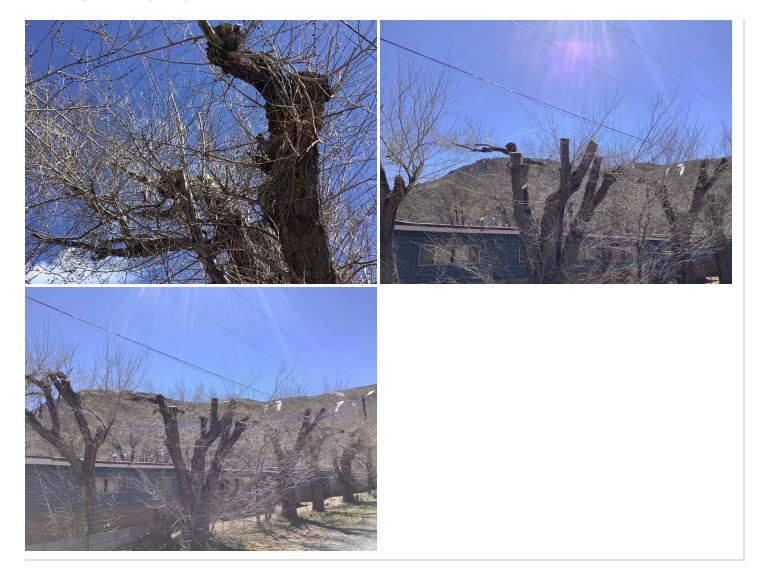
Tree Information	
Tree_ID	
Work_Status	
Work_Order_Circuit	
Refusal	
Date_Created	
Modified_Date	
Section	
Time Entry Date Created	
Work_Order_Span_ID	
Physical_Address	
Pole_Number	
Quantity	
Time_Entry_Quantity	
Species	
Height	
DBH	
Defect_Type	
Location_Comments	
Q1 Work Not Performed	0
Work_Type	
Q2 MCD Not Achieved or Not as Prescribed	1
Q3 Will Not Hold	1
Q4 Potential Hazard Remain	0
Cleanup_Method	
Work_Order_Comments	
Q5 Site Clean	0
Q6 ANSI Not Achieved	1
Q7 Other Trees Affected by Removal	0
Q8 Site Condition Not Stable	0
Comments	Elm at tag was recently worked but MCD not achieved, still has wispy sprout growth at 6ft offset under conductors. It's the second elm heading down tap from pole 80752. This row of landscape elms under conductors would be excellent TGR candidates since they require pollarding to achieve MCD. Minor Stub cuts 4/9/24 Additional clearance achieved by tree crews, growth is now 12 below conductors. Additional photo added to show MCD achieved.
