2024 Liberty Work Complete QC

QC of work complete

QC Assessment Date | April 1, 2024

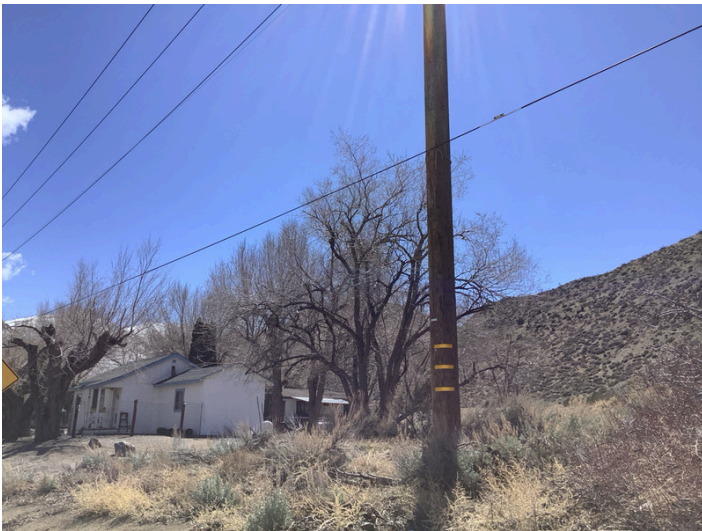
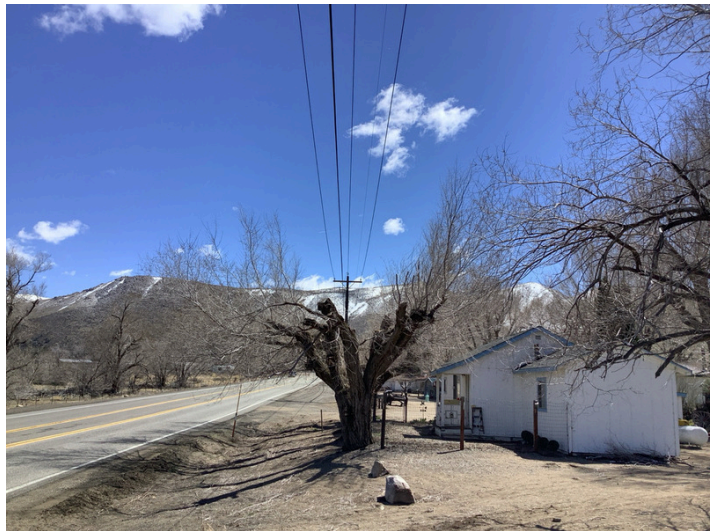
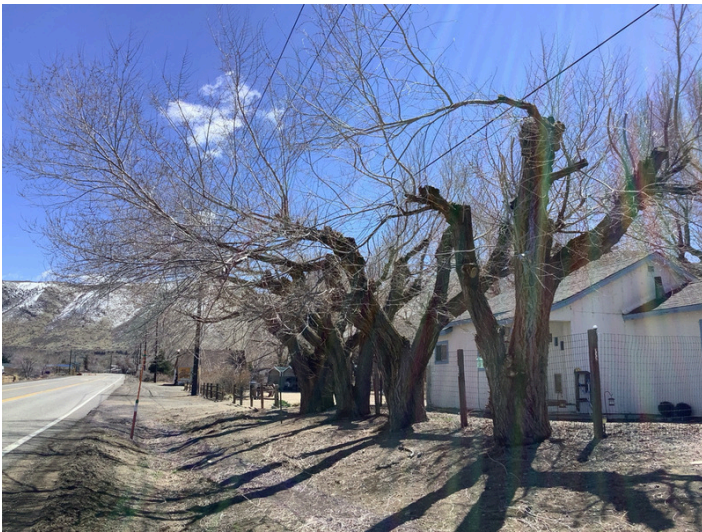
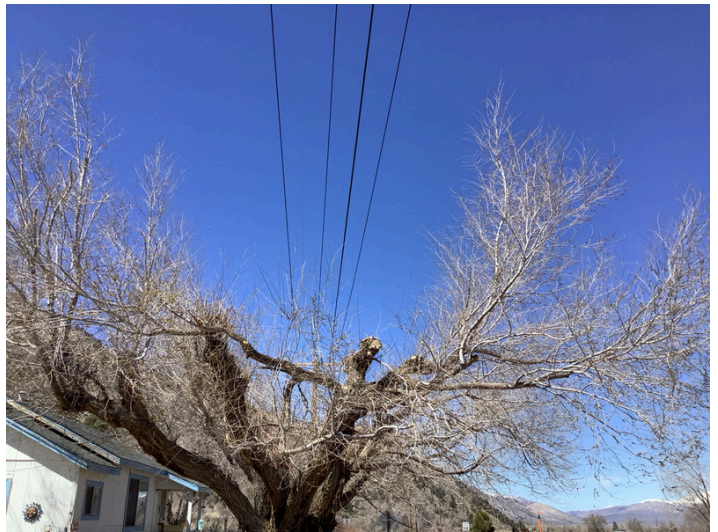
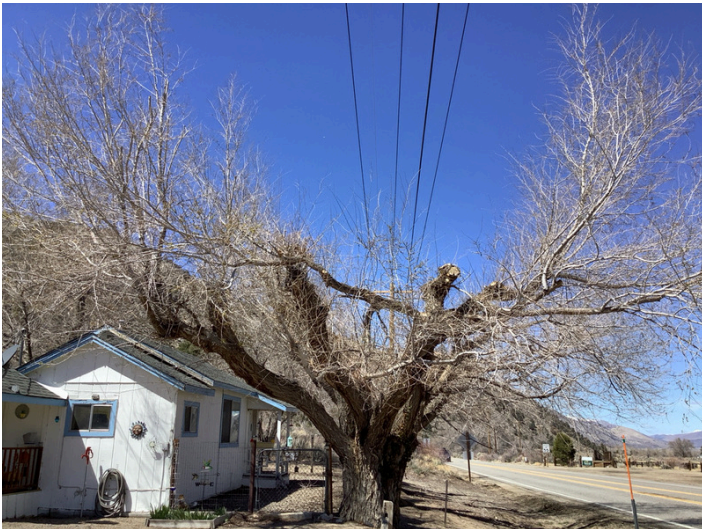
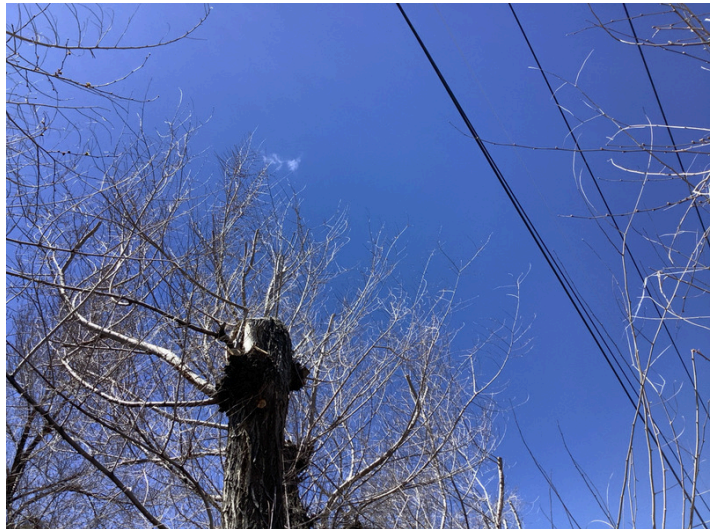
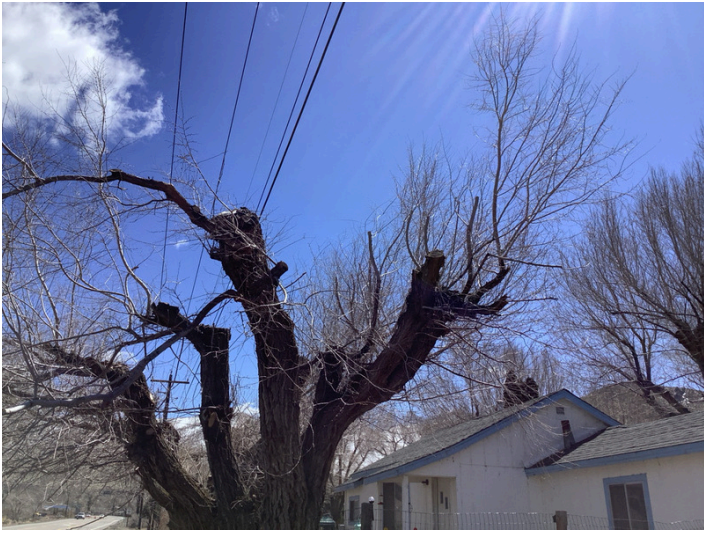
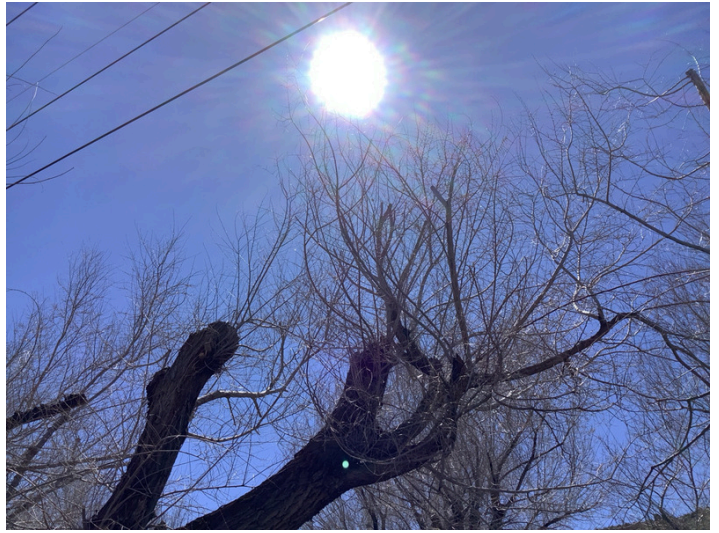
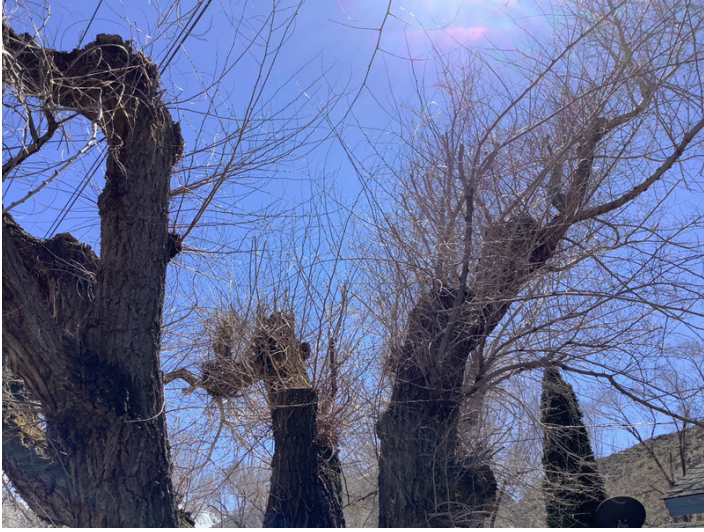
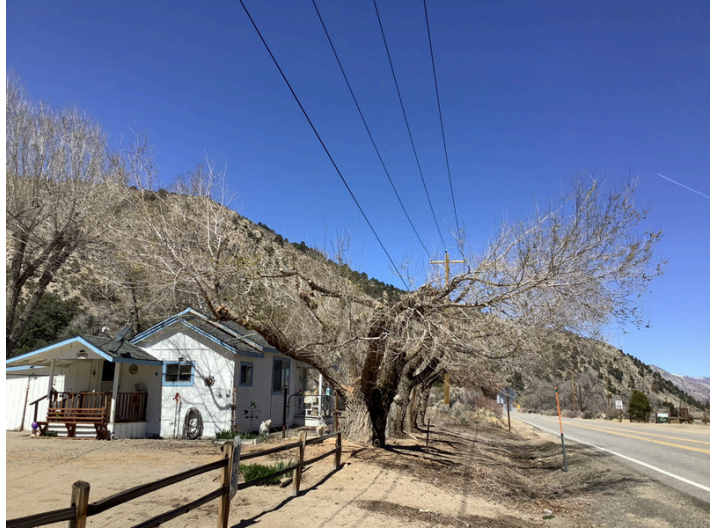
OEIS tag says elm by pole 293672 has growth at 5 ft to conductors, but reactive tag was placed on different polygon. This span has tree wire. The elm at pole was recently worked and currently has 12 ft of clearance offset under conductors. There's a row of 4 elms midspan where reactive tag was placed that were recently worked, those elms did not achieve MCD and currently have growth at 6.5-11 ft offset under conductors. Elm furthest south in the group still has growth at 6.5 ft offset under conductors. Minor Stub cuts on 3 elms. Good TGR candidates since the only way to achieve MCD is to pollard these landscape trees.

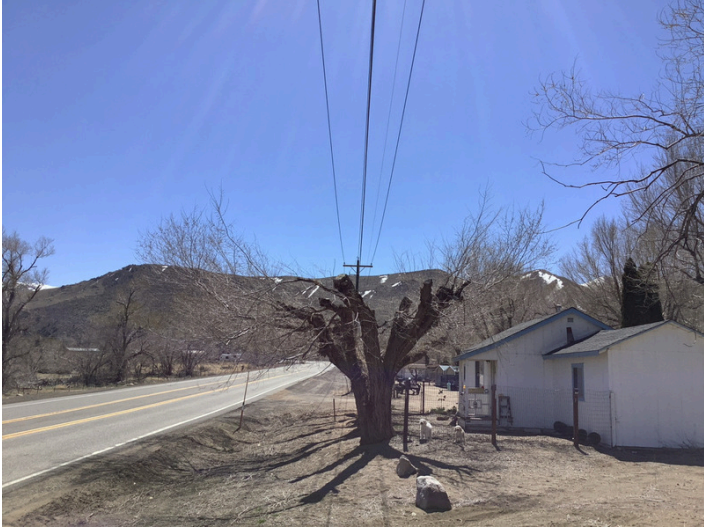
4/9/24 4/9/24 Additional clearance achieved by tree crews, growth is now 12 below conductors. Additional photo added to show MCD achieved.
