Mr. Patrick Doherty
Program Manager | Compliance Assurance Division
Office of Energy Infrastructure Safety
715 P Street, 20th Floor
Sacramento, CA 95814

Reference: Energy Safety-ID: NOV PGE CAC18 20231129 0945

Notice of Violation: Government Code § 15475.1 and the California Code of Regulations, Title 14,

This letter is in response to the above referenced Notice of Violation (NOV) dated March 20, 2024, (NOV Letter) regarding the Office of Energy Infrastructure Safety (Energy Safety) inspection of Pacific Gas and Electric Company's 2023 WMP initiatives in the vicinity of the city of Willits, California.

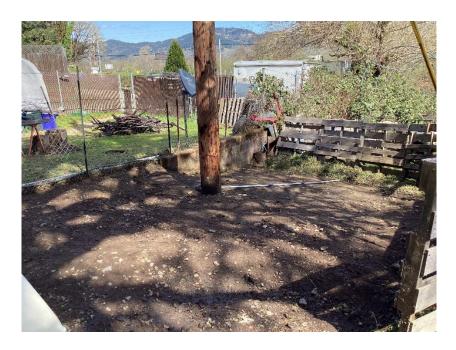
REFERENCE: Image of recent re-inspection of the location and pallet fencing relocated outside the 10-foot firebreak radius.

A customer-owned pallet fence was within the 10-foot firebreak radius at the time of Energy Safety's inspection. As noted in the "Directions" field of the VC Pole Inspection Record above, the subject pole was located within a goat pen. Since the time of Energy Safety's inspection, the property owner agreed to relocate the fencing further from the pole. See below for a photo from a recent inspection.

It is common for property owners to construct fences of wood materials. In this instance, we did not determine the fence to be in violation of the firebreak requirements outlined in 14 CCR Section 1254. Our inspectors must make reasonable interpretations of what constitutes a readily flammable material that may propagate fire between inspection and maintenance cycles.

We respectfully disagree that any corrective actions were required in this case, as no violation occurred. However, in an abundance of caution, we contacted the property owner in question about Energy Safety's concern, and the pallet fencing was relocated outside the 10-foot firebreak radius.
