NOTICE OF VIOLATION

On May 8, 2024, Energy Safety conducted an inspection of PacifiCorp's WMP initiatives in the vicinity of the city of Mount Shasta, California. The inspection report is enclosed herewith. Energy Safety found the following violation(s):

INSPECTION REPORT

| Report Number: | PC_YLO_20240508_1002 |

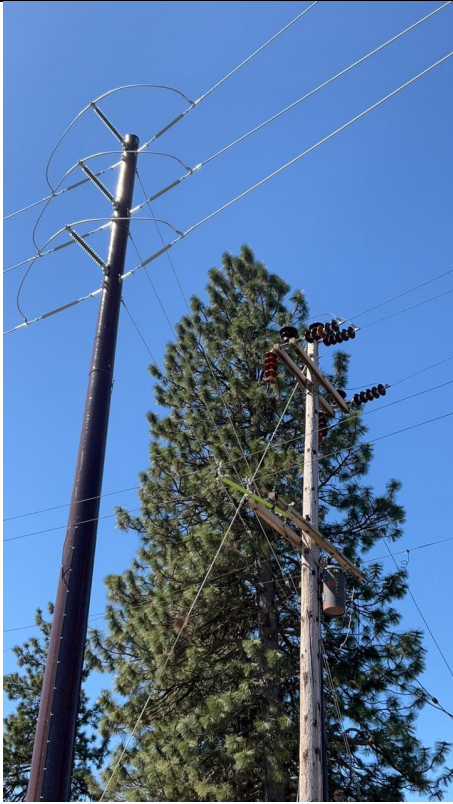
Energy Safety arrived at the provided pole ID 15/48 at 500 S Old Stage Rd, Mount Shasta, CA, 96067, USA, 41.3038341007191, -122.320791319897 and observed that the pole did not have fuses installed where Expulsion Fuse Replacement was reported as completed. The inspector's observation is documented in Violation 1 photographs, which are attachments to this report. Photo number Item3IA1Img1 depicts no fuses on the pole.

Energy Safety concludes that Violation 1 is Minor because of these facts:

1. The reported location provided by PacificCorp indicated that work on the Expulsion Fuse Replacements initiative (8.1.2.12) was reported as completed.
2. No fuses were observed on the indicated pole.

Item3IA1mg1: No fuse installed

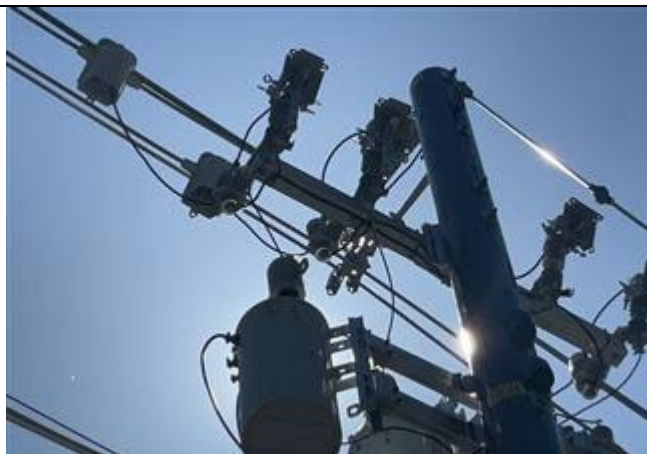
On pole ID 06240004.220600 at 101-299 Bear Springs Rd, Mount Shasta, CA, 96067, USA, 41.299622298582, - 122.305498392864, the inspector observed that three Cal Fire exempt fuses were installed, but a fourth fuse was missing entirely. The inspector's observation is documented in Violation 2 photographs, which are attachments to this report. Photo numbers Item8IA3Img1, and Item8IA3Img2 depict three Cal-Fire exempt fuses present and one missing fuse.

Energy Safety concludes that Violation 2 is Moderate because of these facts:

1. The reported location provided by PacificCorp indicated that work on the Expulsion Fuse Replacements initiative (8.1.2.12) was reported as completed.
2. Energy Safety observed one missing fuse on the pole.

Item8IA3Img1: Missing one out of four expulsion fuses

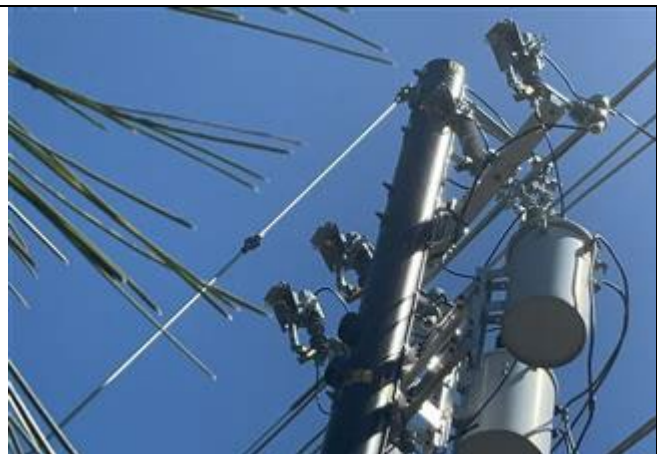
Item8IA3Img2: Missing fuse
