NOTICE OF VIOLATION

INSPECTION REPORT

Electrical Corporation:	PacifiCorp
Report Number:	PC_GCA_20240604_1017
Inspector:	Gary Candelas
WMP Year Inspected:	2024
Data Request Referenced:	DR-229, April 1 to May 8, 2024 vegetation management data
Inspection Selection:	Energy Safety inspected the locations based on PacifiCorp's response to DR-229
Relevant WMP Initiative(s):	8.2.3.1.1 - Wood and Slash Management
Date of inspection:	June 4, 2024
City and/or County of Inspection:	City of Dunsmuir, Siskiyou County
Inspection Purpose:	Assess the accuracy of PacifiCorp's QDR data, completeness of its work, compliance with WMP requirements, and compliance with its protocols.

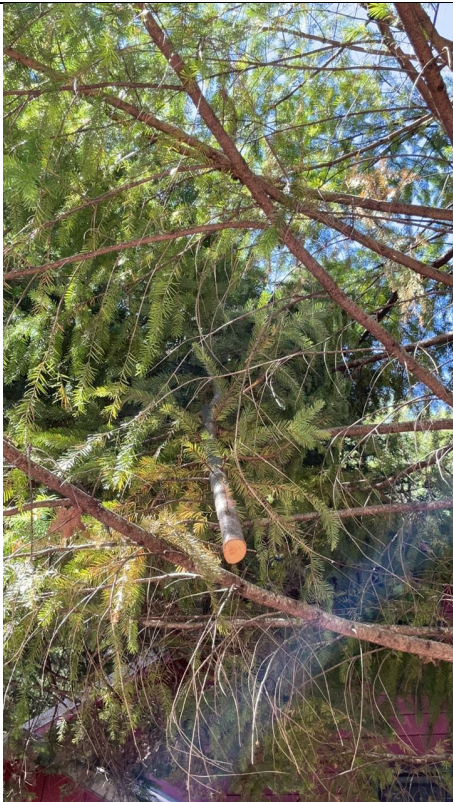
Violation #	Structure ID	Lat/Long	HFTD	Initiative Number	Violation Type	Severity	Violation Description
Violation 1	131040	41.2313964061729, -122.282205299914	Tier 3	8.2.3.1.1 - Wood and Slash Management	Adherence to Protocol	Minor	Vegetation debris was left in the tree canopy.

PacifiCorp's WMP initiative Detailed Inspections and Management Practices for Vegetation Clearances Around Distribution Electrical Lines and Equipment (8.2.2.1) work⁸ was identified as complete at GPS coordinates 41.2313964061729, -122.282205299914 (near 4614 Simpson Avenue in Dunsmuir). In the grow-in zone, 0.1 span east from pole ID 131040, the inspector observed that vegetation debris was left in the tree canopy. The inspection location was in a developed area, a location that PacifiCorp's WMP states that all slash from tree trimming activities will be chipped or removed. Per PacifiCorp's response to DR-229 which PacifiCorp provided to Energy Safety, PacifiCorp completed tree trimming at this location between April 1 and May 8, 2024.⁹ The inspector's observation is documented in the Violation 1 photographs attached to this report. Photo numbers Item1IA1Img1, Item1IA1Img2, Item1IA1Img3, Item1IA1Img4 depict a Douglas fir branch left on site in a Douglas fir tree canopy.

Energy Safety concludes that Violation 1 is "Minor" because vegetation debris was a single branch.

Item1IA1mg1: Vegetation debris left in canopy.

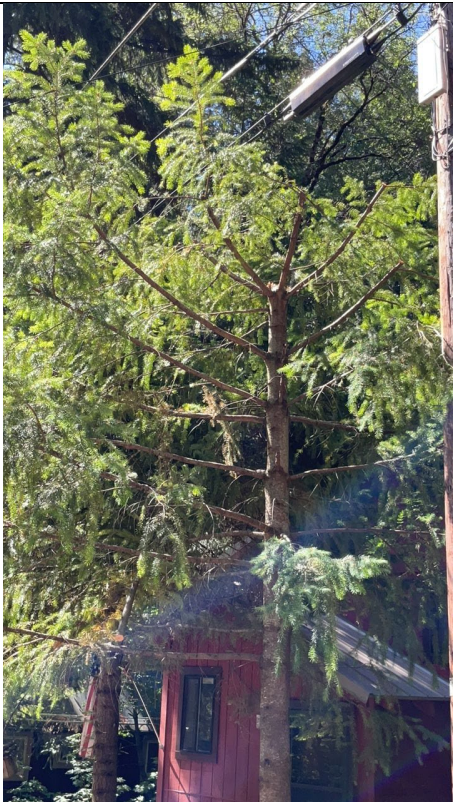
Item1IA1mg2: Douglas fir trimmed with branch left in canopy (lower left corner of image).

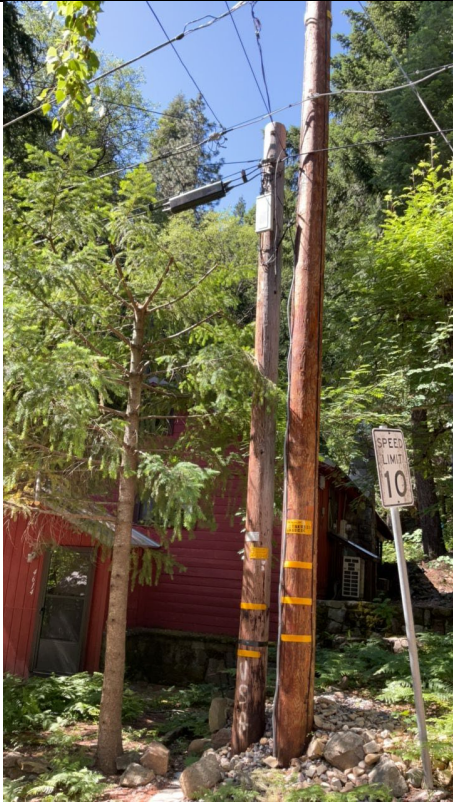
Item1IA1mg3: Douglas fir near pole ID 131040
