NOTICE OF VIOLATION

On June 12, 2024, Energy Safety conducted an inspection of SDG&E's WMP initiatives in the vicinity of the city of Fallbrook, California. The inspection report is enclosed herewith. Energy Safety found the following violation:

INSPECTION REPORT

Electrical Corporation:	San Diego Gas & Electric Company
Report Number:	SDGE_GCA_20240612_0908
Inspector:	Gary Candelas
WMP Year Inspected:	2024
Quarterly Data Report (QDR) Referenced:	Quarter 1 (Q1)
Inspection Selection:	Energy Safety inspected the locations based on SDG&E's Q1 QDR
Relevant WMP Initiative(s):	8.2.3.1 - Pole Clearing (WMP.512)
Date of inspection:	June 12, 2024
City and/or County of Inspection:	Fallbrook, California
Inspection Purpose:	Assess the accuracy of San Diego Gas and Electric Company's QDR data, completeness of its work, compliance with WMP requirements, and compliance with its protocols.

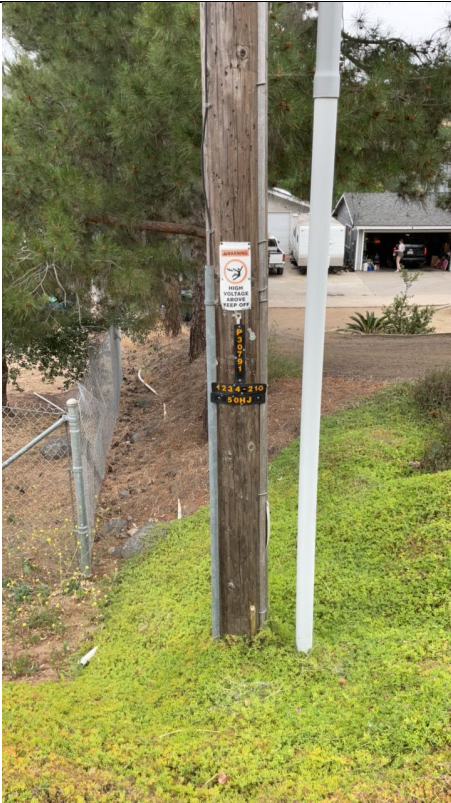
A close-up photograph of a wooden utility pole. A white PVC sleeve is attached to the pole. A yellow identification tag is visible on the pole, with the number '30791' printed on it. The background shows a residential area with a house and a driveway.

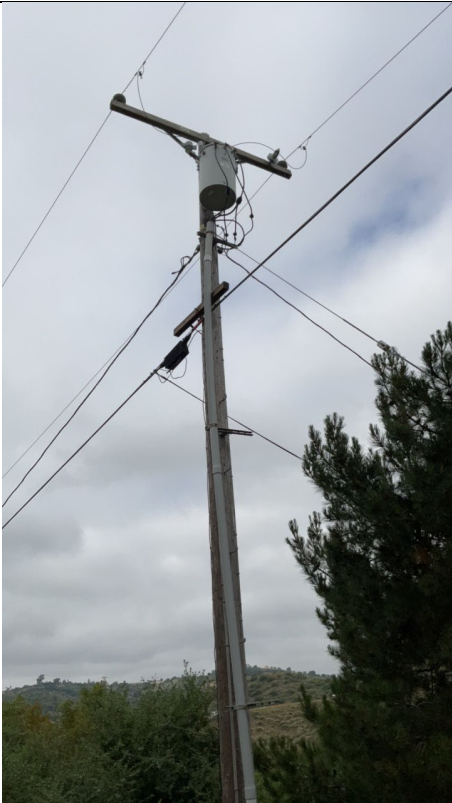
A photograph showing the overall structure of a utility pole. The pole is tall and has several power lines attached to it. The background shows a cloudy sky and some trees.
<p>Item1Gimg1: Pole ID</p>	<p>Item1Gimg2: Overall pole</p>

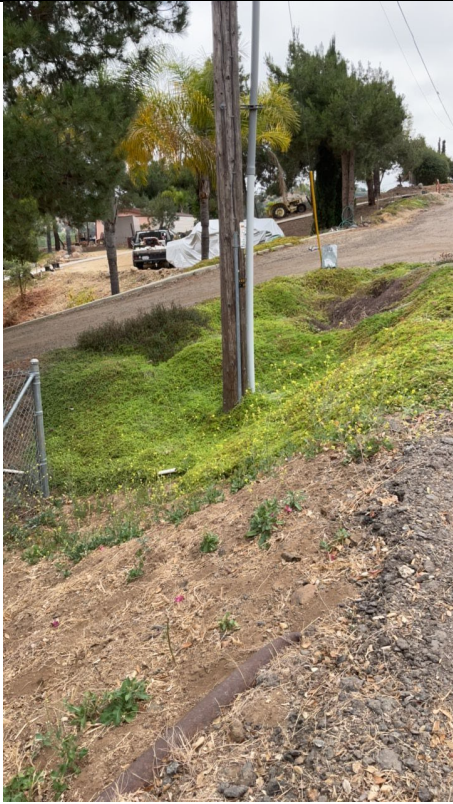
The reported location provided by SDG&E indicated that work on the Pole Clearing Program (.512 WMP initiative number 8.2.3.1.2) was reported as completed. At pole ID 30791 at 406 Skyline Circle in Fallbrook, at GPS coordinates 33.3710204204855, -117.159995846559, the inspector observed ice plant growing within the 10-foot radius of the subject pole. SDG&E's Q1 QDR data indicated the pole was mechanically cleared in February 2024. The inspector's observation is documented in Violation 1 photographs, which are attachments to this report. Photo numbers Item1IA1Img1, Item1IA1Img2, Item1IA1Img3, Item1IA1Img4 depict ice plant growing around pole 30791.

Energy Safety concludes that Violation 1 is "Minor" because the vegetation fuel bed does not consist of light flashy fuels.

Item1IA1img1: Photo looking north from Skyline Circle

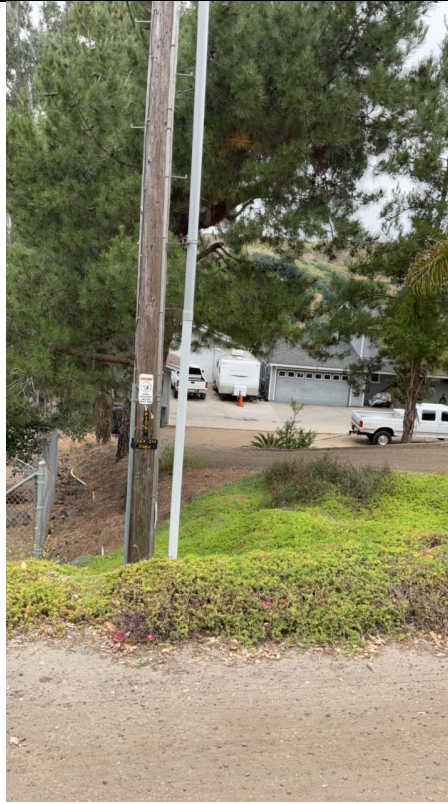
Item1IA1img2: Photo looking west from Skyline Circle

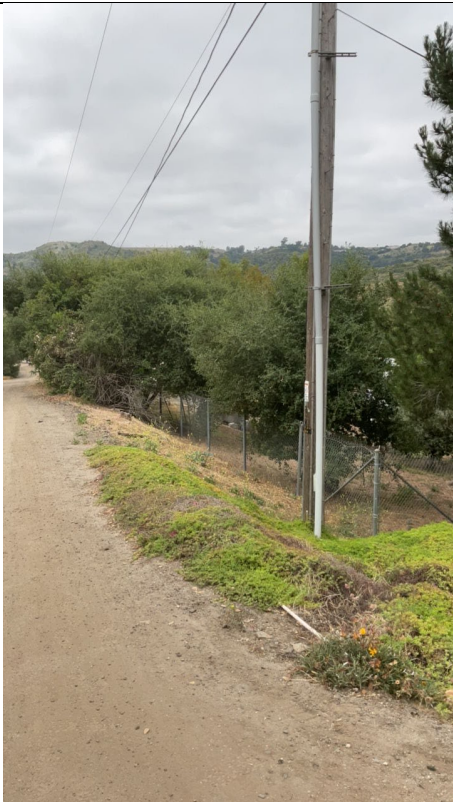
Item1IA1img3: Photo looking south from Skyline Circle
