July 10, 2024

Docket # 2023 NOV

RE: PacifiCorp's Response to Notice of Violation – NOV\_CAD\_PC\_YLO\_20240508\_1002

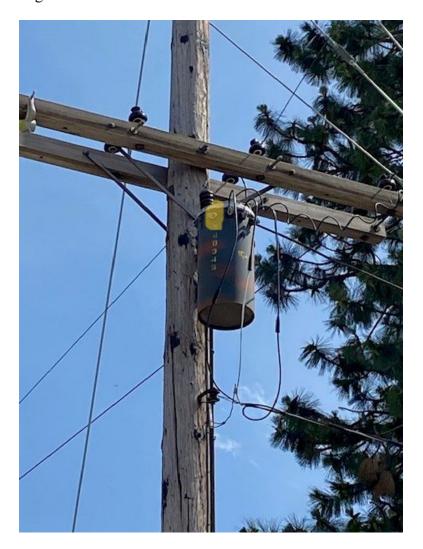
**Violation 1.** Energy Safety observed that in implementing 2023 WMP initiative 8.1.2.12 - Expulsion Fuse Replacements, PacifiCorp failed to provide accurate data in reporting that expulsion fuses were replaced on pole ID 15/48 at coordinates 41.3038341007191, - 122.320791319897. Energy Safety considers this data accuracy violation to be in the Minor risk category.

In response to the notice of violation, the company conducted a field inspection on June 26, 2024. The transformer is a Completely Self Protected (CSP) transformer which means the fuse is located inside the body of the transformer. Therefore, PacifiCorp has determined that an external non-expulsion fuse is not necessary.

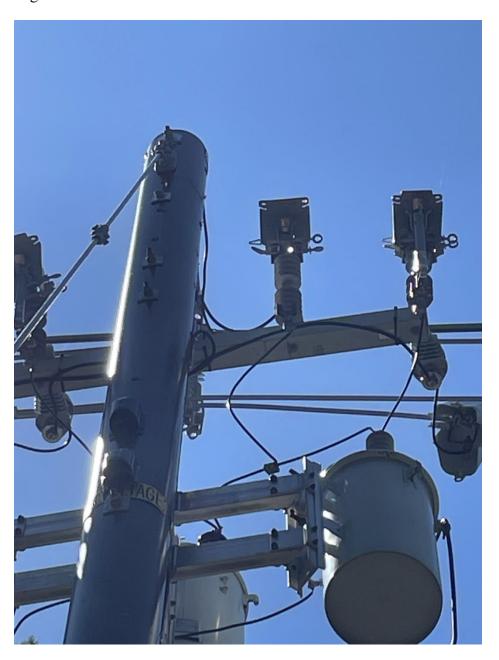
**Violation 2.** In response to the notice of violation, the company conducted a field inspection on June 26, 2024. Energy Safety observed that in implementing 2023 WMP initiative 8.1.2.12 - Expulsion Fuse Replacements, PacifiCorp failed to complete Expulsion Fuse Replacement on pole ID 06240004.220600 at coordinates 41.299622298582, -122.305498392864. Energy Safety considers this completeness violation to be in the Moderate risk category.

The fourth cutout was installed at the time of work and is connected to the system neutral. The cutout has the required guarding and covered jumper conductor. There is not a fuse currently installed in the cutout, and it therefore meets the requirements for exemption. PacifiCorp has no further plans for wildfire mitigation work at this location.
