# Review of 2023 SCE Wildfire Mitigation Targets:

Independent Evaluator Annual Report on  
Compliance (IE ARC)

Prepared for: Southern California Edison (SCE)

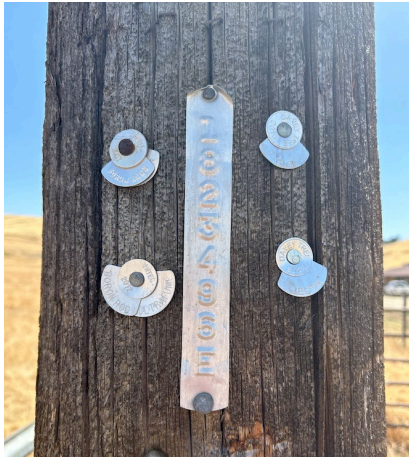
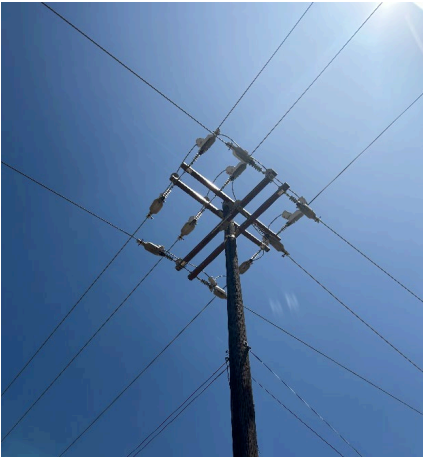
The IE performed a field inspection to confirm completion of SH-16. During this field inspection, the IE noted that Structure 412711003/1823495E had a status listed in the SAP Notifications Tasks Tab of complete (“TSCO”), however upon inspection it did not have vibration dampers installed.

SH-16  
No Vibration  
Dampener

*IE Findings:* The engineering standard provided comports with industry norms, and the IE concurs with the remediated status. The IE notes however that the Work Order indicated the equipment was installed, when instead the pole was considered remediated. This is a systemic concern that aligns with the observed trend of keeping paperwork and tracking systems in order and may be an area for improvement.

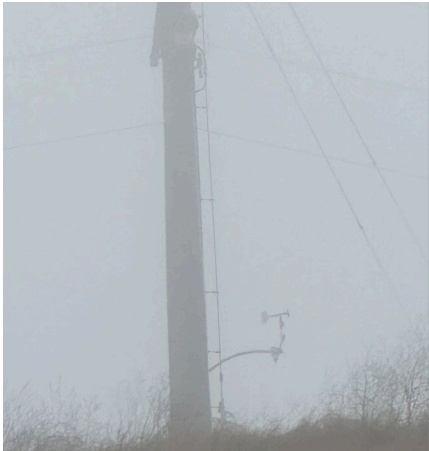
SF-01 - Newhall  
Orchard  
Offline Weather

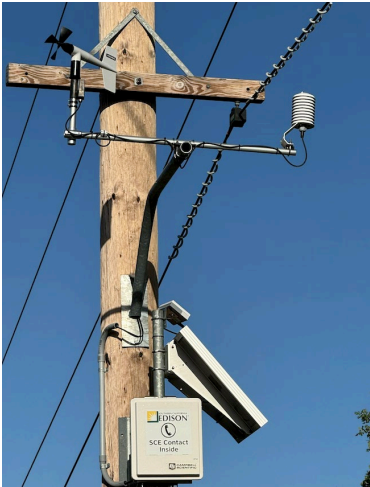
<sup>20</sup> Photo of the vane in Appendix C, while it does not appear that the vane is prevented from turning, it is clear that the pole and cross are shielding the device from the wind, which prevents it from measuring wind accurately. SCE was asked about this concern and responded, SCE stated, “There is no standard for “cross-arm interference” and SCE has not observed any concern around cross-arm interference.”

SF-01 – Brite Valley  
Cross-Arm Potential  
Interference
