## NOTICE OF VIOLATION

On October 25, 2023, Energy Safety conducted an inspection of Liberty Utilities' WMP initiatives in the vicinity of the city of South Lake Tahoe, California. The inspection report is enclosed herewith. Energy Safety found the following violation:

# INSPECTION REPORT

Electrical Corporation:	Liberty Utilities (LU)
Report Number:	LU_CAC18_20231025_0916
Inspector:	CAC18
WMP Year Inspected:	2023
Quarterly Data Report (QDR) Referenced:	Quarter 2 (Q2)
Inspection Selection:	Energy Safety viewed the contents of the Q2 QDR and performed an analysis that resulted in the selection of the WMP initiatives and locations referenced in this report.
Relevant WMP Initiative(s):	Clearance (2023 WMP initiative number 8.2.3.3)
Date of inspection:	October 25, 2023
City and/or County of Inspection:	South Lake Tahoe, El Dorado County
Inspection Purpose:	Assess the accuracy of Liberty Utilities' QDR data, completeness of its work, compliance with WMP requirements, and compliance with its protocols.

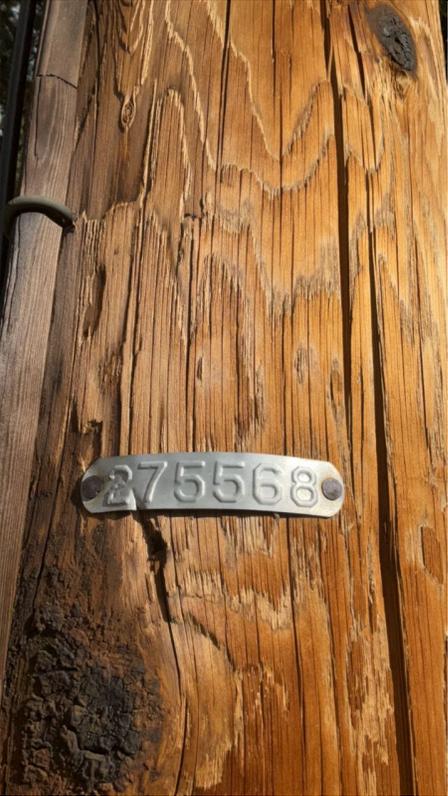
<p><b>Item1GImg1:</b> Pole ID.</p>	<p><b>Item1GImg2:</b> Overall pole.</p>

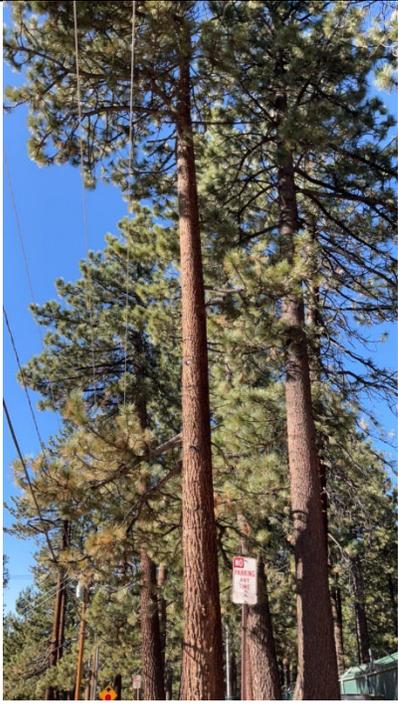
Near pole ID 275568 at 920 Stateline Ave, South Lake Tahoe, CA, 96150, USA, 38.9609062307708, -119.944810162602, the inspector observed a Jeffrey pine within Liberty Utilities' clearance distance of six feet. The inspector's observations are documented in Violation 1 photographs, which are attachments to this report. Photograph numbers Item1IA1Img3 and Item1IA1Img4 depict a Jeffrey pine that is approximately five feet from primary conductors. The radial clearance requirement from these primary conductors (12kV-25kV) is six feet, and Liberty Utilities failed to trim back to 12-15 feet, per Liberty Utilities' MAT shown in Table 8-23 above.

Energy Safety concludes that Violation 1 is Moderate because of these facts:

1. Liberty Utilities' WMP clearance work was identified as complete at this location.
2. A Jeffrey pine tree was within six feet of the primary conductors.
3. Liberty Utilities did not achieve vegetation clearance of between 12 and 15 feet from primary conductors.

**Item1IA1img3:** Green Jeffrey pine approximately five feet from a primary conductor.

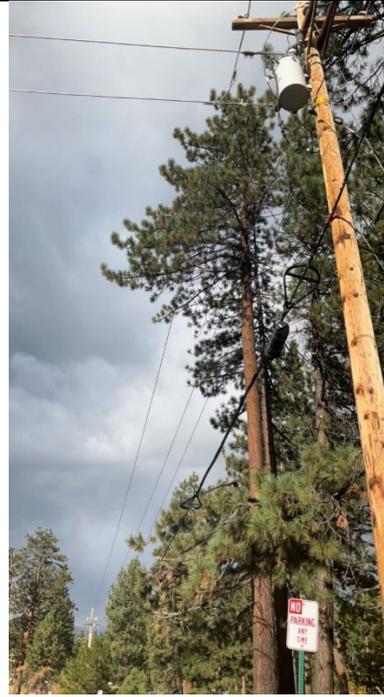
**Item1IA1img4:** Same tree as in image Item1IA1img3. Overall tree picture.
