NOTICE OF VIOLATION

On August 28, 2024, Energy Safety conducted an inspection of SCE's WMP initiatives in the vicinity of the city of Montecito. The inspection report is enclosed herewith. Energy Safety found the following violation:

INSPECTION REPORT

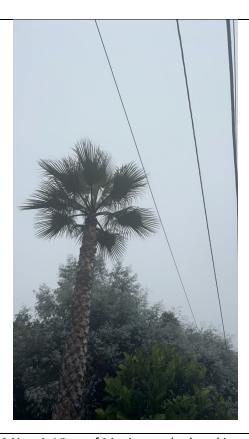
SCE reported that work for the Expanded Clearing program (VM-7 WMP initiative number 8.2.3.3.1) in this area had been completed. SCE's Q2 QDR data indicated that the subject palm was trimmed in May 2024. At 0.3 span to the south from pole ID 2108895E (in front of 131 Sierra Vista Road in Montecito), near GPS coordinates 34.441108, -119.670337, the inspector observed a Mexican palm (*Washingtonia robusta*) growing under the covered conductor and had fronds that were within the 4-foot clearance distance requirement as indicated in SCE's WMP. The inspector measured the distance between the palm and conductor with the Nikon Forestry Pro II laser rangefinder. The palm measured approximately two feet from the conductor, which conflicted with the four feet requirement stated in SCE's WMP. SCE's WMP does not distinguish vegetation clearance distances between covered and bare conductor. The inspector's observation is documented in Violation 1 photographs, which are attachments to this report. Photo numbers Item1IA1Img1, Item1IA1Img2, Item1IA1Img2, Item1IA1Img3 depict the Mexican palm that was within four feet of the conductors.

Energy Safety concludes that Violation 1 is "Minor" because the vegetation encroaching into the minimum clearance requirements may contact the covered conductor before SCE next inspects and trims or removes the palm.

Item1IA1Img1: View of Mexican palm breaking minimum clearance requirements. Photograph was taken from the south side of the sidewalk along Sierra Vista Road facing south.

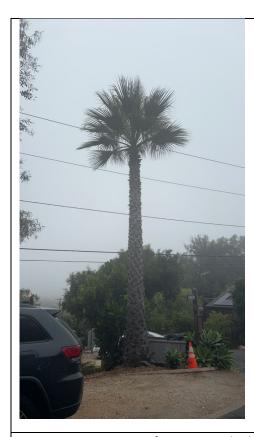
Item1IA1Img3: View of Mexican palm breaking minimum clearance requirements. Photograph was taken from the north side of the sidewalk along Sierra Vista Road directly under the palm.
