NOTICE OF VIOLATION

On August 28, 2024, Energy Safety conducted an inspection of SCE’s WMP initiatives in the vicinity of the city of Santa Barbara. The inspection report is enclosed herewith. Energy Safety found the following violation:

INSPECTION REPORT

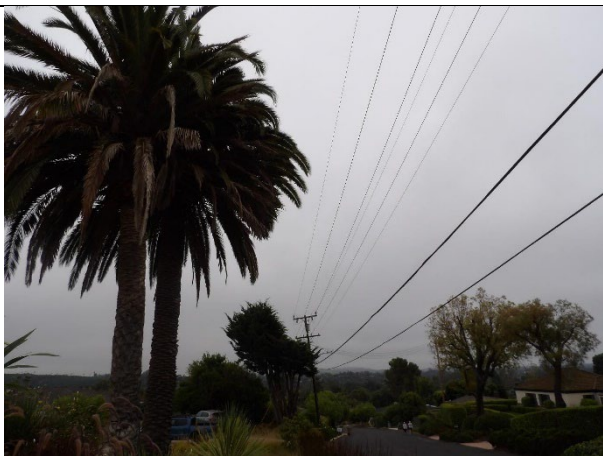
SCE's Q2 QDR data indicated that SCE trimmed the subject palm in April 2024 under SCE's Expanded Clearing program (VM-07 WMP initiative number 8.2.3.3.1). At 0.4 span to the west of pole ID 1413461 toward pole ID 1413462 on 5570 Camino Cerralvo in Santa Barbara, at GPS coordinates 34.461689, -119.819312 in HFRA, the inspector observed a Canary Island date palm (*Phoenix canariensis*) within the four-foot required clearance distance. This location is in HFTD Tier 3 and HFRA. The inspector measured both the palm height and conductor height with the Nikon Forestry Pro II laser rangefinder. The palm measured 48 feet in height to the tallest frond, and the conductor height measured 34 feet, with the closest palm frond measuring two feet to the side of the conductor, which conflicts with the four feet requirement stated in SCE's WMP. The inspector's observation is documented in Violation 1 photographs, which are exhibits to this report. Photo numbers Item1IA1Img1, Item1IA1Img2, Item1IA1Img3 depict the palm that was measured within 2 feet from the conductors.

Energy Safety concludes that Violation 1 is "Moderate" because the vegetation encroaching into the minimum clearance requirements may contact the conductor before SCE next inspects and trims or removes the palm.

Item1IA1mg1: Photograph was taken facing southeast. Photograph depicts a view of the two-foot distance between the palm and conductors.

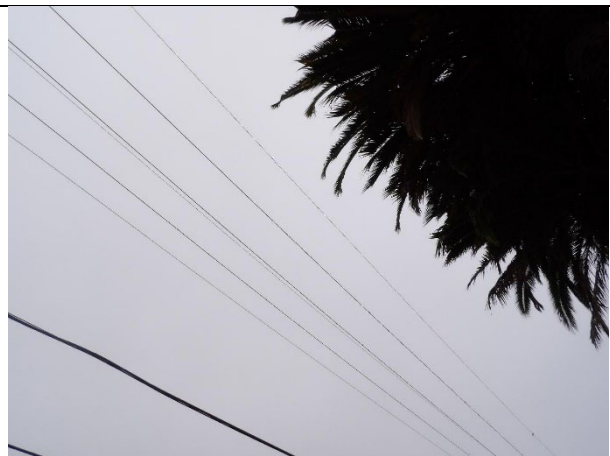
Item1IA1mg2: Photograph was taken looking up at horizontal distance. Photograph depicts a view of the two-foot distance between the palm and conductors.

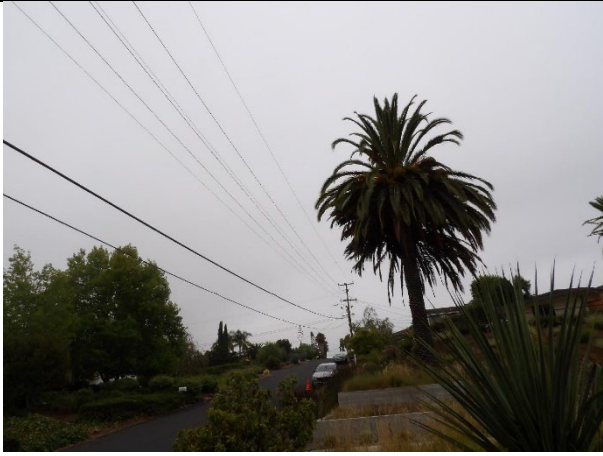
Item1IA1img3: Photograph was taken facing northwest. Photograph depicts a view of the two-foot distance between the palm and conductors.
