NOTICE OF VIOLATION

INSPECTION REPORT

Electrical Corporation:	PacifiCorp
Report Number:	NOV ESD_PC_CAC23_20240912_0738
Inspector:	CAC23
WMP Year Inspected:	2024
Data Request Referenced	Data Request 258
Inspection Selection:	Energy Safety inspected the locations based on PacifiCorp's response to DR 258
Relevant WMP Initiative(s):	8.2.2.1 Detailed Inspections and Management Practices around Distribution Electrical Lines and Equipment, 8.2.2.3 Patrol Inspections of Vegetation around Distribution, 8.2.3.2 Clearance, 8.2.3.1.1 Wood and Slash Management
Dates of inspections:	September 10 - 12, 2024
City and/or County of Inspection:	Siskiyou County
Inspection Purpose:	Assess the accuracy of PacifiCorp's DR 258 data, completeness of its work, compliance with WMP requirements, and compliance with its protocols.

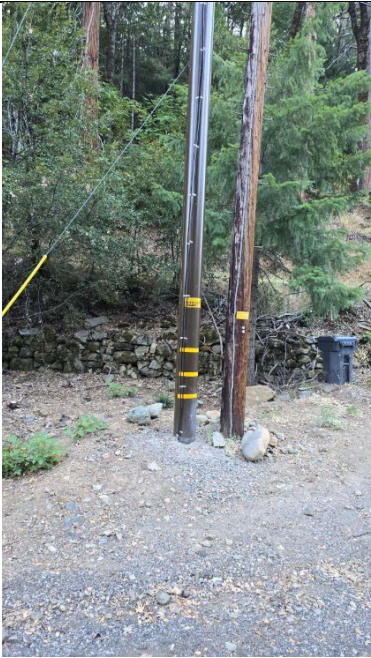
Item1GImg1: Pole ID	Item1GImg2: View of slash near vegetation management activities.

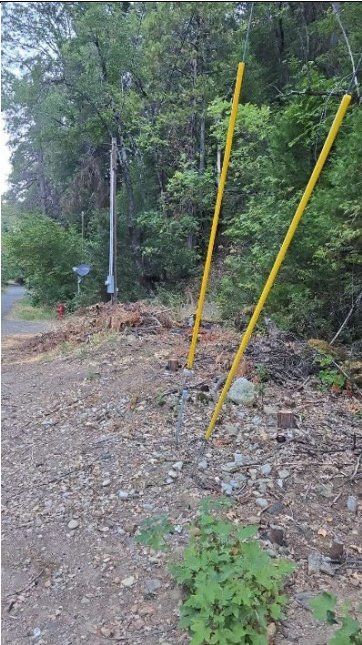
PacifiCorp reported that it had completed work for the vegetation clearance program (VM-01 WMP initiative number 8.2.2.1). PacifiCorp's DR 258 indicated that a cedar (*Calocedrus spp.*), an oak (*Quercus spp.*), and two maple (*Acer spp.*) trees along the primary conductor span were trimmed in June 2024. Near pole ID 247140 and GPS coordinates 41.2185600599993, -122.27200591999792, the inspector observed slash left from the vegetation management activities. The inspector's observations are documented in Violation 1 photographs, which are exhibits to this report. Photo numbers Item1GImg1, Item1GImg2, Item1GImg3, and Item1GImg4 depict the inspector's observations as well as slash from vegetation management activities at the location.

Energy Safety concludes that Violation 1 is "Minor" because the presence of slash in the form of dry fuels does not immediately create conditions conducive to fire ignition, however it might not be removed before PacifiCorp next inspects the area.

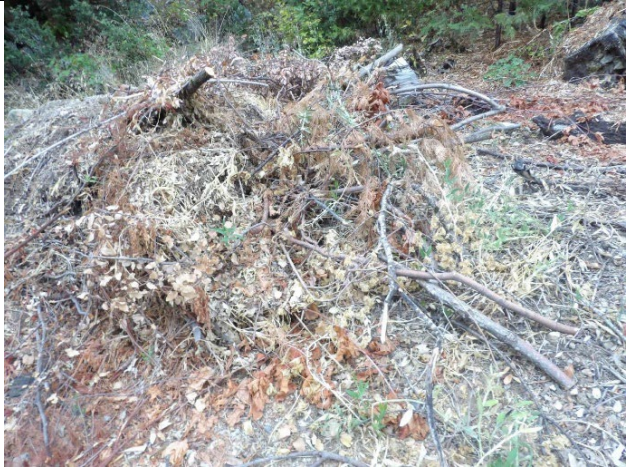
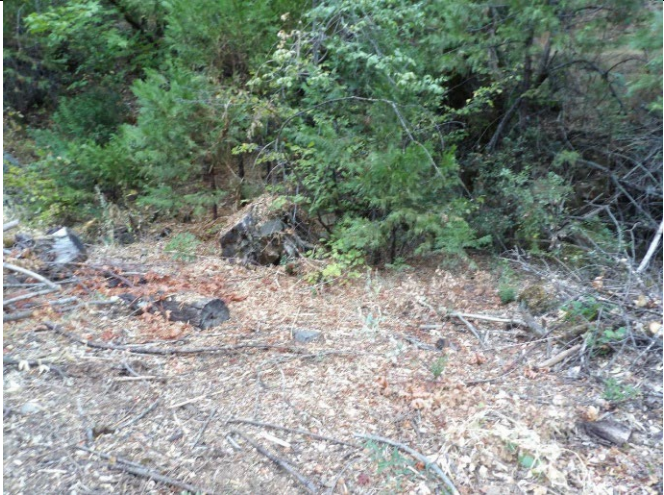
Item1GImg3: View of slash left on site.	Item1Img4: Secondary view of slash left on site.

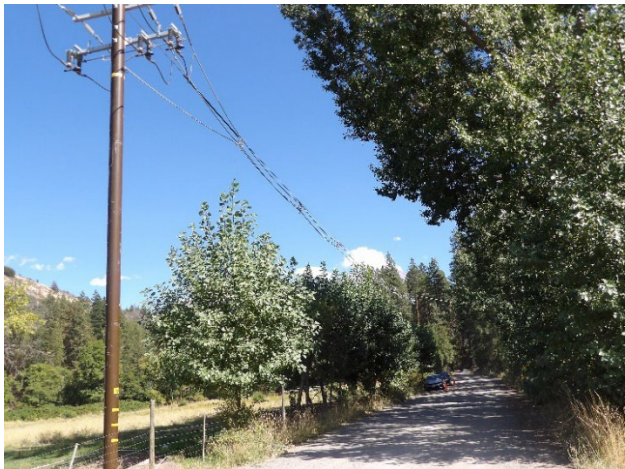
Item2Img2: View facing northeast

At a location 0.5 span west of pole ID 038701, near GPS coordinates 41.43164017, -122.40271051, the inspector observed that one of the Black cottonwood (*P. trichocarpa*) trees was two feet directly under the covered conductor. PacifiCorp's WMP does not distinguish vegetation clearance distances between covered and bare conductor. The inspector utilized a Nikon Forestry Pro II to measure this distance.

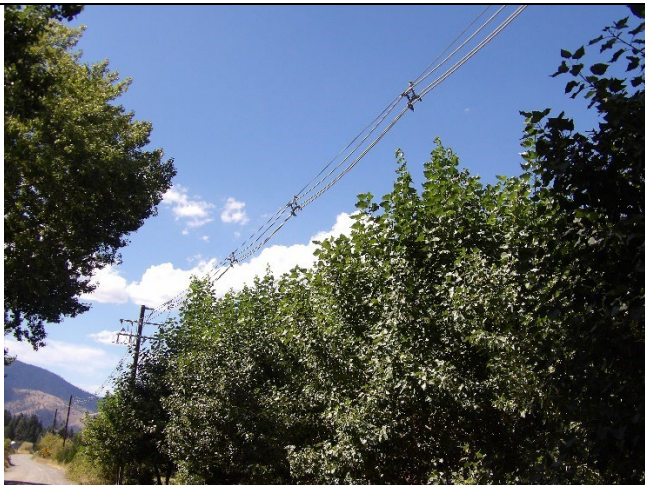
Given the time between reported work and inspections (approximately four months), Energy Safety has determined that it is unlikely that the tree was trimmed to the initiative protocol requirements of 12 feet at the time of work. Additionally, given the fast growth rate of this species under the conductor, the tree may contact the conductor before the next patrol inspection for distribution lines. These observations are documented in the photographs in Exhibit B to this report.

Energy Safety concludes that Violation 2 is "Minor" because the vegetation encroaching into the minimum clearance requirements may contact the covered conductor before PacifiCorp next inspects and trims or removes the trees.

Item2Img3: View of vegetation two feet under the conductor facing north
