NOTICE OF VIOLATION

INSPECTION REPORT

VMP ID: VP_BC125-H01_1632349_2020

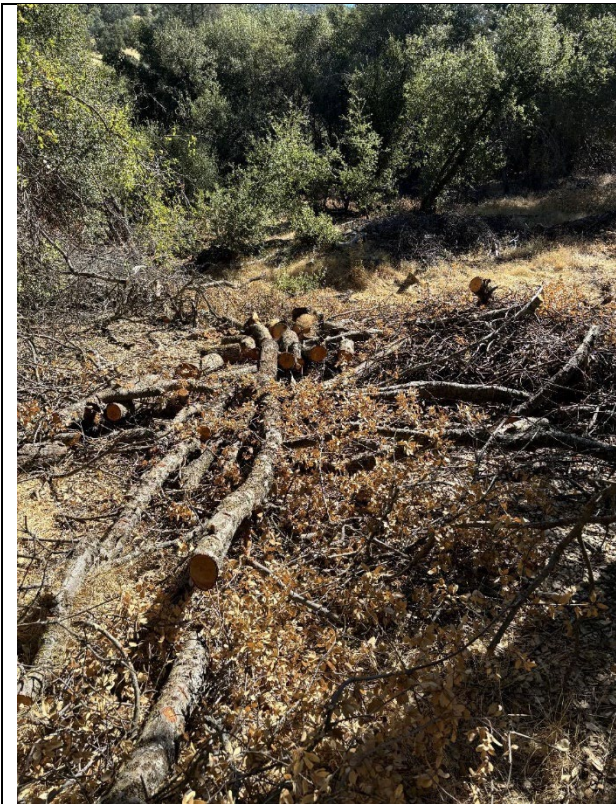
Item1Gimg1: Photo of the pile of slash and wood debris and other debris.

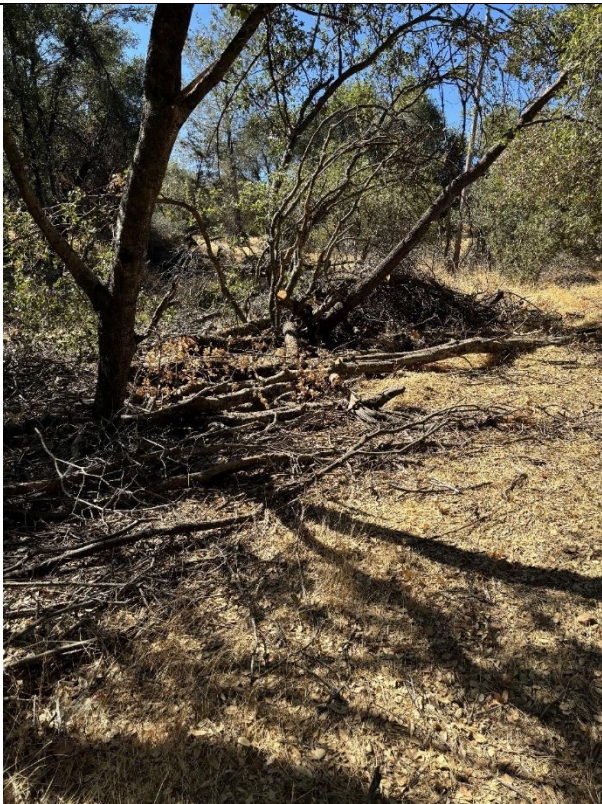
Item1Gimg2: Photo of the pile of slash and woody debris and the surrounding area.

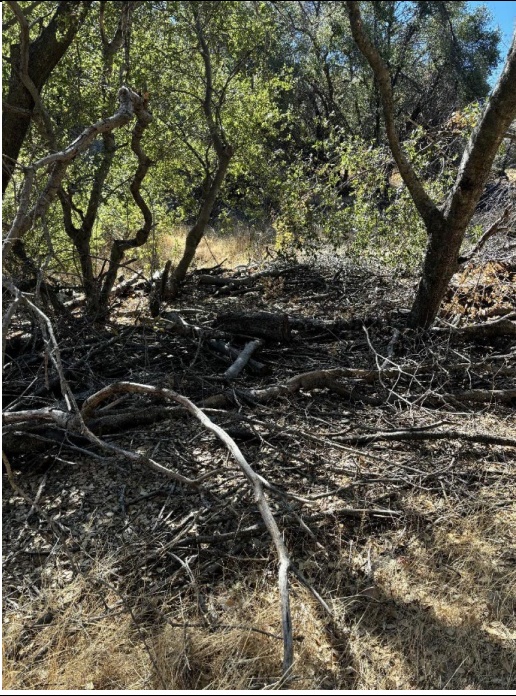
Item1G1mg3: Photo of the area near the pile of slash and woody debris. The pile is not depicted in the photograph.

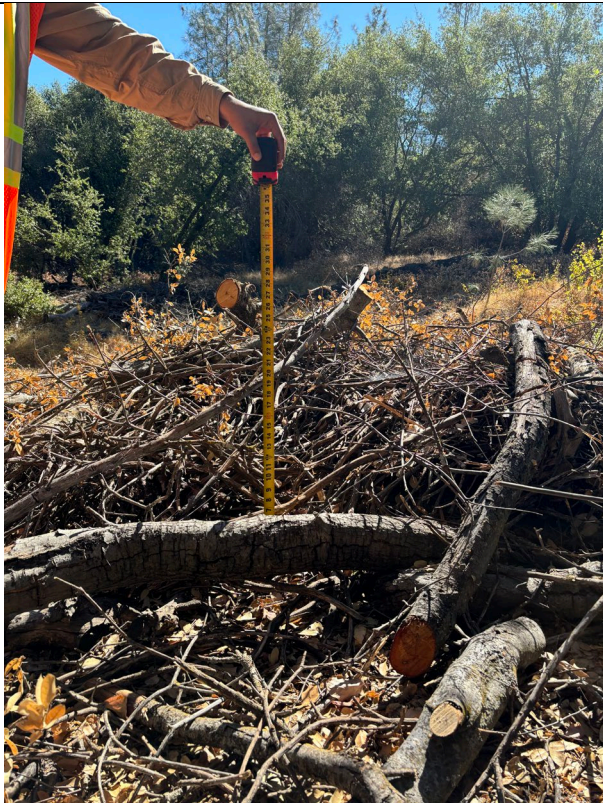
Energy Safety concludes that Violation 1 is "Moderate" because the slash pile is over 18-inches in height, creating a potential fuel source for wildfire.

At VMP ID VP_BC125-H01_1632349_2020 near GPS coordinates 37.523551, -120.004405, PG&E reported it completed work under its TRI program. PG&E's Q2 data reports that its crews removed a gray pine, 54 feet tall and 17 inches in diameter on June 5, 2024. Energy Safety's inspector observed slash, wood chips, and woody debris from a gray pine (*Pinus sabiniana*), most of which appeared to have been felled and left in place. Additionally, the inspector observed a pile of slash debris was higher than 18 inches, and which was approximately 26 inches at the highest point. The inspector's observation is documented in Violation 1

photographs, which are exhibits to this report. Photo numbers Item1IA1Img1, Item1IA1Img2, depict a slash pile over 18-inches in height, and Item1IA1Img3, Item1IA1Img4 depict other slash, chips and woody debris associated with PG&E's work.

Item1IA1mg1: Pile of slash and woody debris is at least 18 inches in height and is approximately 26 inches in height in some places. Photograph taken from the east side of the pile.

Since Energy Safety's inspection, PG&E conducted a field visit on September 23, 2024, and completed the clean-up and disposal of wood and slash at 5549 Gold Creek Lane by September 25, 2024. Therefore, Energy Safety considers violation ESD_PGE_RIB_20240911_1355 closed. No further action from PG&E is required in response to this violation.

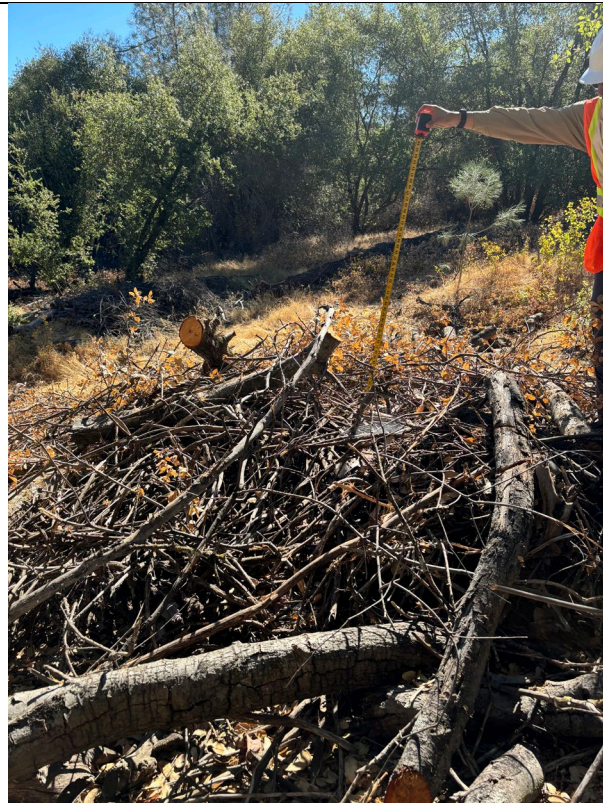
Item1IA1mg2: Pile of slash and woody debris is at least 18 inches in height and is approximately 26 inches in height in some places. Photograph taken from the east side of the pile.

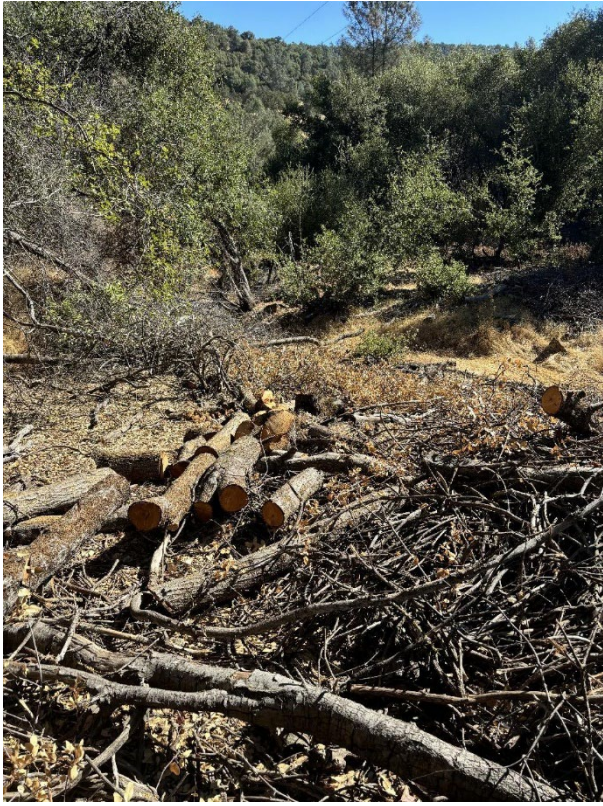
Item1IA1Img3: Woody debris adjacent to the slash pile in Item1IA1Img1 to the north.

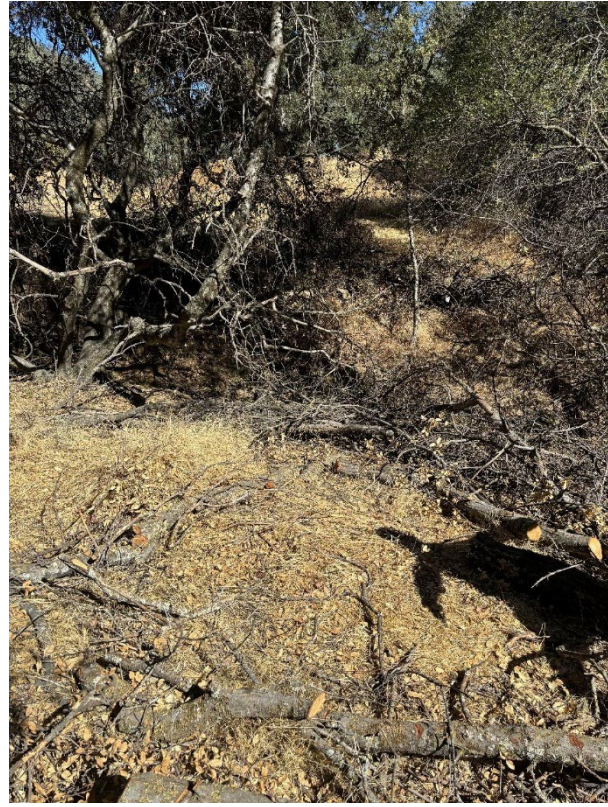
Item1IA1Img4: Other photograph of slash and woodchips near the slash pile in Item1IA1Img1.
