NOTICE OF VIOLATION

INSPECTION REPORT

Electrical Corporation:	San Diego Gas and Electric
Report Number:	NOV ESD_SDGE_CAC23_20240925_1227
Inspector:	CAC23
WMP Year Inspected:	2024
Quarterly Data Report (QDR) Referenced:	Quarter 2 (Q2)
Inspection Selection:	Energy Safety inspected the locations based on SDG&E's Q2 QDR.
Relevant WMP Initiative(s):	8.2.3.1 Pole Clearing (WMP .512)
Date of inspection:	September 25, 2024
City and/or County of Inspection:	Escondido, California
Inspection Purpose:	Assess the accuracy of SDG&E's QDR data, completeness of its work, compliance with WMP requirements, and compliance with its protocols.

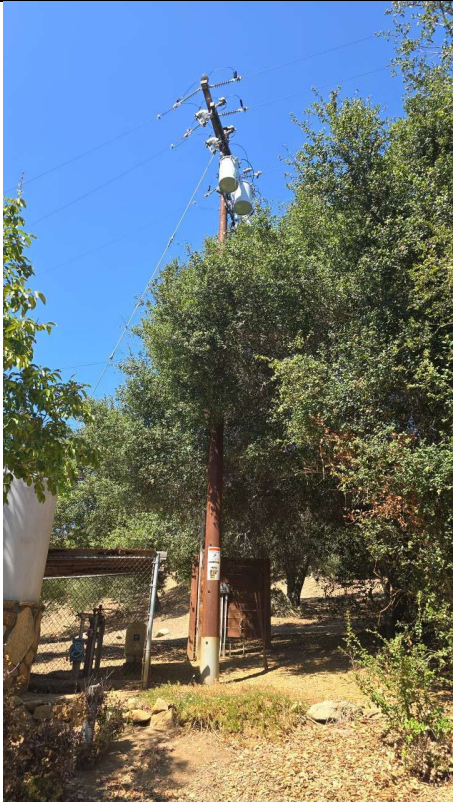
At VMP ID357-CZ1004 near GPS coordinates 33.158108, -116.977228 in Escondido, SDG&E reported that it completed work under its Pole Clearing program (.512 WMP initiative number 8.2.3.1). SDG&E's Q3 data reports that pole ID 814864 located along Old Guejito Grade Road was mechanically cleared. However, the inspector observed that SDG&E did not complete its pole clearing activity at the location, having left ground cover within the 10-foot clearance radius. Dead vegetation was also present within the 10-foot clearance radius. That dead vegetation appeared to consist of the same ground cover vegetation which was growing there in addition to leaf litter and other flammable debris. The inspector's observation is documented in Violation 1 photographs, which are exhibits to this report. Photo numbers Item1G1mg1 and Item1G1mg2 depict the pole ID 814864 and the overall pole. Photo numbers Item1G1mg3, Item1G1mg4, and Item1A11mg1 show the desiccated vegetation and additional leaf litter at the base of the pole within the 10-foot radius.

Item1GImg2: Overall pole and vegetation near the base of the pole.

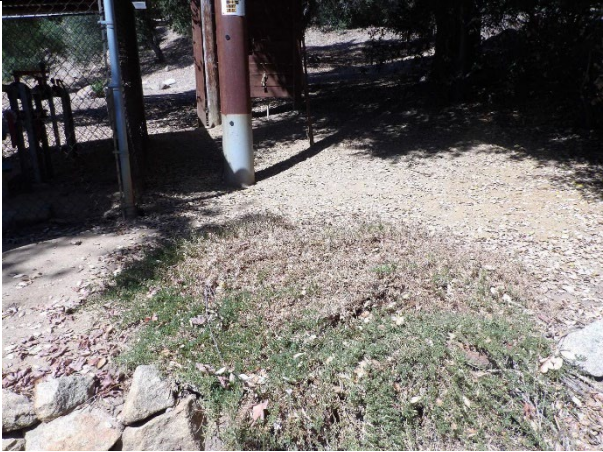
Energy Safety concludes that Violation 1 is "Minor" because the remaining vegetation fuel bed consists of light flashy fuels in the form of desiccated vegetation and leaf litter.

Item1GImg3: Vegetation within the 10-foot radius of the pole.

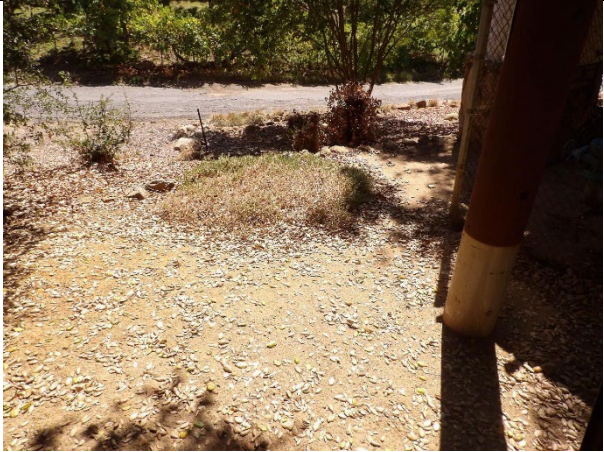
Item1GImg4: Vegetation within the 10-foot radius of the pole.

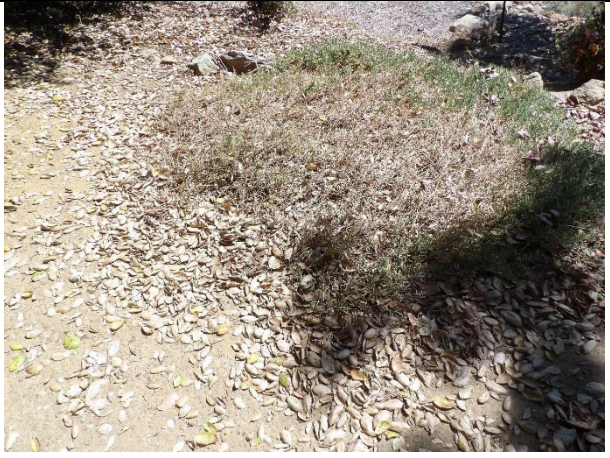
Item1IA1Img1: Closeup view of dry vegetation.
