NOTICE OF VIOLATION

On November 21, 2024, Energy Safety conducted an inspection of SDG&E's WMP initiatives in the vicinity of the city of Lakeside in High Fire Threat District (HFTD) Tier 2. The inspection report is enclosed herewith. Energy Safety found the following violation:

INSPECTION REPORT

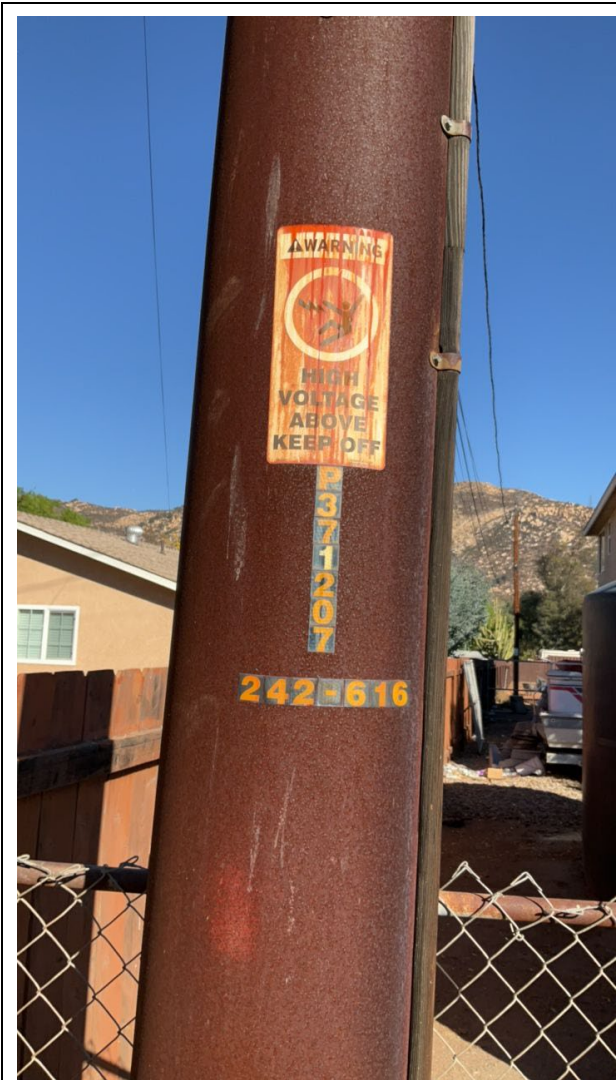
Item1Gimg1: Pole ID P371207.

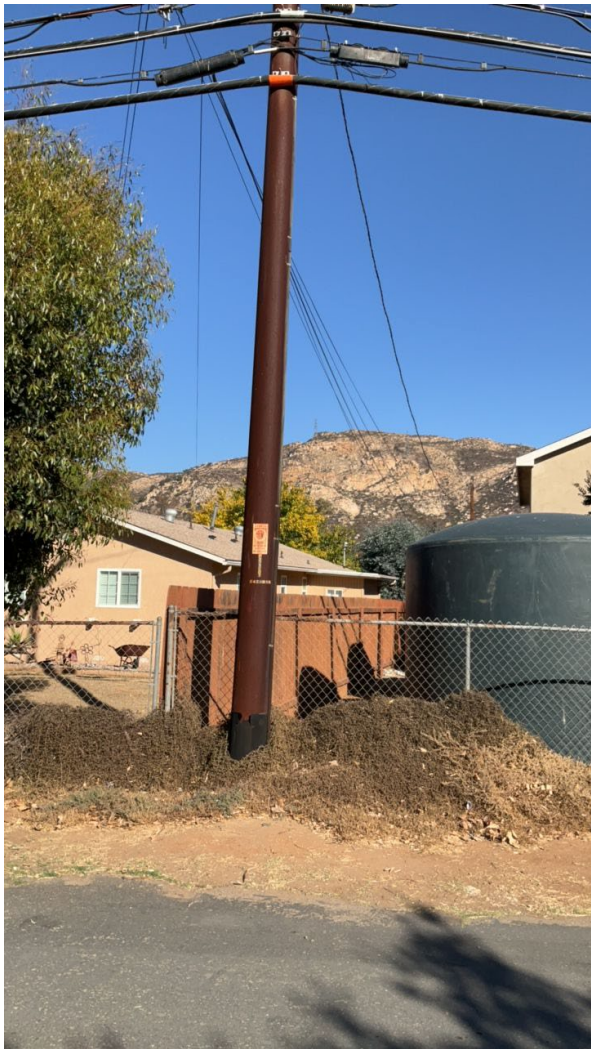
Energy Safety concludes that Violation 1 is "Moderate" because the remaining vegetation fuel bed consists of flammable material in the form of dying, dry vegetation.

Item1Gimg2: Overall pole and vegetation surrounding the base of the pole.

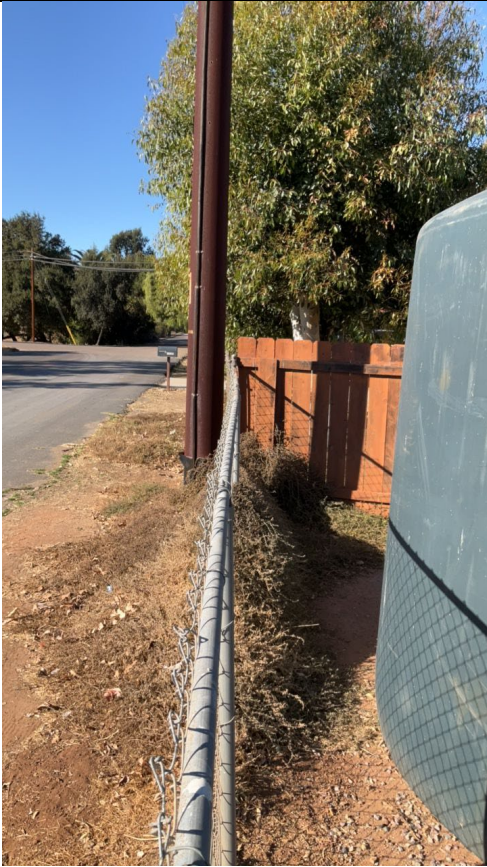
Item1GImg3: View of dying, flammable vegetation along fence within 10-foot radius of pole.

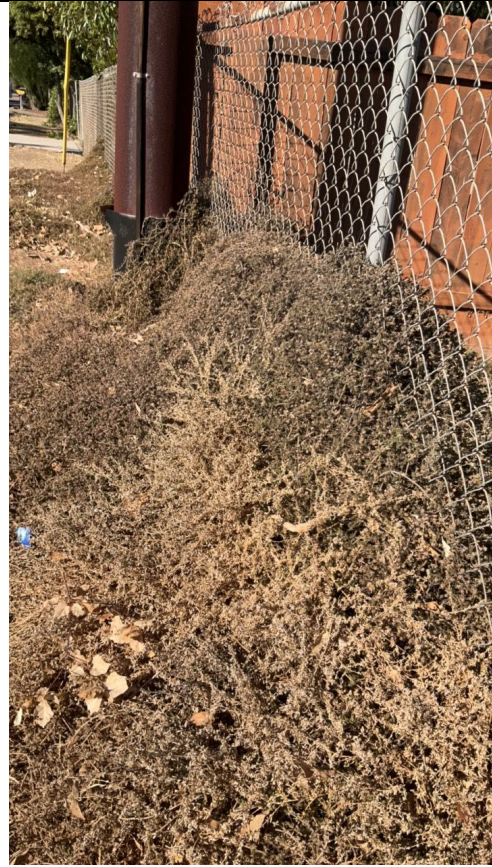
Item1GImg4: Closeup view of dying, flammable vegetation within 10-foot radius.

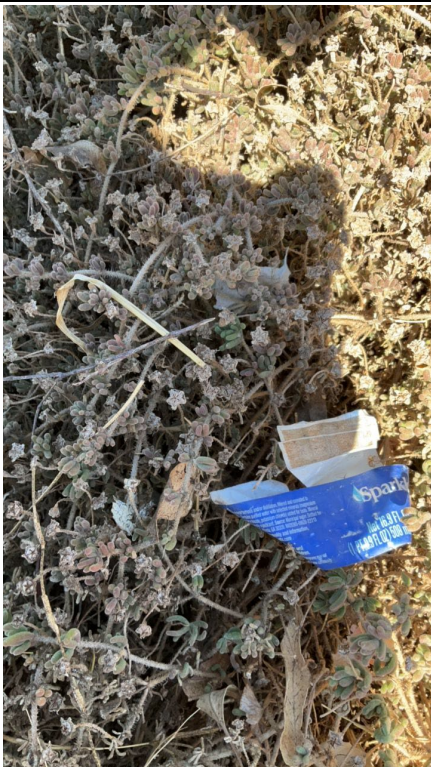
Item1IA1Img1: Closeup of dying, flammable vegetation and trash within the vegetation.

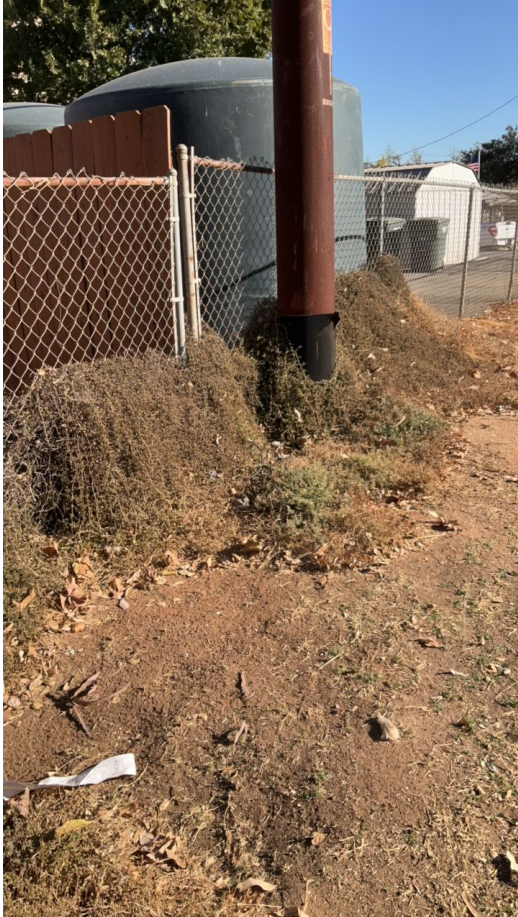
At Vegetation Management Point (VMP) ID 452-YY16833 near GPS coordinates 32.881357, -116.927326 in Lakeside, SDG&E reported that it completed work under its Pole Clearing program (WMP initiative number 8.2.3.1). SDG&E's Q3 QDR data reports that pole ID P371207 located near 11235 Highway 67 was mechanically cleared on August 18, 2024. However, the inspector observed that SDG&E did not complete its pole clearing activity at the location, having left dying, dry vegetation (ice plant) within the 10-foot clearance radius of the subject pole. The inspector's observation is documented in Violation 1 photographs, which are exhibits to this report. Photo numbers Item1G1mg1 and Item1G1mg2 depict the pole ID P371207 and the overall pole. Photo number Item1G1mg3 shows the vegetation on both sides of the fence and photo numbers Item1G1mg4, Item1IA1img1, and Item1IA1img4 depicts a closer view of the dying vegetation within the 10-foot radius. Photo numbers Item1IA1img2 and Item1IA1img3 also show vegetation within the 10-foot radius of the pole.

Item1IA1Img2: View facing northeast on Santa Maria Road.

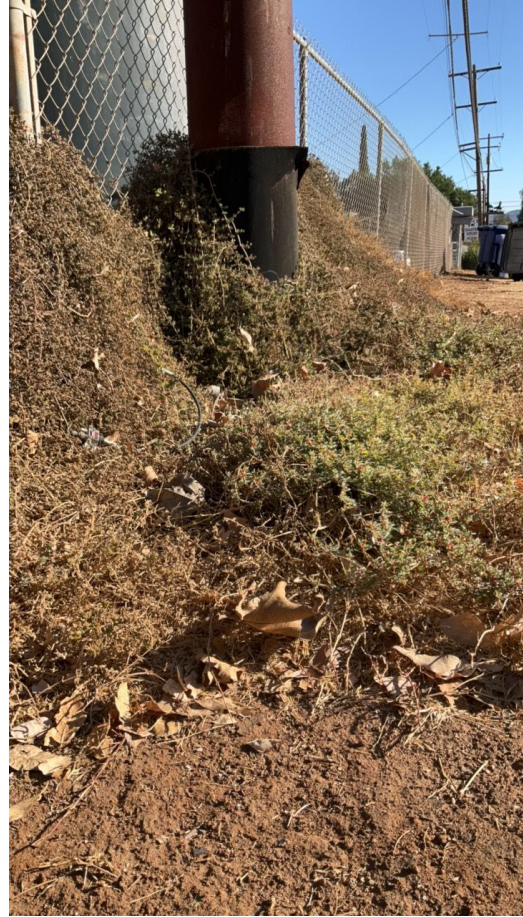
Item1IA1Img3: View facing southeast.
