## NOTICE OF VIOLATION

# INSPECTION REPORT

Electrical Corporation:	Pacific Gas and Electric Company
Report Number:	CAD_PGE_ATJ_20240813_1556
Inspector:	Anthony Trujillo
WMP Year Inspected:	2023
Quarterly Data Report (QDR) Referenced:	Quarter 4 (Q4)
Inspection Selection:	Energy Safety viewed the contents of the Q4 QDR and performed an analysis that resulted in the selection of the WMP initiatives and locations referenced in this report.
Relevant WMP Initiative(s):	Covered conductor installation - distribution (2023 WMP initiative number 8.1.2.1)
Date of inspection:	August 13, 2024
City and/or County of Inspection:	Mariposa, Mariposa County
Inspection Purpose:	Assess the accuracy of Pacific Gas and Electric Companies QDR data, completeness of its work, compliance with WMP requirements, and compliance with its protocols.

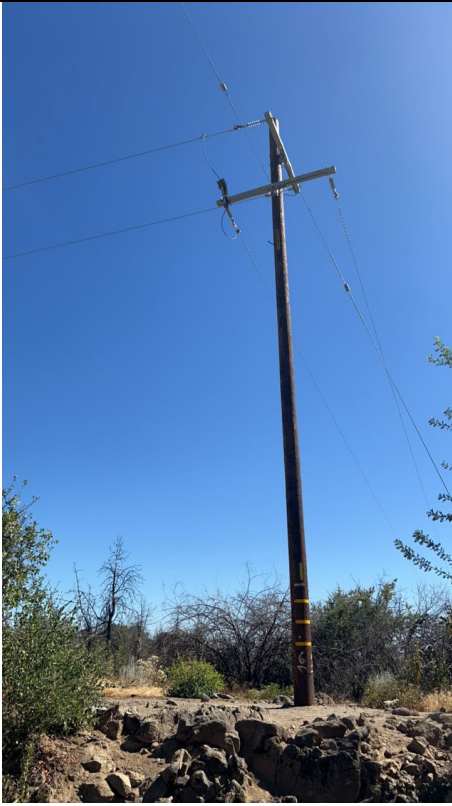
The inspector's observation is documented in Violation 1 photographs, which are attachments to this report. For pole ID 121479485, photo numbers Item1GIImg1 and Item1IA1Img1 depict bare conductor and a new crossarm where covered conductor installation was reported as completed.

A close-up photograph of the wooden pole. A yellow identification tag is attached to the pole with two screws. The tag contains the number '121479485' and a barcode. Below the tag, a metal band is wrapped around the pole with the number '248418' embossed on it.
<p><b>Item1Gimg1:</b> Overall pole south view</p>	<p><b>Item1Gimg2:</b> Pole ID</p>

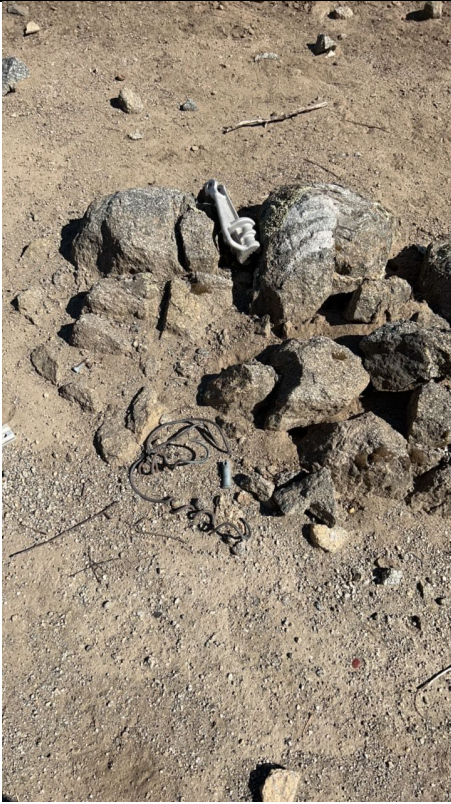
**Item1GImg3:** Abandoned dead end insulator

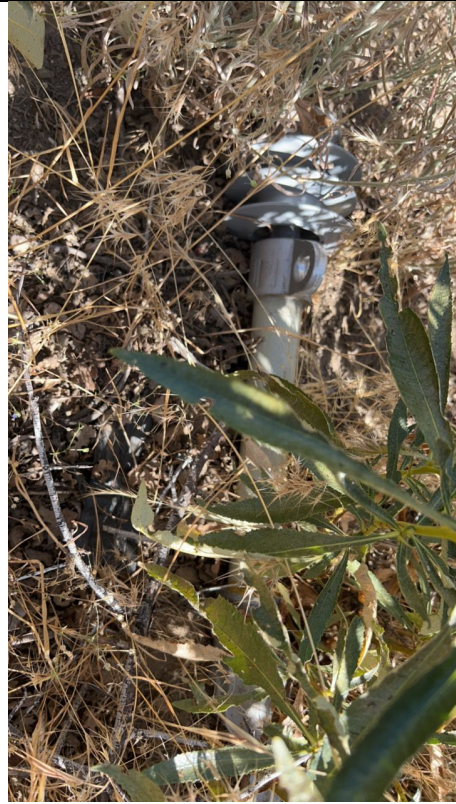
**Item1GImg4:** Abandoned triplex insulator lying within vegetation

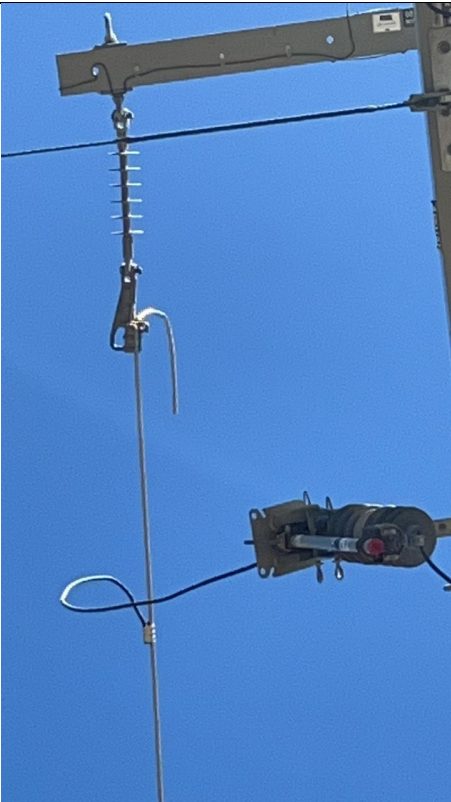
**Item1IA1Img1:** New bare wire, crossarms, and cut-out

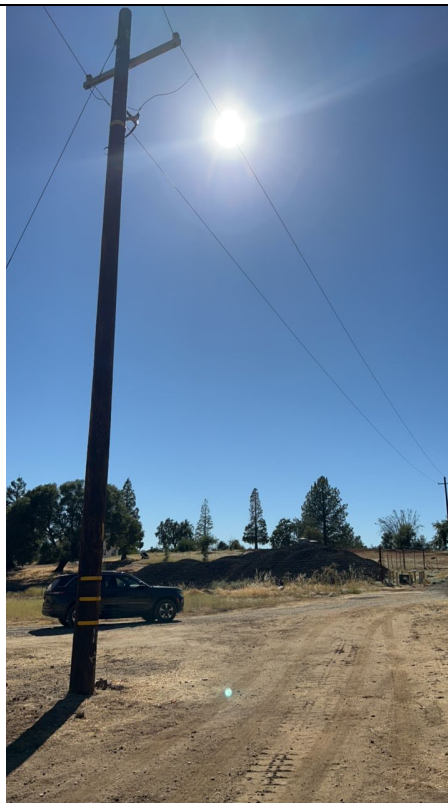
Item2GImg2: Overall pole with riser and underground pad mounted transformer in background

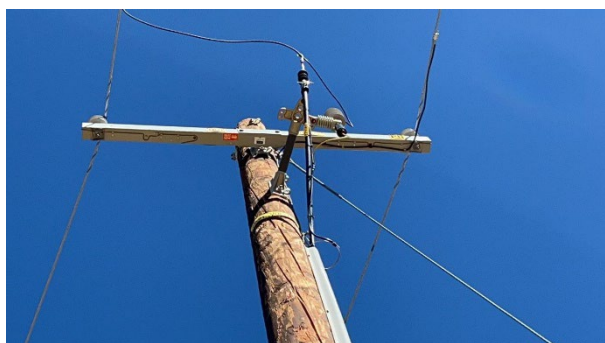
For pole ID 121026973 photo numbers Item2IA1Img1, Item2IA1Img2, and Item2IA1Img3 depict new bare conductor and the nearest pad mounted transformer box where covered conductor installation was reported as completed.

Item2IA1mg1: Bare conductor with new crossarms and insulators

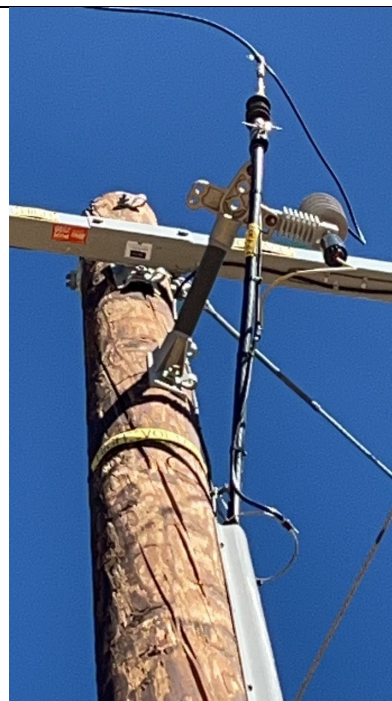
Item2IA1mg2: Riser

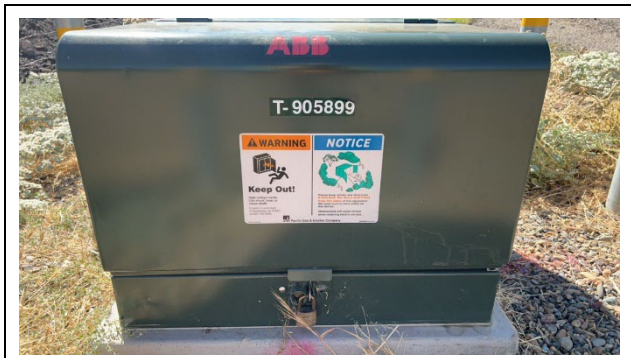
**Item2IA1mg3:** Nearest pad mounted transformer

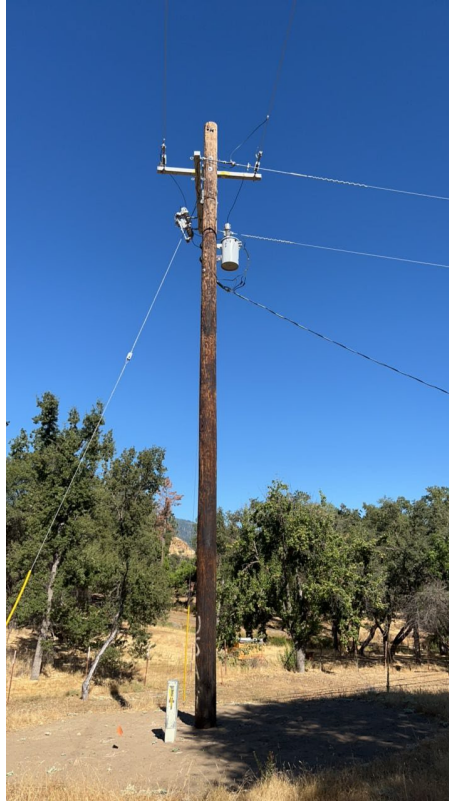
For pole ID 121075190 photo numbers Item3GIImg2, Item3IA1Img1, and Item3IA1Img2 depict bare conductor where covered conductor installation was reported as completed.

Item3GImg2: Overall pole east view

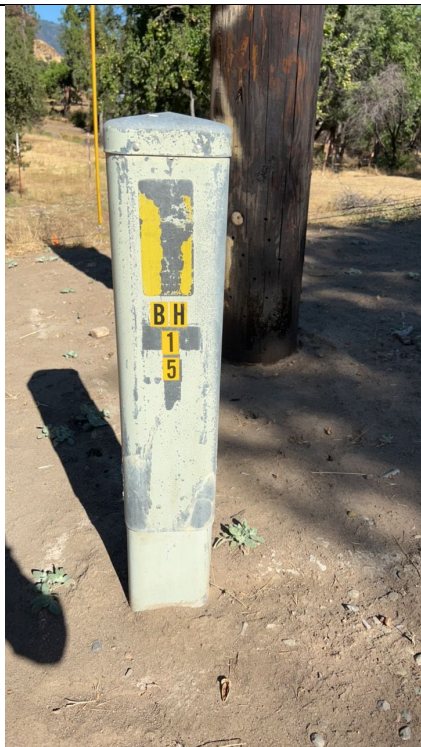
Item3GImg3: Equipment at base of pole

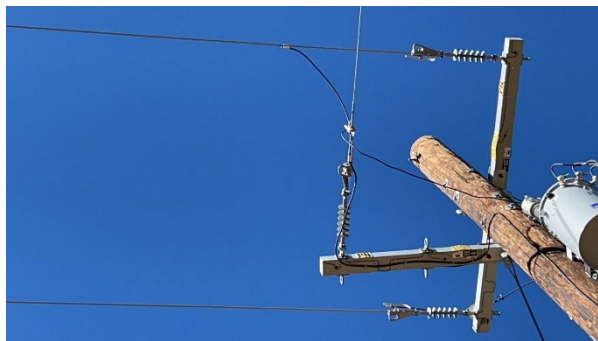
Item3IA1Img1: Bare conductor

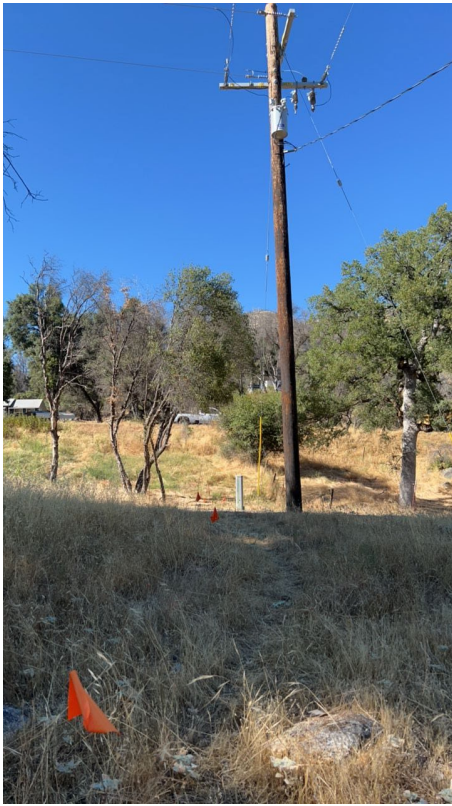
**Item3IA1Img2:** Overall north view
