NOTICE OF VIOLATION

On January 28, 2025, Energy Safety conducted an inspection of SCE's WMP initiatives in the vicinity of the city of Ojai. The inspection report is enclosed herewith. Energy Safety found the following violation:

INSPECTION REPORT

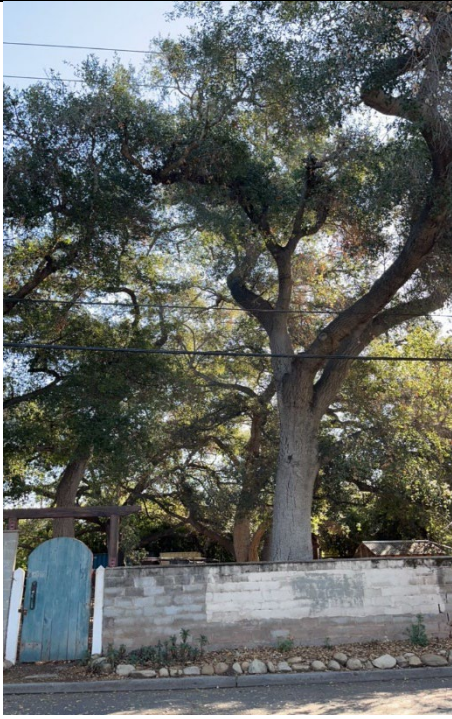
SCE's Q3 QDR data indicated that SCE trimmed an oak tree under its Expanded Clearing program (VM-07 WMP initiative number 8.2.3.3.1) at Vegetation Management Point (VMP) ID 1WL4v00000306j9GAC-2024_3, near GPS coordinates 34.447290, -119.278711, in August 2024. The inspector observed the subject oak tree at 0.4 span north of pole 396394E, behind 210 S Padre Juan Avenue in Ojai, growing under the covered conductor and had branches within the 4-foot clearance distance requirement as indicated in SCE's WMP. The inspector measured both the oak tree height and conductor height with the Nikon Forestry Pro II laser rangefinder. The oak tree measured 31.9 feet in height to the tallest branch directly under the conductor and the conductor height measured 35.5 feet in height. The distance between the highest oak branch directly underneath the conductor and the conductor was no more than 3.6 feet, which less than the four feet required by in SCE's WMP. The inspector's observation is documented in Violation 1 photographs, which are exhibits to this report. Photo numbers Item1IA1Img1 and Item1IA1Img2 depict the subject oak tree branches within four feet of the covered conductors. Photo number Item1GIImg1 depicts the Pole ID, and photo numbers Item1GIImg2 and Item1GIImg3 depict the tree's location.

<p>Item1GImg1: Pole ID 396394E.</p>	<p>Item1GImg2: Oak tree north of pole 396394E.</p>

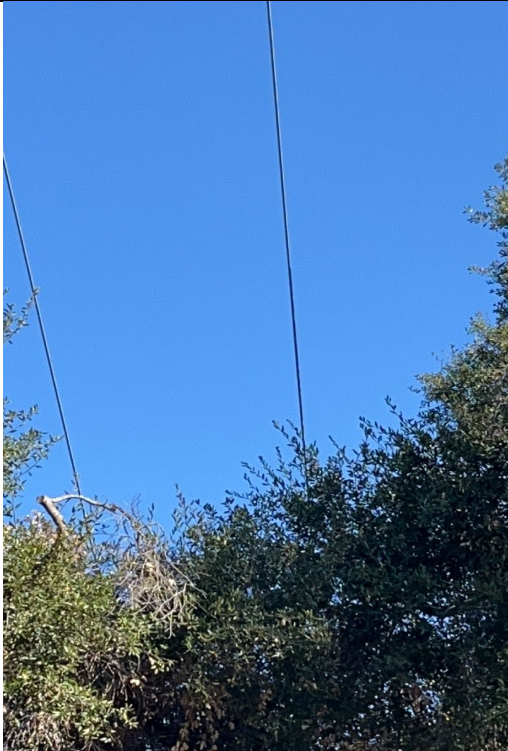
Energy Safety concludes that Violation 1 is "Minor" because the vegetation is encroaching into the minimum clearance requirements, however the conductor above the tree is covered and therefore does not present an immediate fire risk.

Item1IA1Img1: Oak tree breaking minimum clearance requirements. Photograph was taken from Mesa Drive and S Padre Juan Avenue 49 feet away from the oak tree.

In accordance with Energy Safety Guidelines,² within 30 days from the issuance of this NOV, SCE must provide a response informing Energy Safety of corrective actions taken or planned to remedy the above identified violation and prevent recurrence. Alternatively, should SCE disagree with the NOV, SCE must submit to Energy Safety a response stating it disagrees with the violation, the reason or justification for the disagreement and all
