Preliminary Ignition Investigation Report

Ignition Database Index:	531
Electric Incident Investigation (EII) Number:	N/A
HAWC Incident Name:	N/A
PG&E Facility Ignition?	Yes
CPUC Reportable Ignition?	Yes
Date & Time of Incident:	May 2, 2022 1631 hours
Street Address:	[REDACTED]
City:	Nevada City
County:	Nevada
Latitude/Longitude:	[REDACTED]
PG&E Division:	Sierra
High Fire Threat District (HFTD):	Tier 3
Fire Index Area:	330
Fire Potential Index (FPI) Rating:	R1
Was there a PSPS event at the time of ignition?	No
Failure Driver:	Contact from object
Failure Sub-driver:	Vegetation contact-PG&E contracted crew (2 nd party)
Circuit:	Brunswick 1103
Circuit Protection Zone:	Brunswick 1103173934
Nominal Voltage:	12kV
PG&E Equipment associated with ignition:	Primary conductor
EPSS enabled at time of ignition?	No
Fault Type:	Line to ground
Wire Down (Primary)?	Primary conductor broken and, on the ground
MAVF Score	TBD
Lead Agency/Agency Having Jurisdiction:	Nevada County Consolidated Fire District

Executive Summary

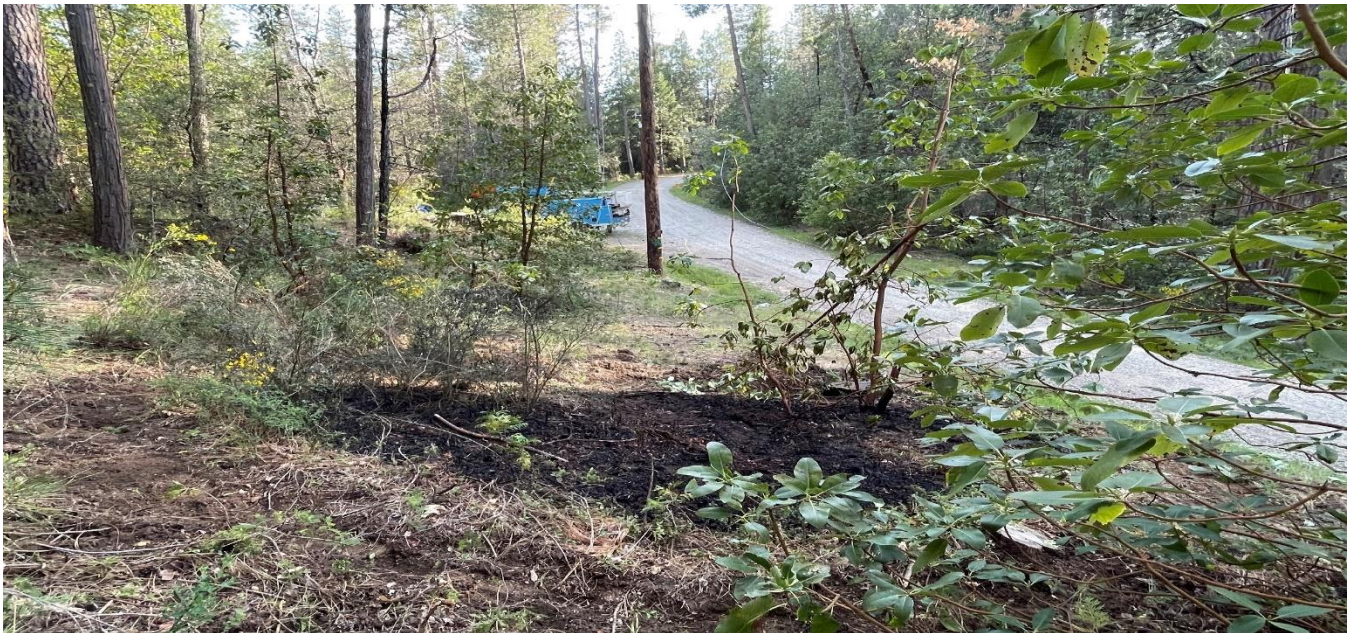
Figure 2 Photo taken by the responding troubleman showing approximate 10 X 12-foot fire.

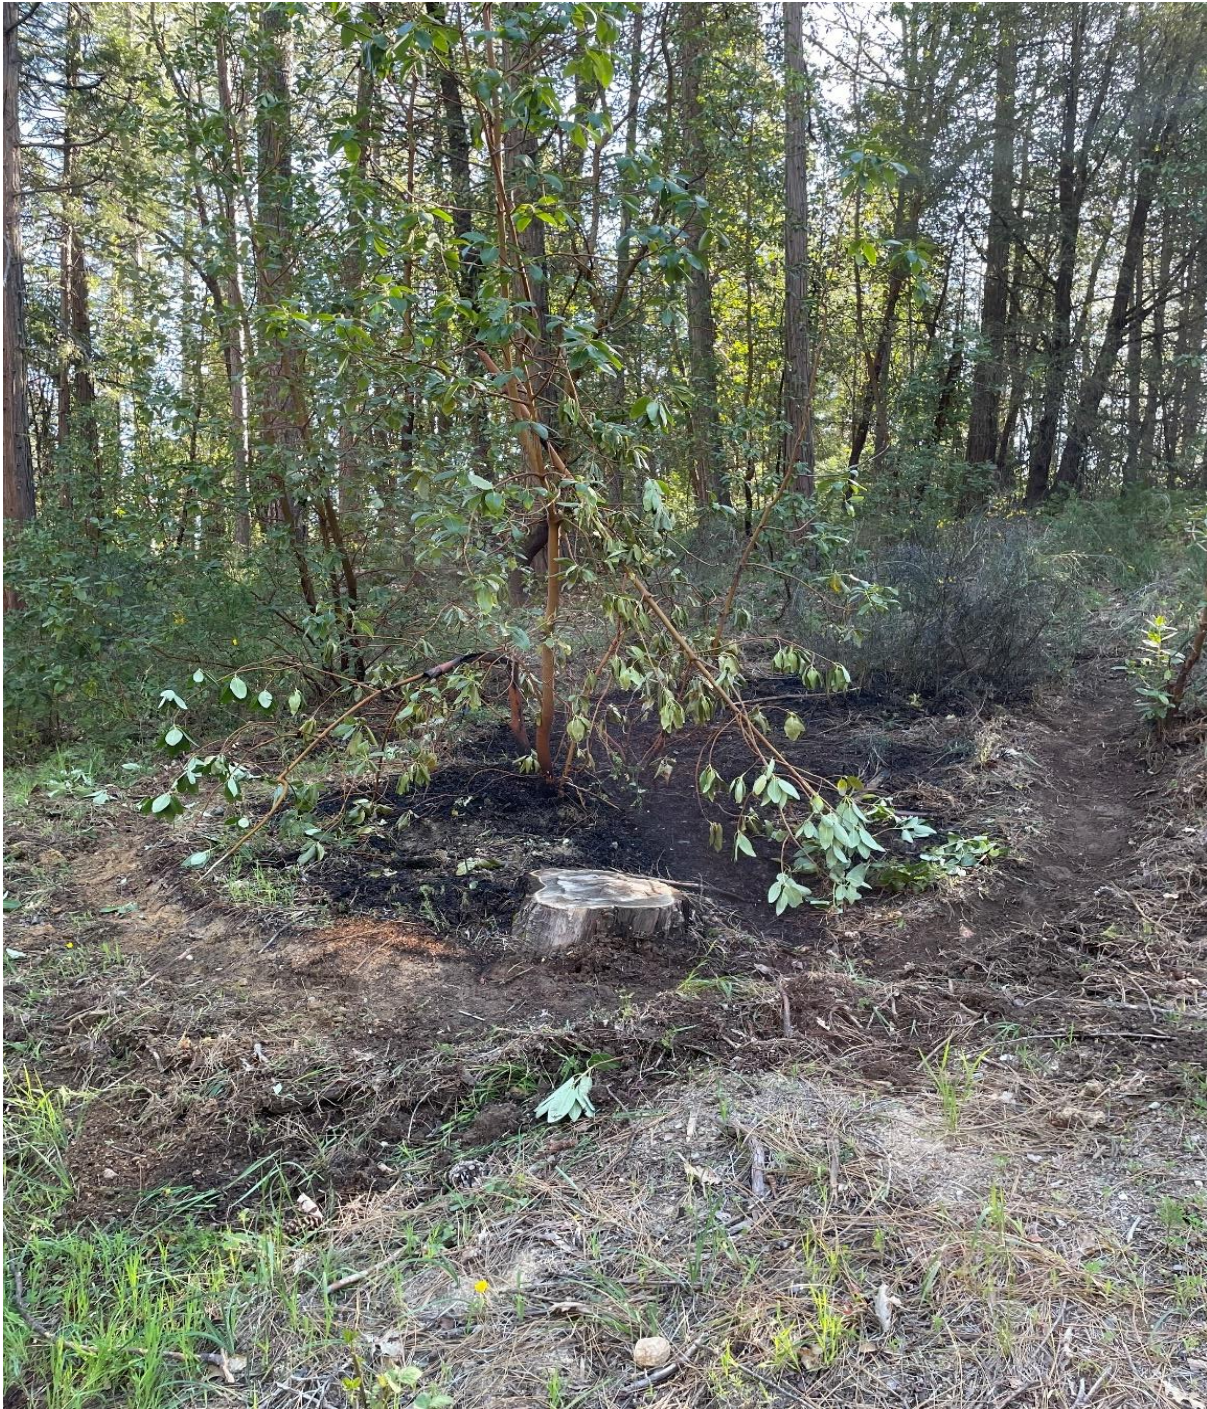
Figure 3 Photo taken by responding troubleman showing burned spot and vegetative condition in the area.

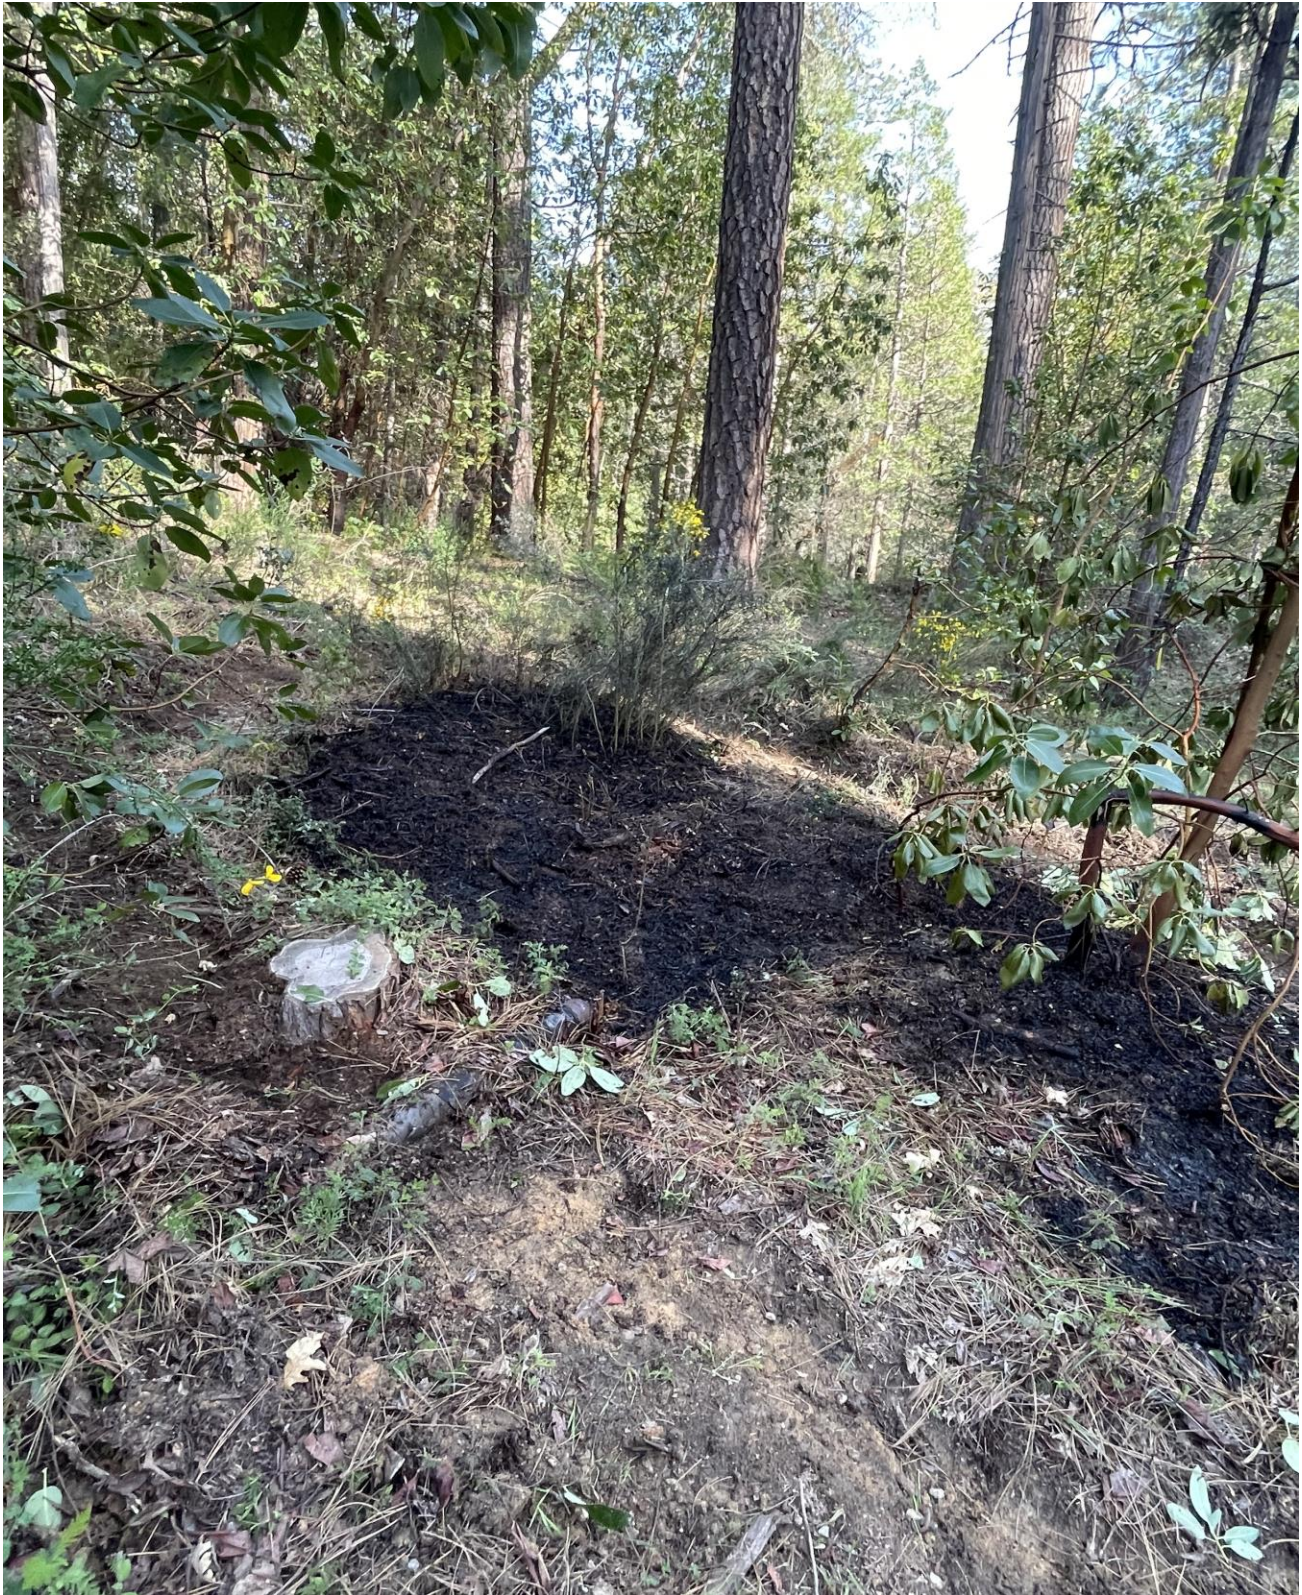
Figure 4 Photo taken by responding troubleman showing close up of fire area.

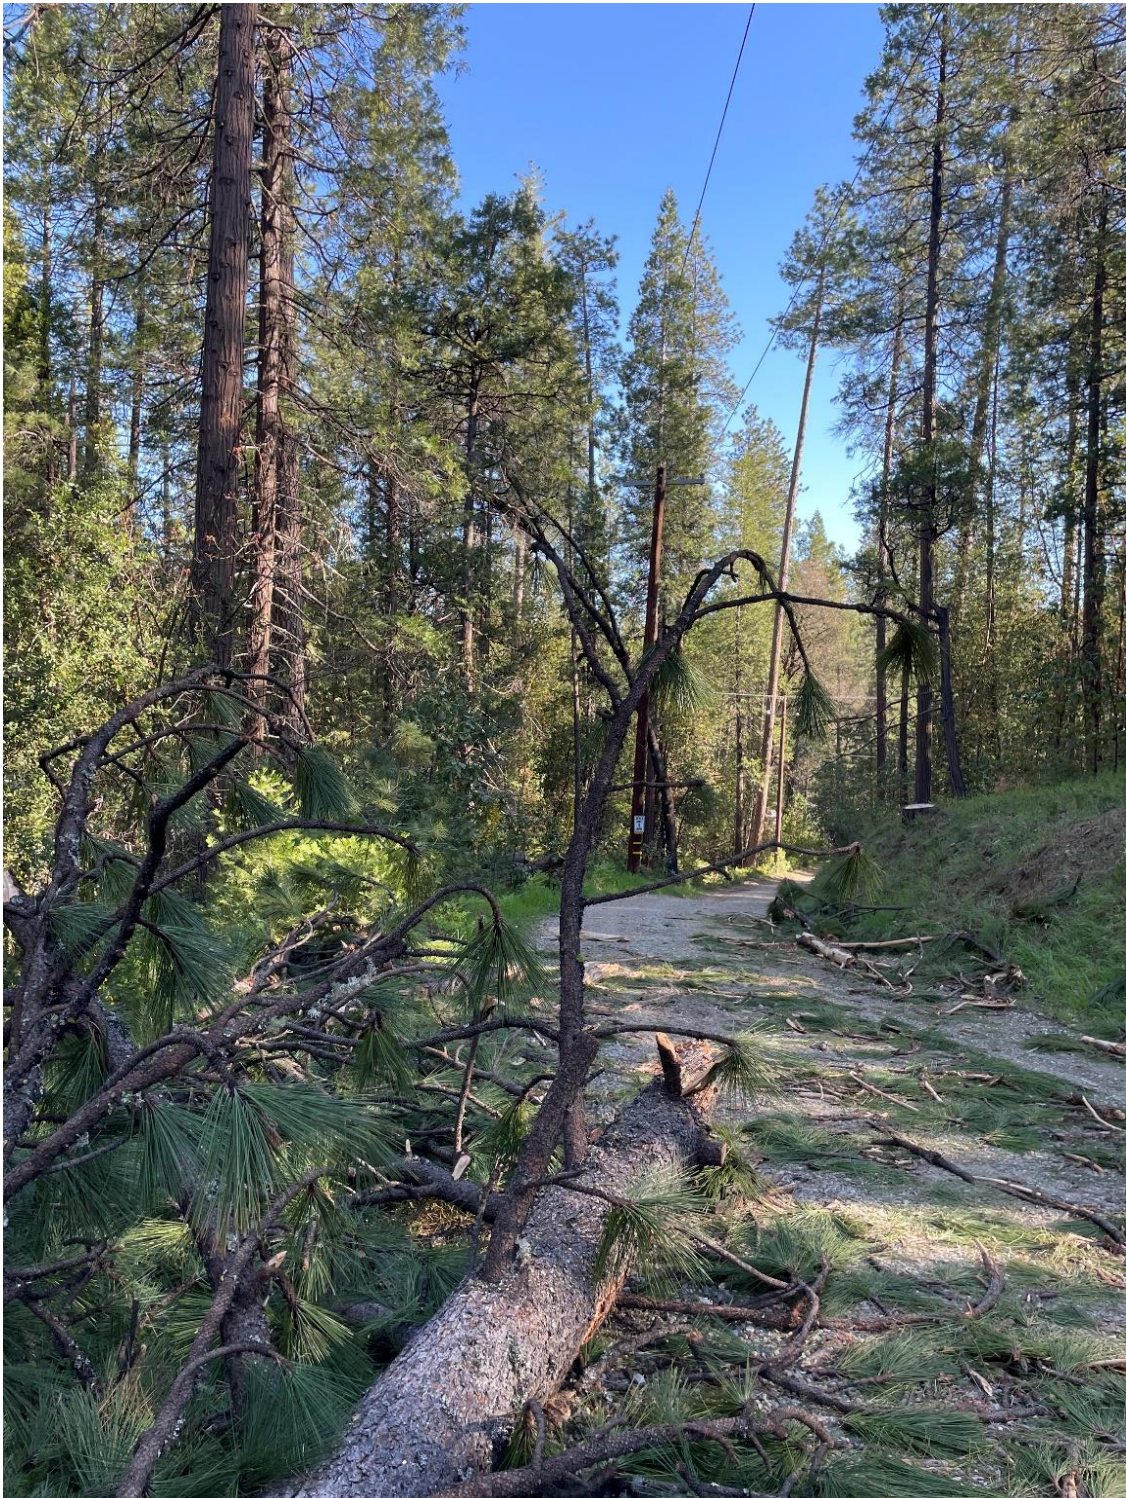
This incident involved a 2nd party contact (a PG&E contracted) Enhanced Vegetation Management (EVM) crew, Evergreen Arborist. The subject tree was originally assigned a R3B_Rmv 3-B prescription (meaning a large tree with a higher degree of difficulty in removal usually requiring roping and rigging, identified for removal due to its potential hazard to PG&E facilities) with the EVM team's PI comments stating "the tree is growing weird and has previously broken and is possibly rotten or cracked about 40 feet up the trunk. Remove to reduce the hazard."

Figure 5 Photo taken by VM team showing a portion of the 120-foot tall, 35 DBH, subject tree and lines above.

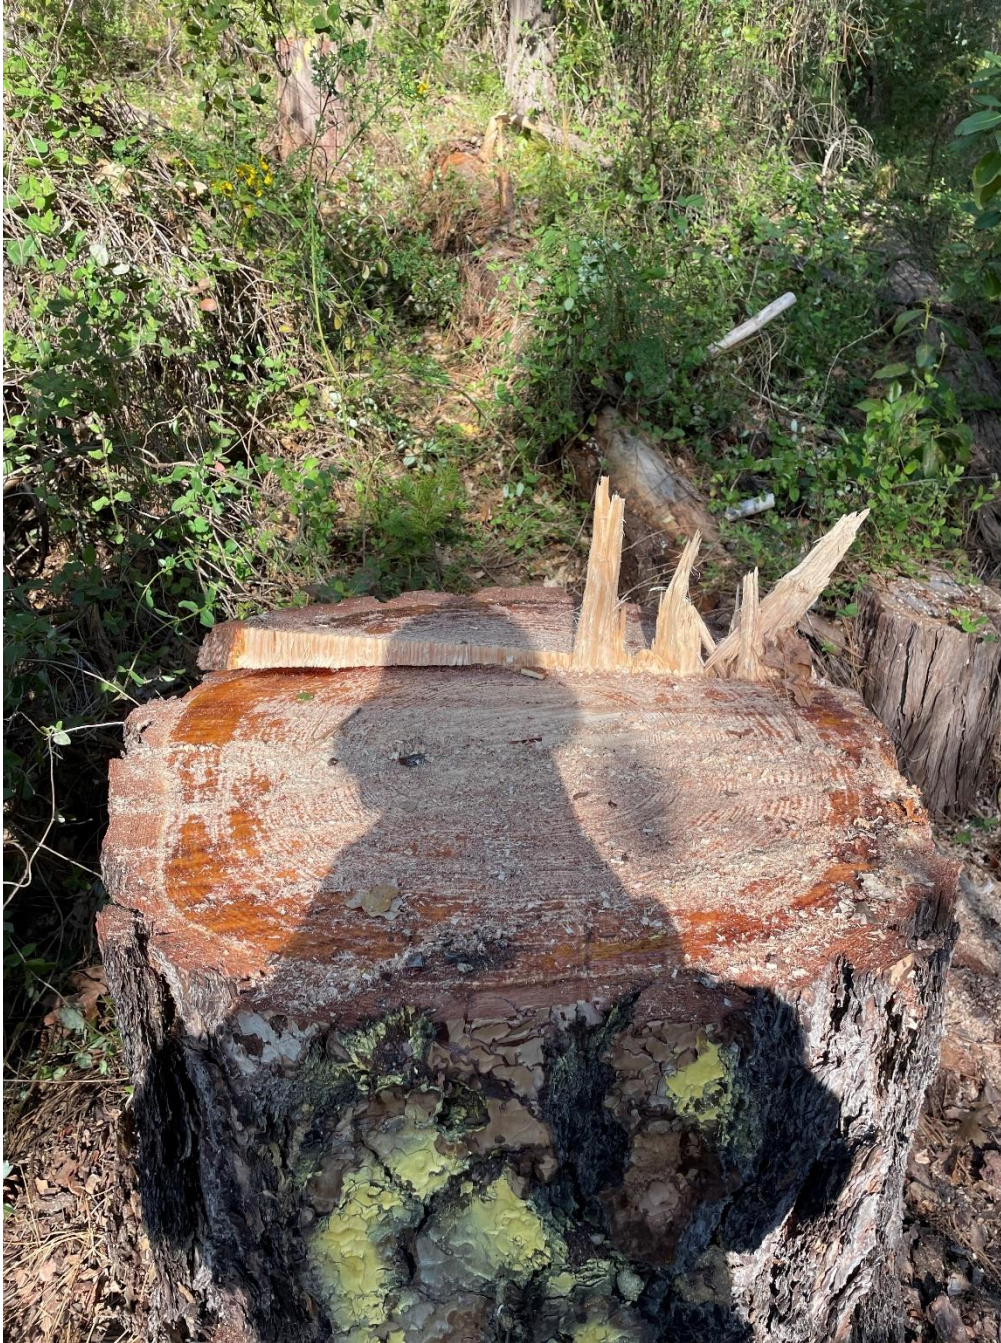
Figure 6 Photo taken by VM team showing stump of subject tree.

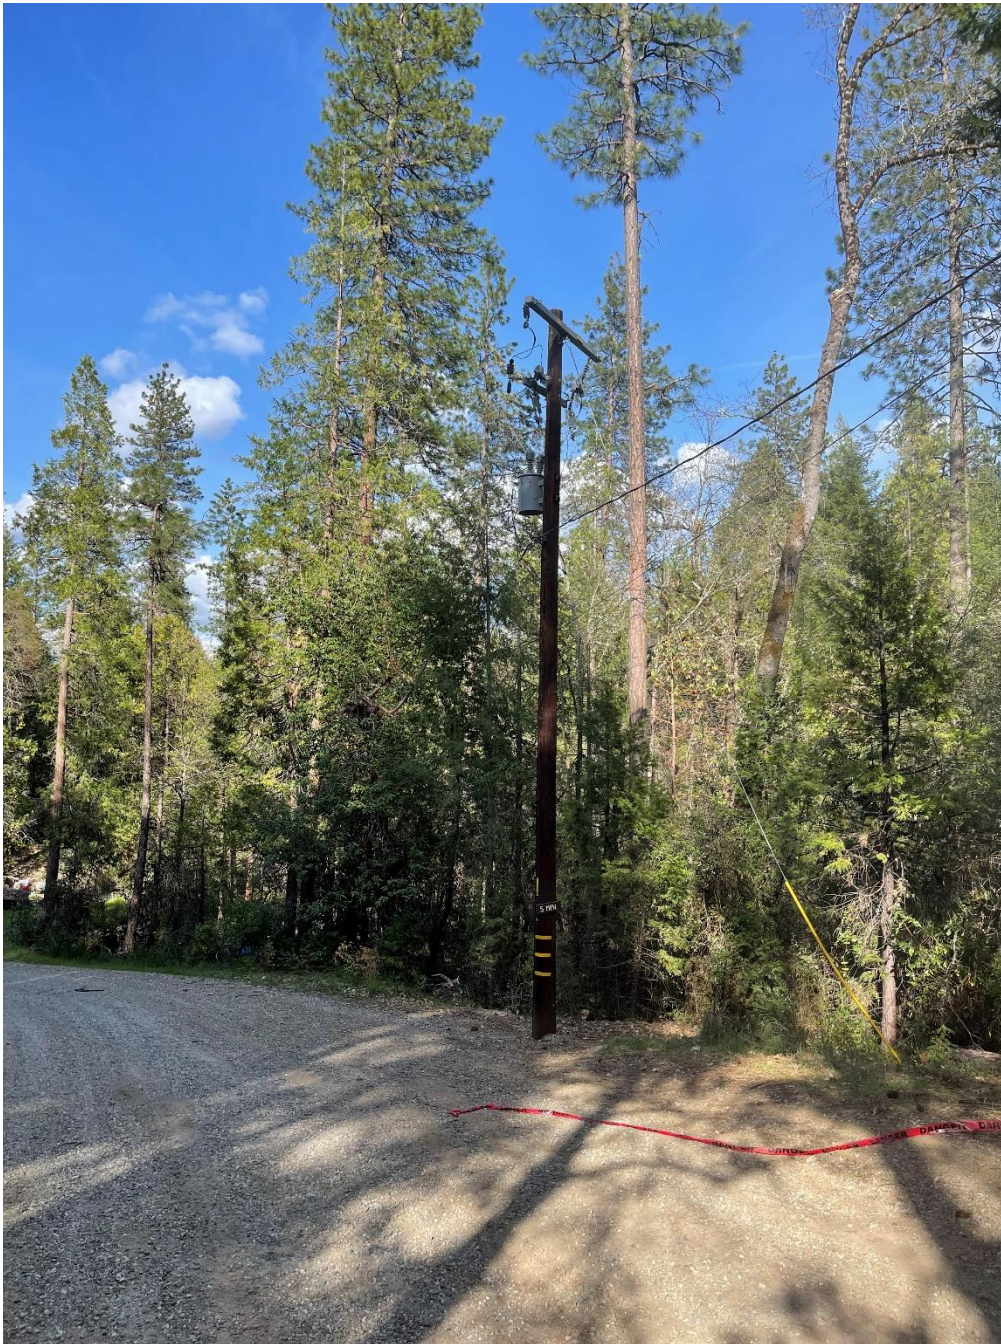
Figure 7 Photo taken by responding troubleman showing trees in the area in proximity to pole.

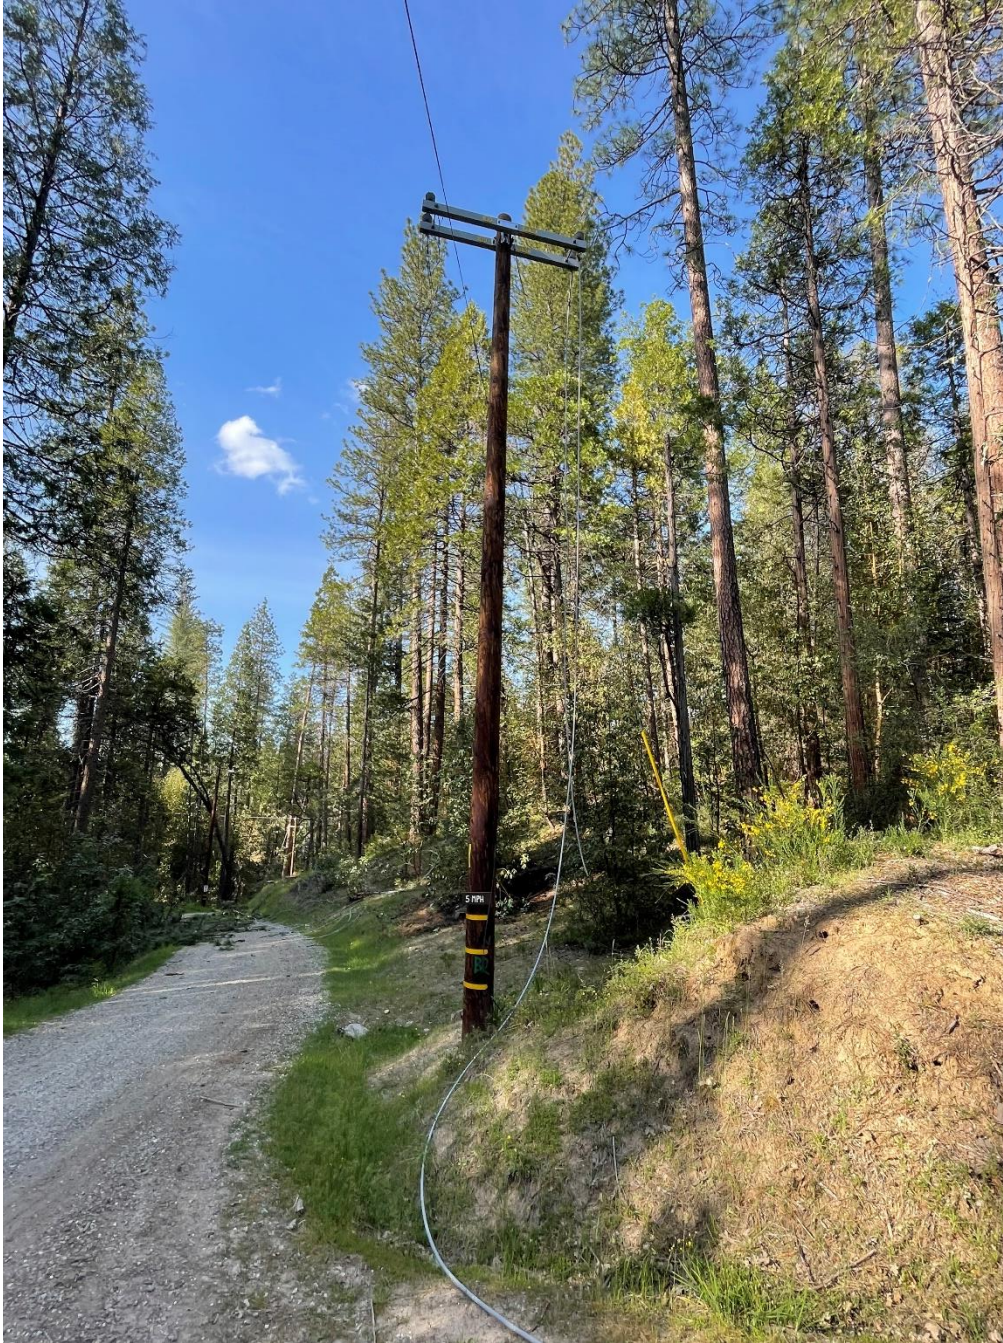
On May 2, 2022 at 1631 hours, a PG&E troubleman was dispatched to the Brunswick 1103 12kV distribution circuit near Lake Vera Purdon Road in Nevada City in response to a report of a power outage, wires down and a small fire. The troubleman arrived on scene near pole SAP ID # 104007214 and noted that a PG&E contracted tree crew company (Evergreen Arborist Inc) fell a pine tree through an Aluminum Cable Steel Reinforced (ACSR) tree wire. The troubleman also noted that there was wire down on the ground east of fuse cut out (FUCO) # 7705 (see figures # 8 and # 9 below.)

Figure 8 Photo taken by responding troubleman showing wire down.

Two Electric Corrective (EC) tags were created because of this incident. Priority "A" EC tag # 123480524 associated with pole SAP ID # 104007214 to replace 2000 of overhead conductor. Repairs were completed on May 3, 2022. Priority "A" EC tag # 123480521 associated with pole SAP ID # 104007213 to replace the conductor due to it being burned and cut in multiple places. Repairs were completed on May 3, 2022.

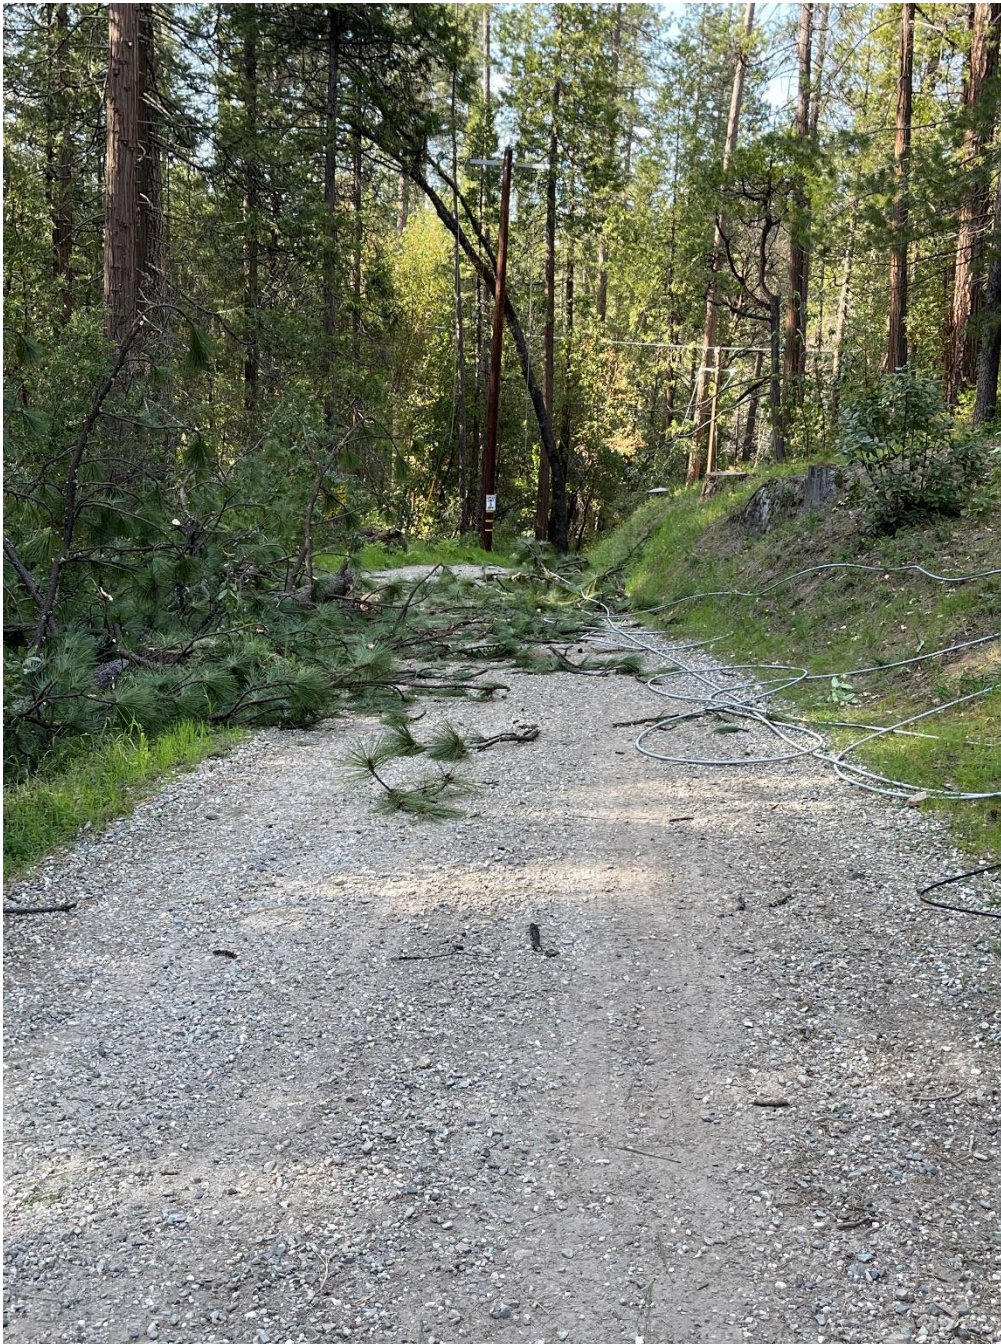
Figure 9 Photo taken by responding troubleman showing subject tree remnants and wire down.

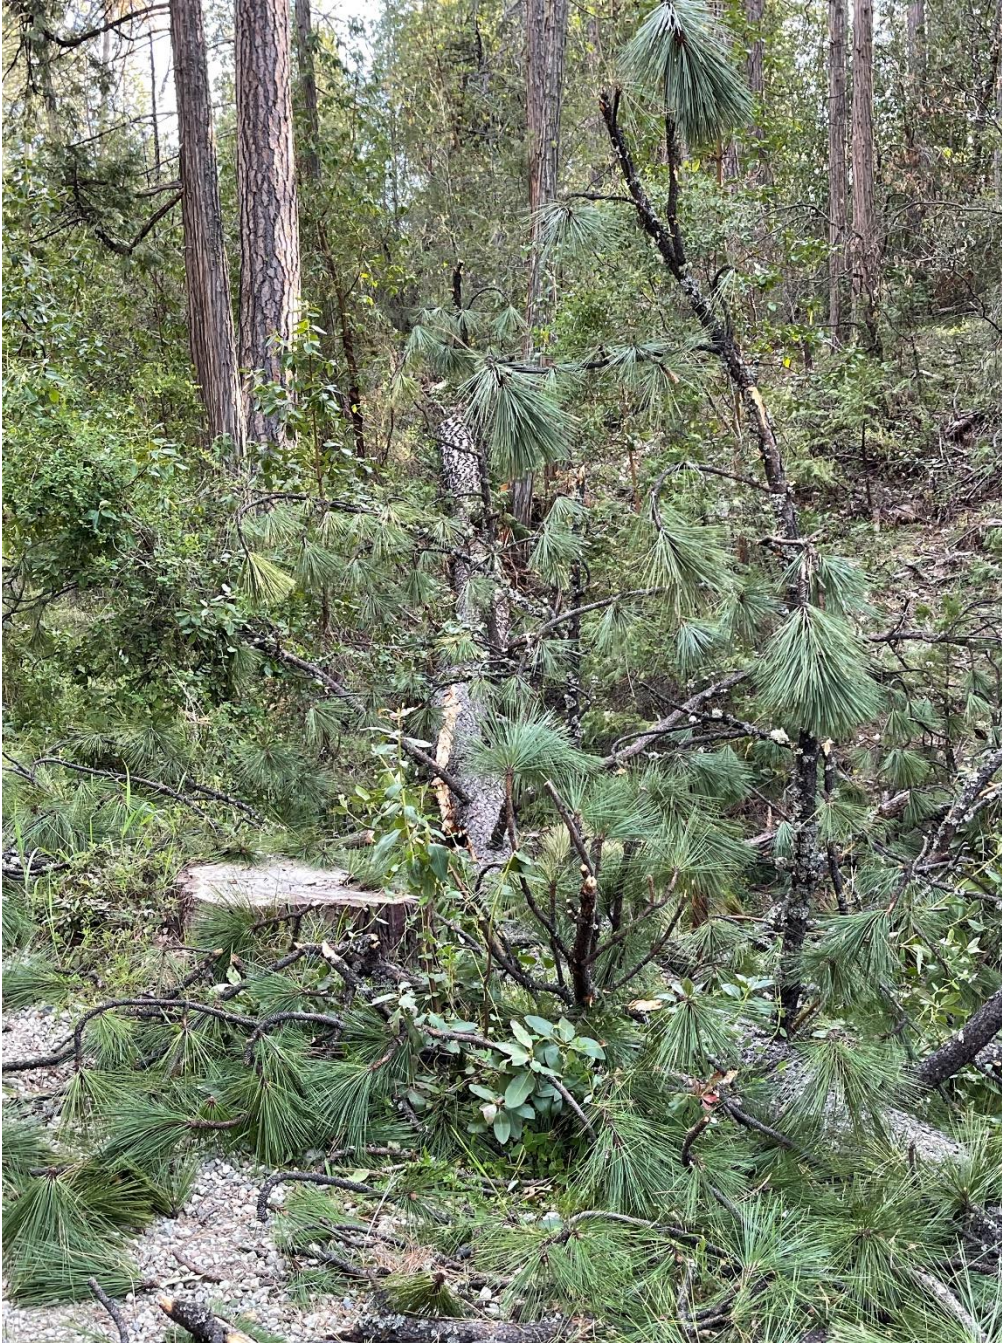
Figure 10 Photo taken by VM Team showing portions of pine tree.

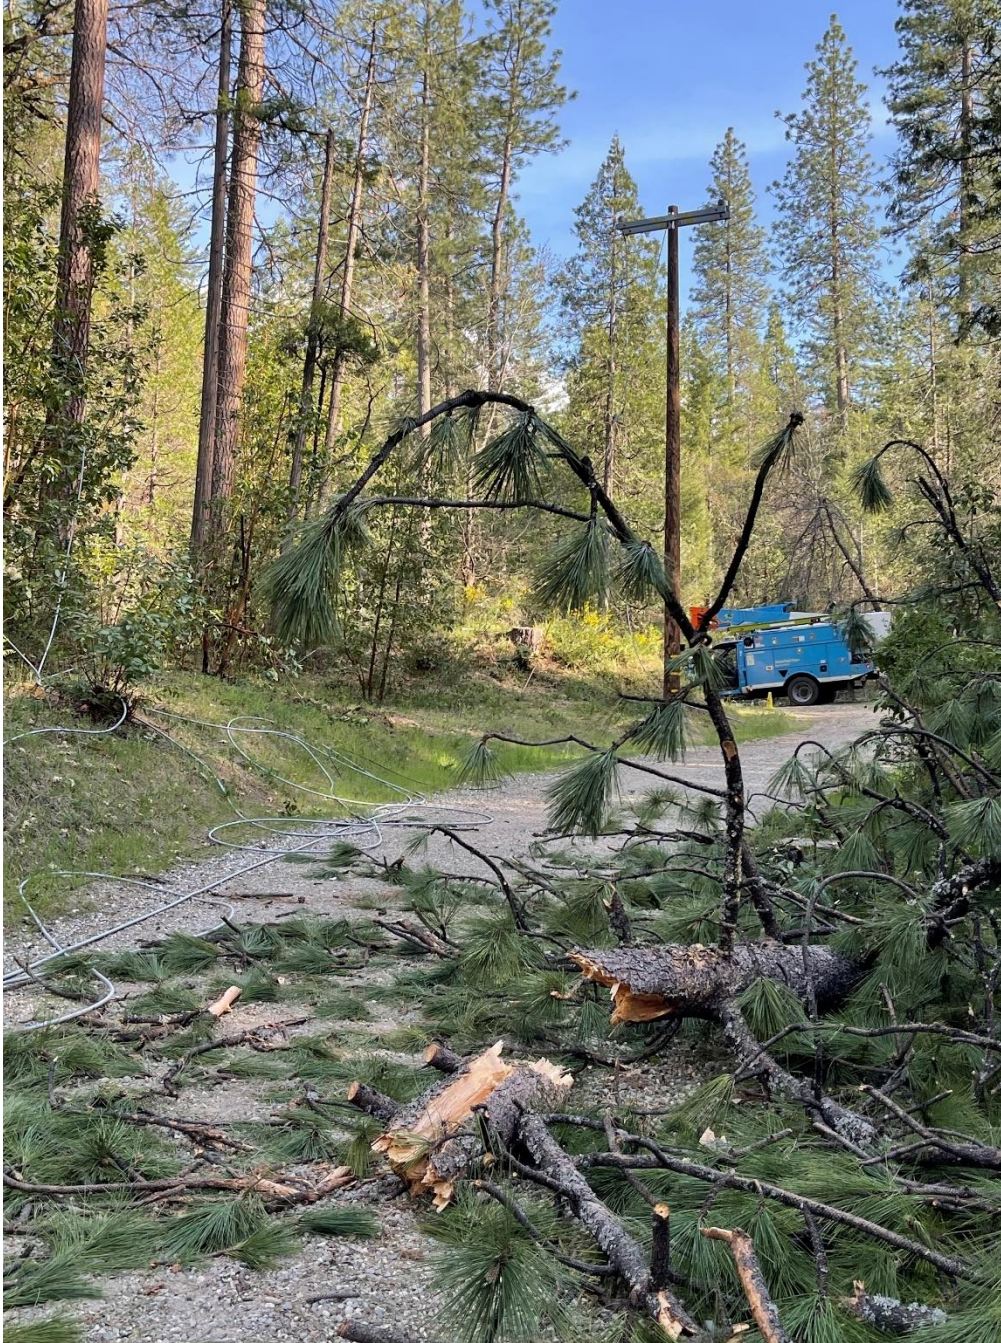
Figure 11 Photo taken by responding troubleman showing subject tree.

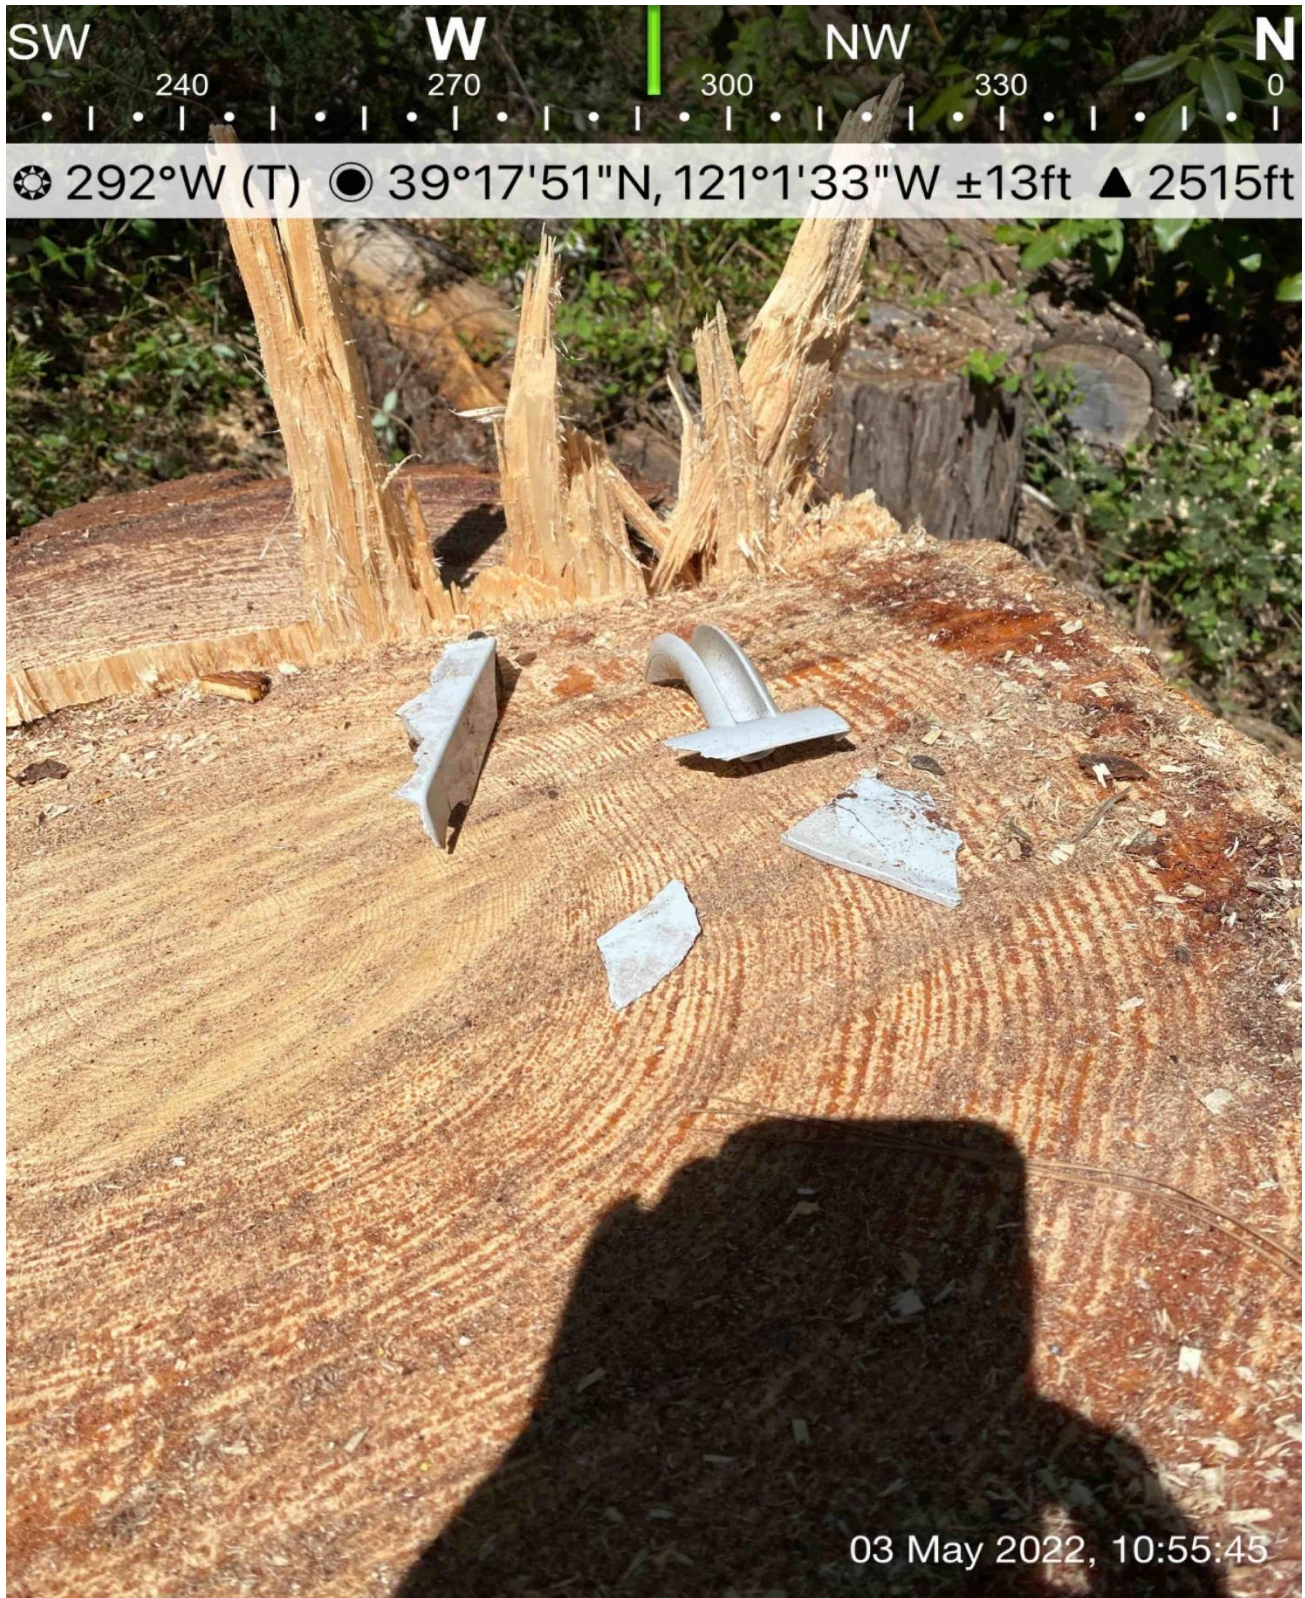
The tree crew was in the process of falling the pine tree for removal. The tree crew set up rigging on the subject tree to assist in the controlled, directional falling of the tree by tying a rope from the top of the subject tree to a redirect device on the second tree, then to a come- along at a third tree operated by the ground person. The TC foreman put in a conventional tree felling cut. The conventional cut may have had inadequate holding wood. Additionally, during the felling, the ground person noticed slack forming in the rope and tried to get the attention of the foreman using his Fox40 whistle but was unsuccessful. The poor-quality cut and slack in the rigging resulted in loss of control of the directional fell causing the tree to fall and as the tree fell, it struck the distribution lines. The energized lines came to the ground causing a vegetation fire approximately 10 X 12 feet in size (see figures # 2, # 3 and # 4 below.) The tree crew retreated to a safe location, notified the local fire department of the incident and the tree crew stood down for the remainder of the day.

Figure 12 Photo taken by VM team showing broken chainsaw parts on the tree stump.

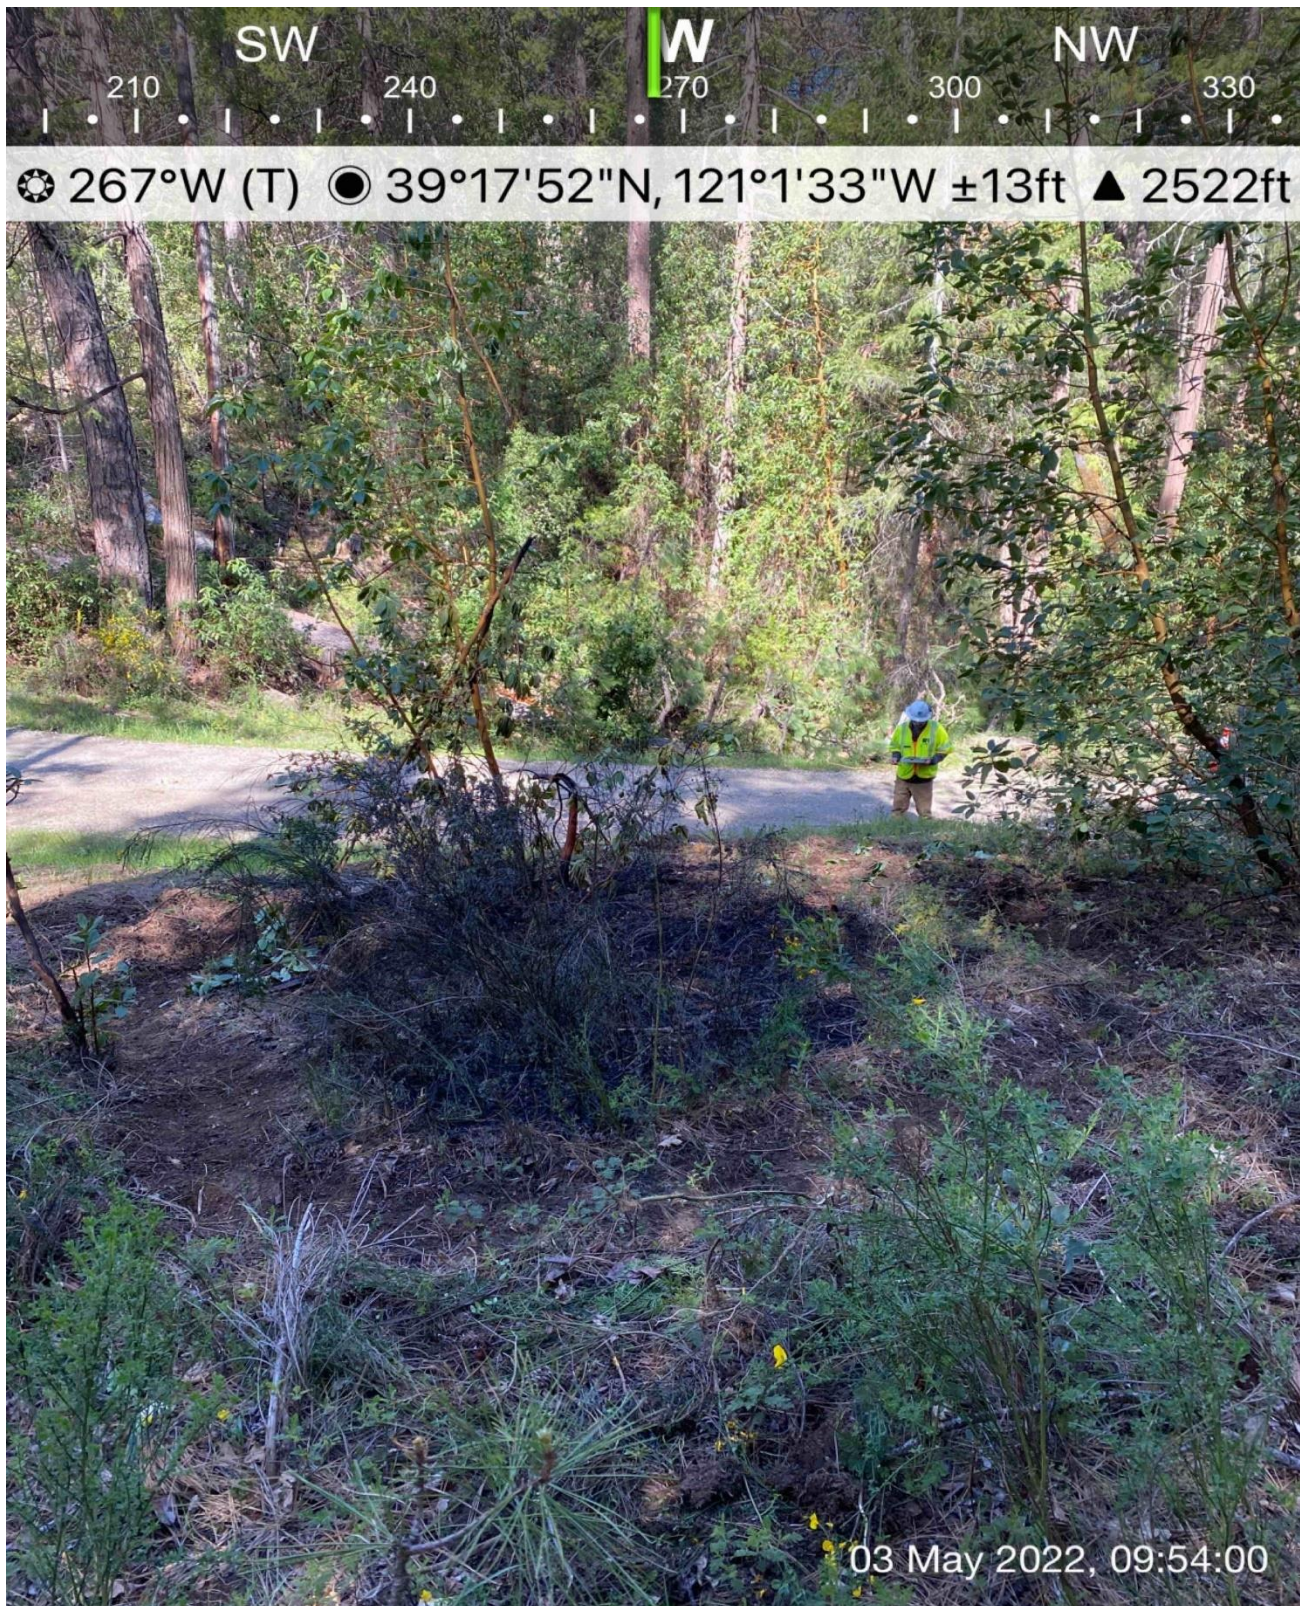
Figure 13 Photo taken by VM team showing fire area and vegetative state in the incident area.

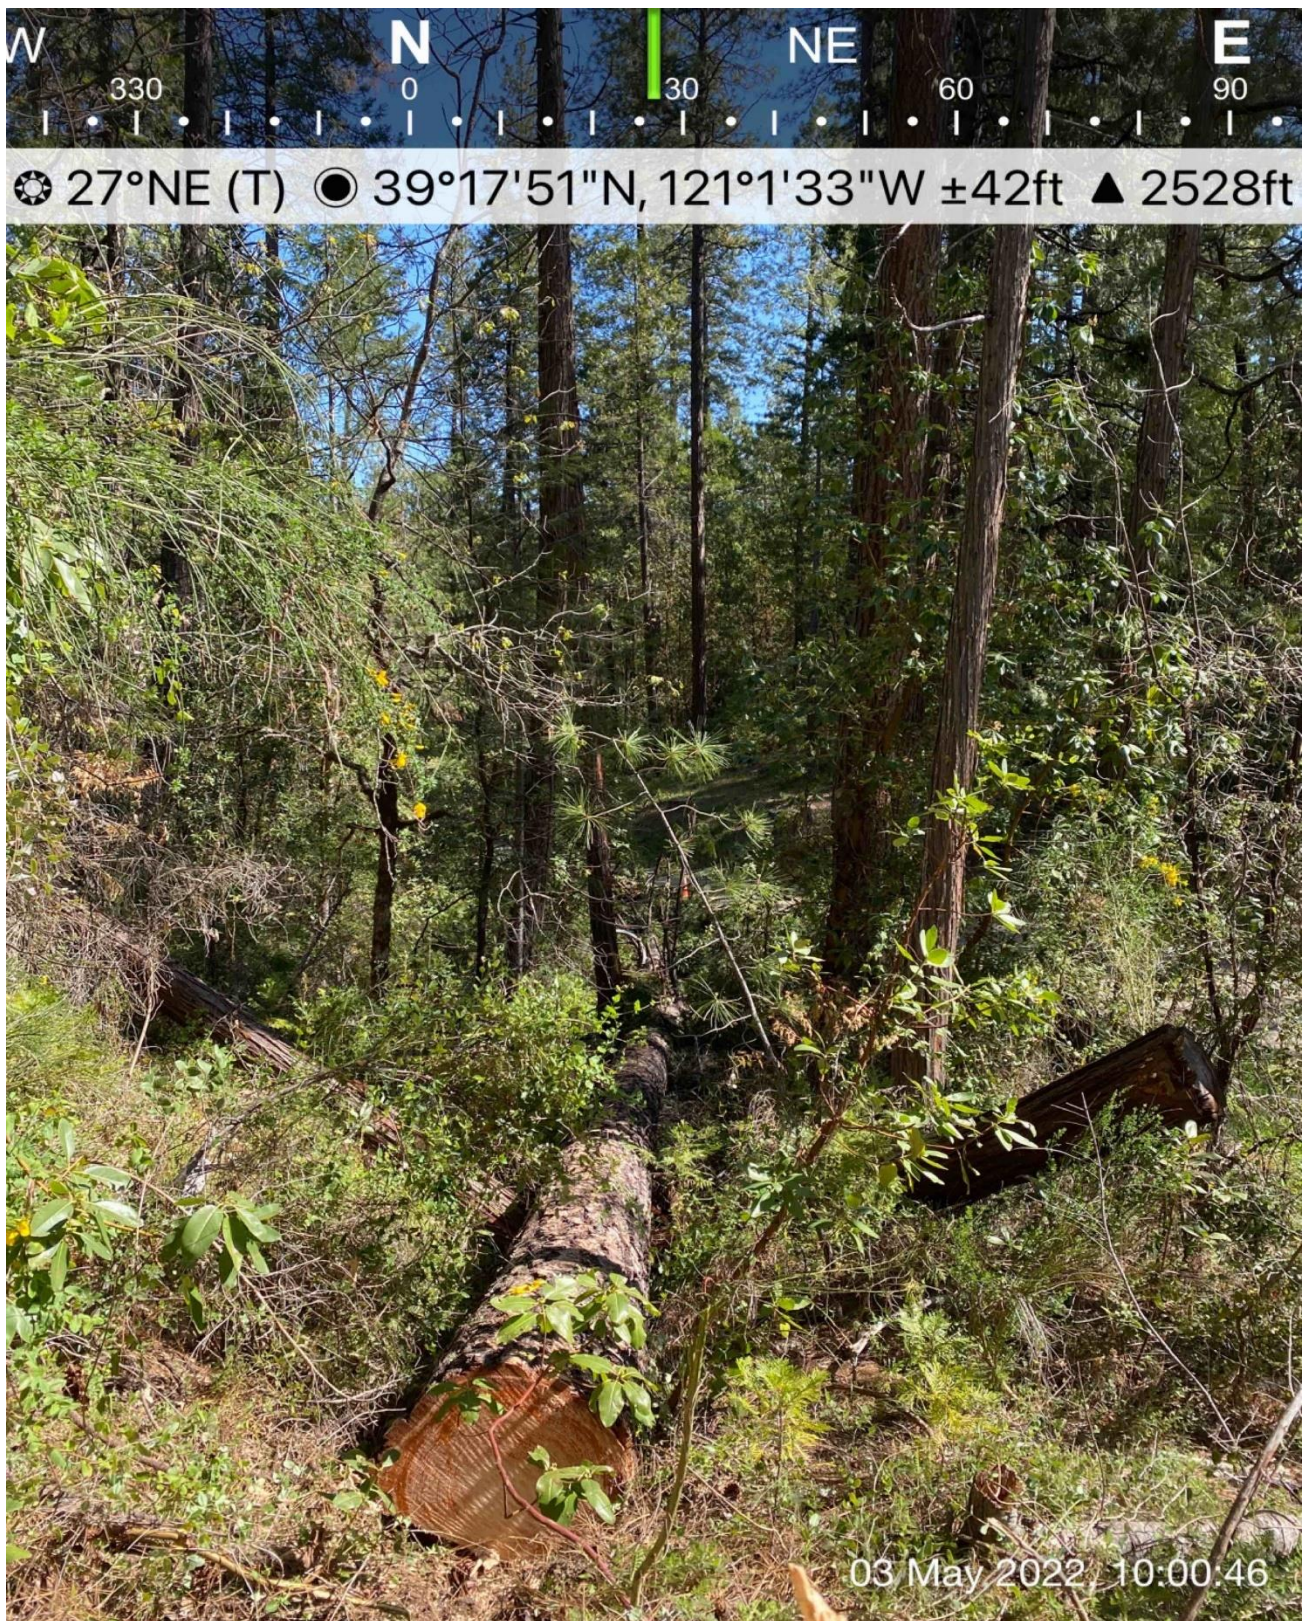
Figure 14 Photo taken by VM team showing downed subject tree.
