# Preliminary Ignition Investigation Report

<b>Ignition Database Index:</b>	539
<b>Electric Incident Investigation (EII) Number:</b>	None
<b>Assigned Attorney</b>	None
<b>HAWC Incident Name:</b>	Skyway
<b>Suspected Point of Origin Near PG&amp;E Facilities:</b>	Vegetation near downed conductor
<b>PG&amp;E Facilities Possibly Attributable:</b>	Yes
<b>CPUC Reportable?</b>	Yes
<b>Date &amp; Time of Incident:</b>	05/10/2021 0658 hours
<b>Latitude/Longitude</b>	[REDACTED]
<b>Street Address:</b>	[REDACTED]
<b>City:</b>	Magalia
<b>County:</b>	Butte
<b>PG&amp;E Division:</b>	North Valley
<b>High Fire Threat District (HFTD):</b>	Tier 3
<b>Fire Index Area:</b>	280
<b>Fire Potential Index (FPI) Rating:</b>	R4
<b>Was there a PSPS event at the time of ignition?</b>	No
<b>Asset Type Involved:</b>	Conductor, transformer
<b>Circuit:</b>	Paradise 1105
<b>Circuit Protection Zone:</b>	Paradise 1105-LR2214
<b>Nominal Voltage:</b>	12kV
<b>Lead Agency/Agency Having Jurisdiction:</b>	CalFire

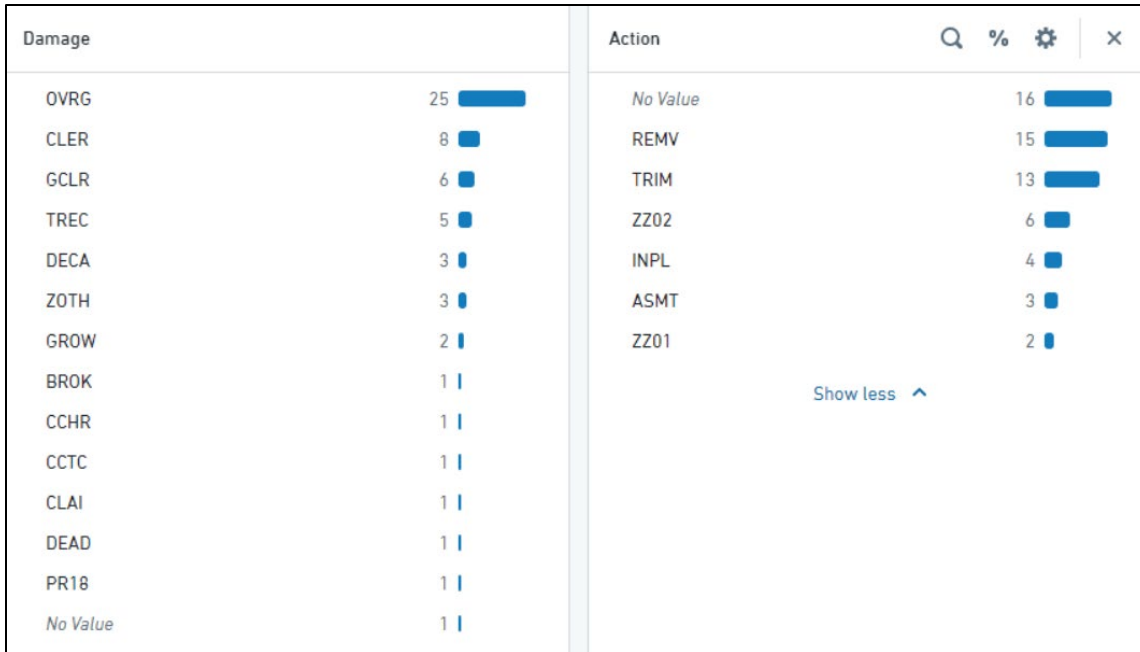
Figure A: Summary of Damage and Action codes for 59 previous EC Tags associated with Object "Tree" in Foundry.

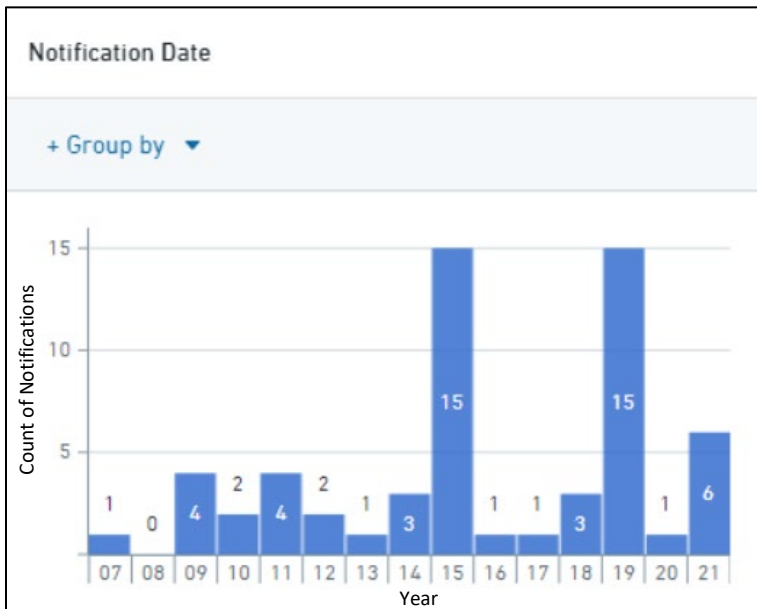
Figure B: Summary of years when 59 previous EC Tags associated with Object "Tree" in Foundry were issued.

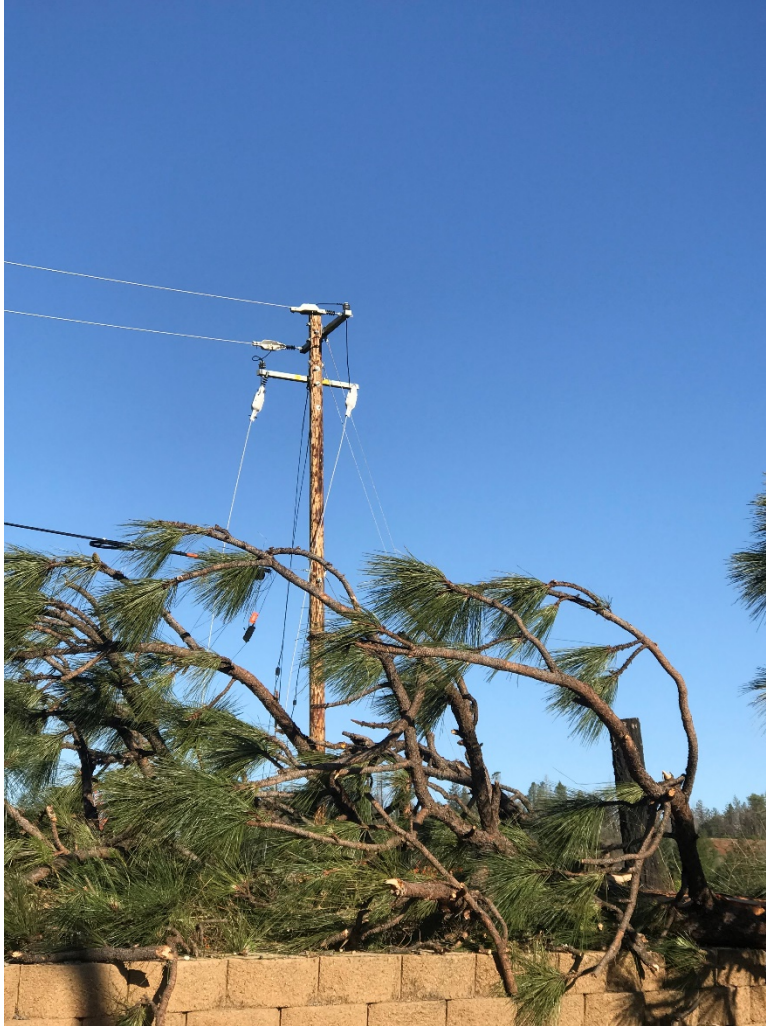
PG&E Vegetation Management (VM) indicated the trunk of the failed Ponderosa Pine tree had been damaged by fire during the November 8, 2018 Camp Fire, and the incident location was in the Camp Fire burn scar. According to VM, exposed heartwood at the trunk break location contained moisture, but there was no visible rot. Furthermore, VM reported the tree canopy was visibly green and healthy on the incident date. The 125-foot-tall Ponderosa Pine was located approximately 55 feet from the conductors and within striking distance. The segment was last patrolled by VM on October 5, 2020.

*Figure 1: Failed tree and downed conductor.*

PG&E crews replaced the transformer and damaged conductors under EC Notification #120991691.

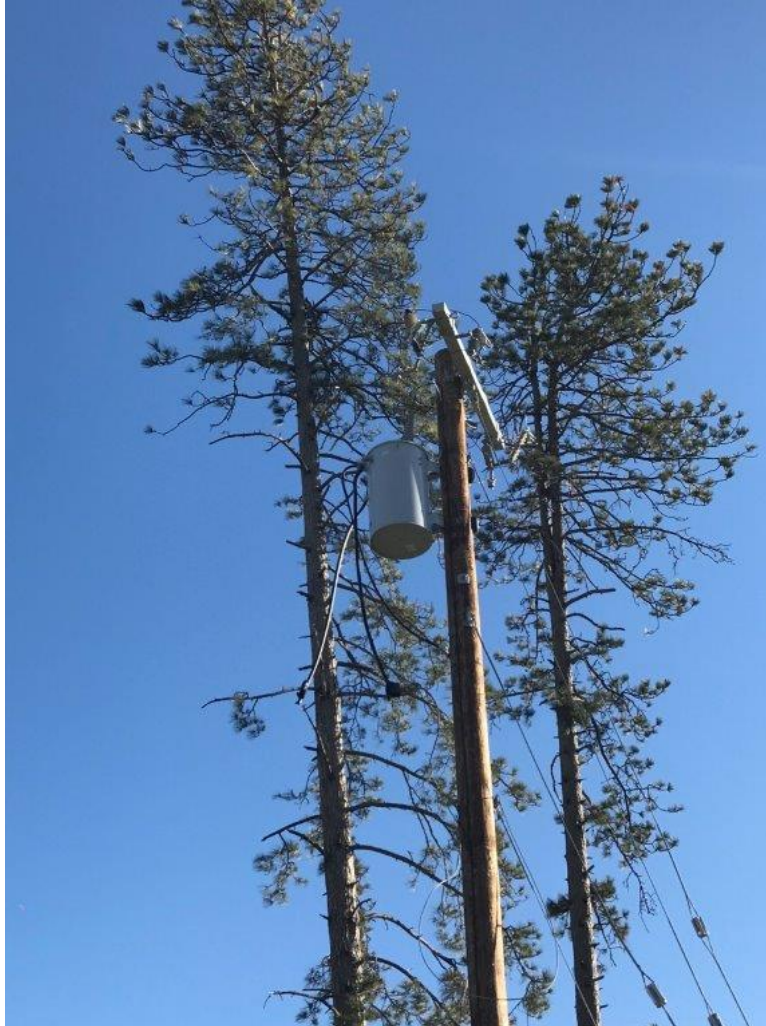
*Figure 2: Damaged transformer.*

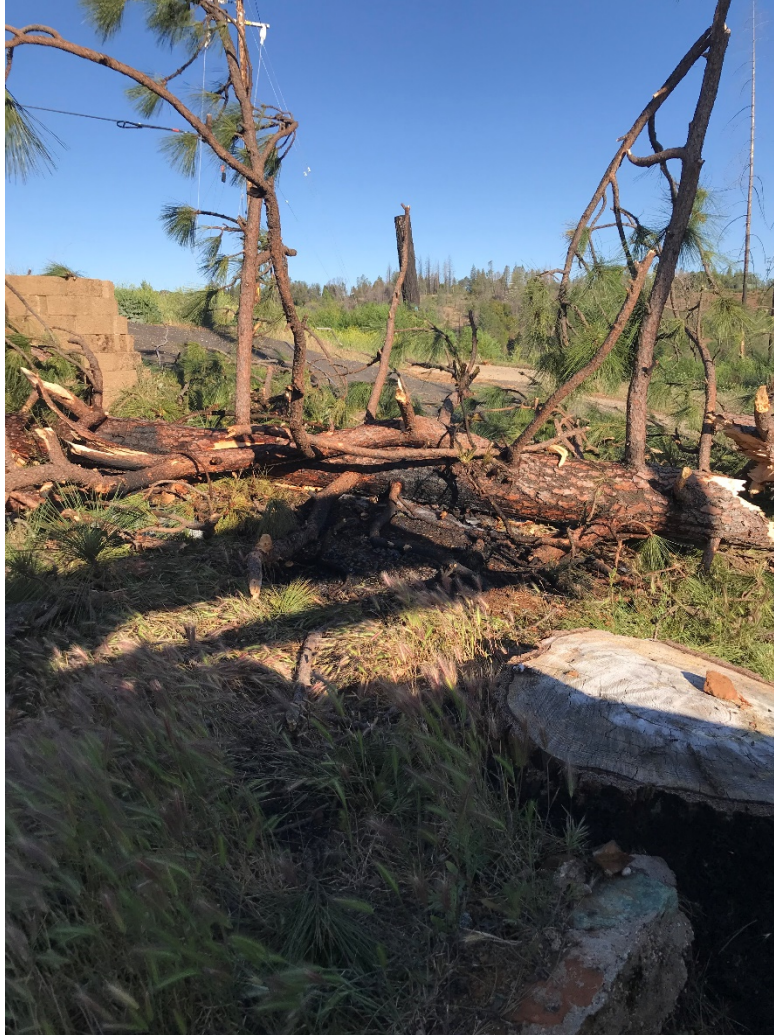
The ignition resulted in a grass fire of approximately 20 feet by 20 feet located near the base of a distribution pole (Figure 2). The 522-minute outage affected 14 customers. There were no findings of property damage or injuries, and no media coverage associated with this incident was identified.

*Figure 3: Photo of burned vegetation.*
