SUBJECT: Southern California Edison Company's Response to Notice of Violation
NOV_CAD_SCE_CAC12_20250131_1121

Notice	Violation	Structures
NOV_CAD_SCE_CAC12_20250131_1121	1	1987176E

Energy Safety's Notice states that in implementing 2024 WMP initiative 8.1.3.1 - Distribution Detailed Inspections and Remediations (IN-1.1), SCE failed to complete the replacement of a damaged wildlife cover on Pole ID 1987176E, Grid Hardening ID 413816950-1987176E at coordinates 35.086770, -118.651642..

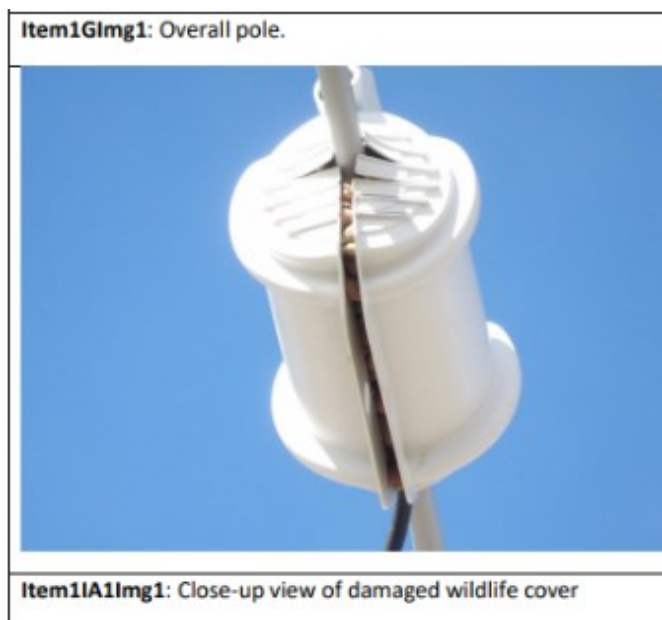
SCE disagrees with the conclusion in the Notice of Violation that SCE "failed to complete replacement of a damaged wildlife cover." Woodpeckers accumulate acorns in wildlife covers, which can cause distortion. The internal pressure from the acorns expanded the cover, giving the appearance of being damaged. However, the cover remains functionally intact and continues to protect the exposed connector. Although

the Notice describes the wildlife cover as “damaged”, the gap in the cover depicted in Photo #1 below is part of the wildlife cover design to allow ventilation and drainage, and its installation is consistent with SCE’s Distribution Overhead Construction Standards (DOH). Section 535 of SCE’s DOH (sheet 17 of 35) states that: “(s)ome wildlife covers have small gaps or seams as part of the covering design. Installation of the cover should be considered in order to allow moisture to drain through said gaps or openings.” A screenshot of the relevant section of the DOH is pasted below.

Photo #1: Taken by Energy Safety during their field visit on January 31, 2025

Wildlife behavior, such as woodpeckers storing acorns inside wildlife covers, is difficult to control. SCE actively inspects and addresses such issues as they arise and continues to evaluate design improvements to better withstand animal interference.
