NOTICE OF VIOLATION

INSPECTION REPORT

Electrical Corporation:	Southern California Edison Company
Report Number:	CAD_SCE_YLO_20250507_1312
Inspector:	Yana Loginova
WMP Year Inspected:	2024
Quarterly Data Report (QDR) Referenced:	Quarter 4 (Q4)
Inspection Selection:	Energy Safety viewed the contents of the Q4 QDR and performed an analysis that resulted in the selection of the WMP initiatives and locations referenced in this report.
Relevant WMP Initiative(s):	8.1.3.1 - Distribution Detailed Inspections and Remediations (IN-1.1)
Date of inspection:	May 6 and 7, 2025
City and/or County of Inspection:	Moreno Valley, Riverside County
Inspection Purpose:	Assess the accuracy of Southern California Edison Company's QDR data, completeness of its work, compliance with WMP requirements, and compliance with its protocols.

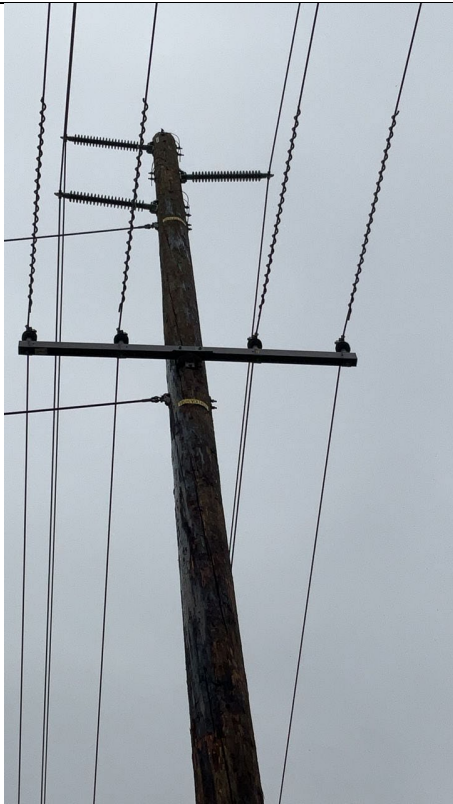
Structure ID: 4491282E

Violation 1. Energy Safety observed that in implementing 2024 WMP initiative Distribution High Fire Risk-Informed (HFRI) Inspections and Remediations, SCE failed to complete the installation of wildlife covers on pole ID 4491282E, Grid Hardening ID 410903704-4491282E at coordinates 33.8778523501859, - 117.054665982962. Energy Safety considers this completeness violation to be in the Minor risk category.

On pole ID 4491282E, Grid Hardening ID 410903704-4491282E at 34574-34810 Gilman Springs Rd, Moreno Valley, CA, 92555, USA, 33.8778523501859, -117.054665982962, the inspector observed that no wildlife covers were installed. The inspector's observation is documented in Violation 1 photographs, which are attachments to this report. Photo number Item1IA1Img1 depicts that there are no wildlife covers on the pole.

1. Southern California Edison Company's 2024 WMP 8.1.3.1 Distribution Detailed Inspections and Remediations work identified that the remediation of wildlife covers was complete at this location.
2. The wildlife covers were not installed.

Item1IA1mg1: View showing no wildlife covers installed

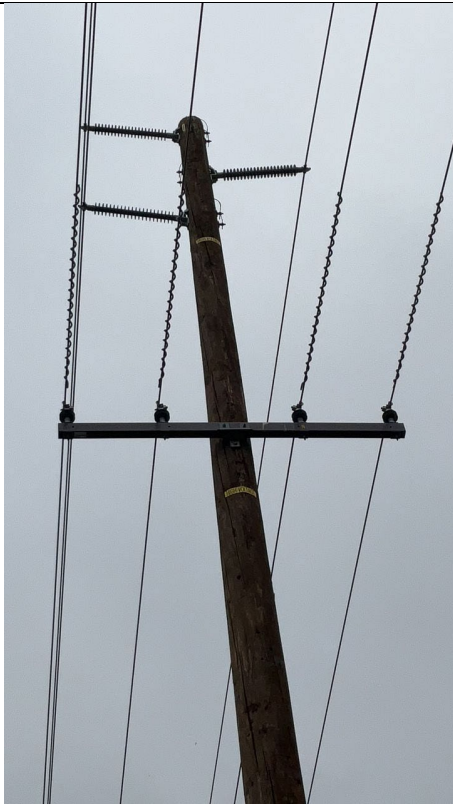
Structure ID: 4491284E

Violation 2. Energy Safety observed that in implementing 2024 WMP initiative Distribution High Fire Risk-Informed (HFRI) Inspections and Remediations, SCE failed to complete the installation of wildlife covers on pole ID 4491284E, Grid Hardening ID 410903706-4491284E at coordinates 33.8770083289109, - 117.053538555059. Energy Safety considers this completeness violation to be in the Minor risk category.

On pole ID 4491284E, Grid Hardening ID 410903706-4491284E at 34574-34810 Gilman Springs Rd, Moreno Valley, CA, 92555, USA, 33.8770083289109, -117.053538555059, the inspector observed that no wildlife covers were installed. The inspector's observation is documented in Violation 2 photographs, which are attachments to this report. Photo number Item2IA1Img1 depicts that there are no wildlife covers on the pole.

1. Southern California Edison Company's 2024 WMP 8.1.3.1 Distribution Detailed Inspections and Remediations work identified that the remediation of wildlife covers was complete at this location.
2. The wildlife covers were not installed.

Item2IA1mg1: View showing no wildlife covers installed

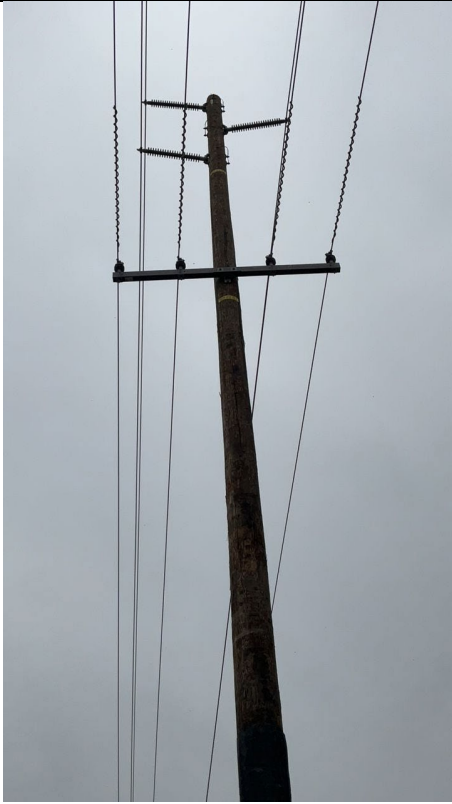
Structure ID: 4491285E

Violation 3. Energy Safety observed that in implementing 2024 WMP initiative Distribution High Fire Risk-Informed (HFRI) Inspections and Remediations, SCE failed to complete the installation of wildlife covers on pole ID 4491285E, Grid Hardening ID 410903707-4491285E at coordinates 33.8766139282821, - 117.053015480442. Energy Safety considers this completeness violation to be in the Minor risk category.

On pole ID 4491285E, Grid Hardening ID 410903707-4491285E at 34574-34810 Gilman Springs Rd, Moreno Valley, CA, 92555, USA, 33.8766139282821, -117.053015480442, the inspector observed that no wildlife covers were installed. The inspector's observation is documented in Violation 3 photographs, which are attachments to this report. Photo number Item3IA1Img1 depicts that there are no wildlife covers on the pole.

1. Southern California Edison Company's 2024 WMP 8.1.3.1 Distribution Detailed Inspections and Remediations work identified that the remediation of wildlife covers was complete at this location.
2. The wildlife covers were not installed.

Item3IA1mg1: View showing no wildlife covers installed
