#### **NOTICE OF VIOLATION**

On May 6 and 7, 2025, Energy Safety conducted an inspection of SCE's WMP initiatives in the vicinity of the city of Moreno Valley, California. The inspection report is enclosed herewith. Energy Safety found the following violation(s):

### **INSPECTION REPORT**

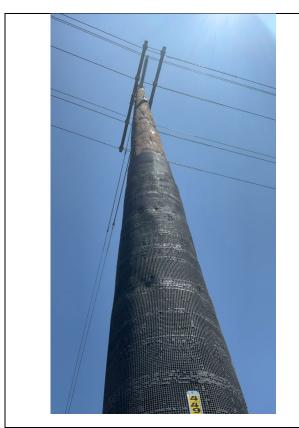
On pole ID 4491276E, Grid Hardening ID 410890030-4491276E at 34574-34810 Gilman Springs Rd, Moreno Valley, CA, 92555, USA, 33.8801406636701, -117.057241119606, the inspector observed that no wildlife covers were installed. The inspector's observation is documented in Violation 1 photographs, which are attachments to this report. Photo numbers Item1IA1Img1 andItem1IA1Img2 depict that there are no wildlife covers on the pole. Per information provided by SCE to the Compliance Inbox on June 4, 2025, at 4:13 pm, the remediation was completed.

- 1. Southern California Edison Company's 2024 WMP 8.1.3.1 Distribution Detailed Inspections and Remediations work identified that the remediation of wildlife covers was complete at this location.
- 2. The wildlife covers were not installed.

**Item1IA1Img1:** View showing no wildlife covers installed

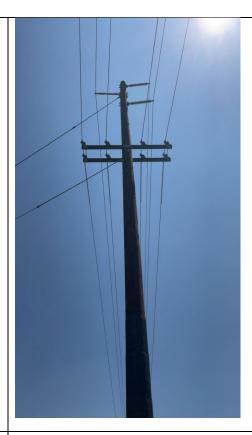
**Item1IA1Img2:** View showing no wildlife covers installed

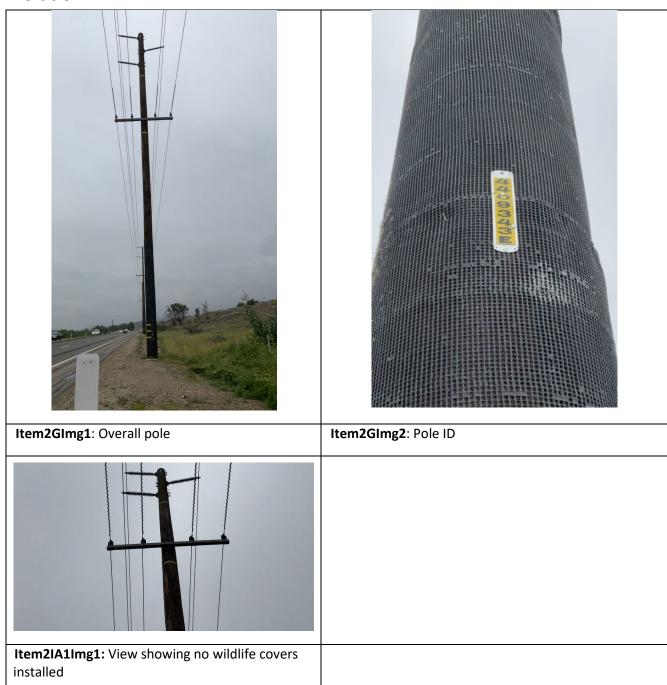
On pole ID4409343E, Grid Hardening ID 410902966-4409343E at 34574-34810 Gilman Springs Rd, Moreno Valley, CA, 92555, USA, 33.8762343885424, -117.052504766644, the inspector observed that no wildlife covers were installed. The inspector's observation is documented in Violation 2 photographs, which are attachments to this report. Photo number Item2IA1Img1 depicts that there are no wildlife covers on the pole. Per information provided by SCE to the Compliance Inbox on June 4, 2025, at 4:13 pm, the remediation was completed.

- 1. Southern California Edison Company's 2024 WMP 8.1.3.1 Distribution Detailed Inspections and Remediations work identified that the remediation of wildlife covers was complete at this location.
- 2. The wildlife covers were not installed.

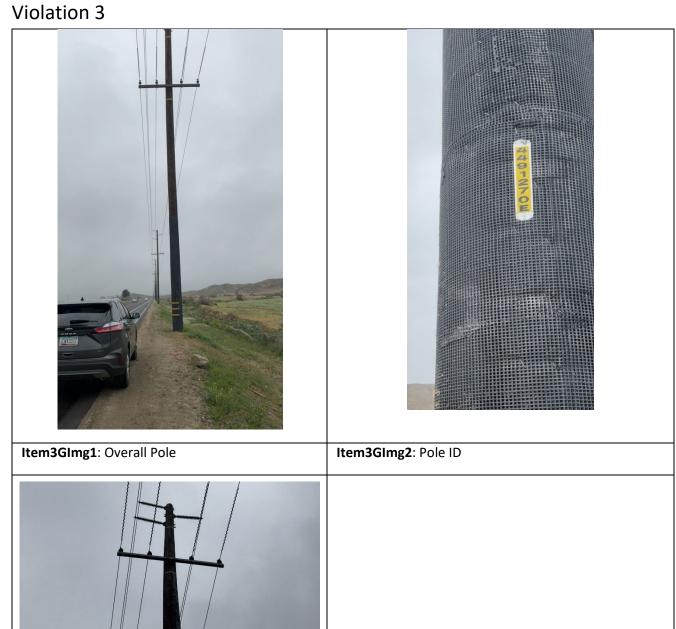
Exhibit C: Photo Log **Structure ID:** 4491270E

On pole ID 4491270E, Grid Hardening ID 410903697-4491270E at 34392-34496 Gilman Springs Rd, Moreno Valley, CA, 92555, USA, 33.8830308626952, -117.060798967357, the inspector observed that no wildlife covers were installed. The inspector's observation is documented in Violation 3 photographs, which are attachments to this report. Photo number Item3IA1Img1 depicts that there are no wildlife covers on the pole. Per information provided by SCE to the Compliance Inbox on June 4, 2025, at 4:13 pm, the remediation was completed.

- 1. Southern California Edison Company's 2024 WMP 8.1.3.1 Distribution Detailed Inspections and Remediations work identified that the remediation of wildlife covers was complete at this location.
- 2. The wildlife covers were not installed.

Item3IA1Img1: View showing no wildlife covers

installed

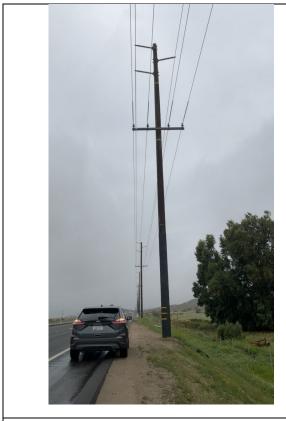
On pole ID4491271E, Grid Hardening ID 410903698-4491271E at 34392-34496 Gilman Springs Rd, Moreno Valley, CA, 92555, USA, 33.8825732020637, -117.060211493416, the inspector observed that no wildlife covers were installed. The inspector's observation is documented in Violation 4 photographs, which are attachments to this report. Photo numbers Item4IA1Img1 and Item4IA1Img2 depict there are no wildlife covers on the pole. Per information provided by SCE to the Compliance Inbox on June 4, 2025, at 4:13 pm, the remediation was completed.

- 1. Southern California Edison Company's 2024 WMP 8.1.3.1 Distribution Detailed Inspections and Remediations work identified that the remediation of wildlife covers was complete at this location.
- 2. The wildlife covers were not installed.

**Item4IA1Img1:** View showing no wildlife covers installed

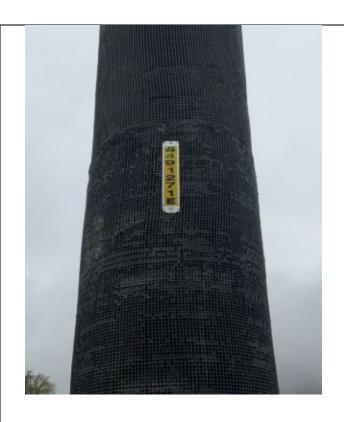
**Item4IA1Img2:** View showing no wildlife covers installed
