## NOTICE OF VIOLATION

# INSPECTION REPORT

Electrical Corporation:	Southern California Edison Company
Report Number:	CAD_SCE_YLO_20250507_1048
Inspector:	Yana Loginova
WMP Year Inspected:	2024
Quarterly Data Report (QDR) Referenced:	Quarter 4 (Q4)
Inspection Selection:	Energy Safety viewed the contents of the Q4 QDR and performed an analysis that resulted in the selection of the WMP initiatives and locations referenced in this report.
Relevant WMP Initiative(s):	8.1.3.1 - Distribution Detailed Inspections and Remediations (IN-1.1)
Date of inspection:	May 07, 2025
City and/or County of Inspection:	Moreno Valley, Riverside County
Inspection Purpose:	Assess the accuracy of Southern California Edison Company’s QDR data, completeness of its work, compliance with WMP requirements, and compliance with its protocols.

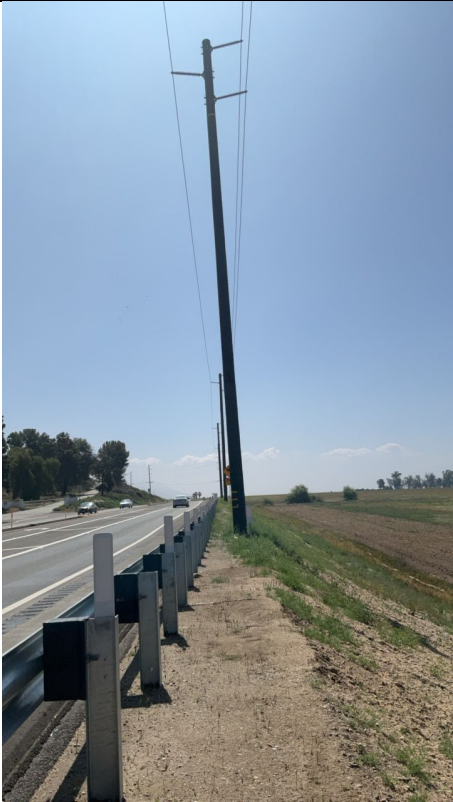
Violation 1: On pole ID 4491254E, Grid Hardening ID 410903686-4491254E at 15759-15859 Gilman Springs Rd, Moreno Valley, CA, 92555, USA, 33.8924261093468, -117.079745617984, the inspector observed that the tower carried only transmission infrastructure, even though a distribution infrastructure-related initiative was reported completed at the location. The inspector's observation is documented in Violation 1 photographs, which are an attachment to this report. Photo number Item1IA1Img1 depicts only transmission infrastructure, and no distribution infrastructure, while the distribution infrastructure-related initiative was reported complete at the location.

Item1GImg1: Overall pole	Item1GImg2: Pole ID

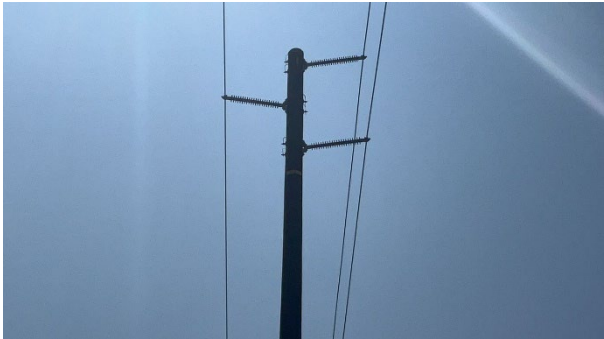
Item1IA1Img1: Transmission only line, no distribution present

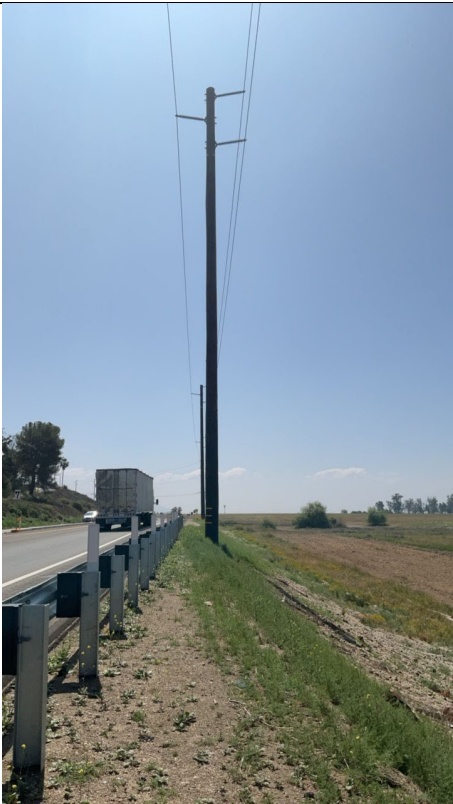
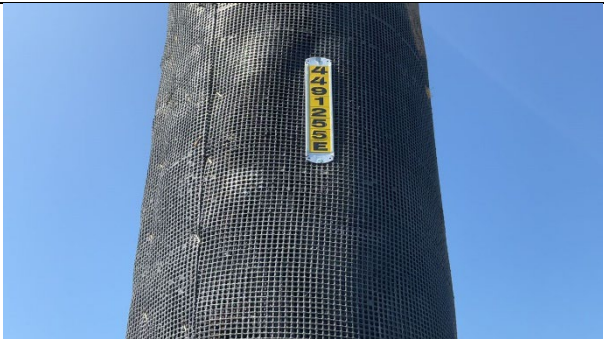
Violation 2: On pole ID 4491255E, Grid Hardening ID 410903687-4491255E at 15759-15859 Gilman Springs Rd, Moreno Valley, CA, 92555, USA, 33.8920208848202, -117.079111135204, the inspector observed that the tower carried only transmission infrastructure, even though a distribution infrastructure-related initiative was reported completed at the location. The inspector's observation is documented in Violation 2 photographs, which are an attachment to this report. Photo number Item2IA1Img1 depicts only transmission infrastructure, and no distribution infrastructure, while the distribution infrastructure-related initiative was reported complete at the location.

Item2GImg1: Overall pole	Item2GImg2: Pole ID

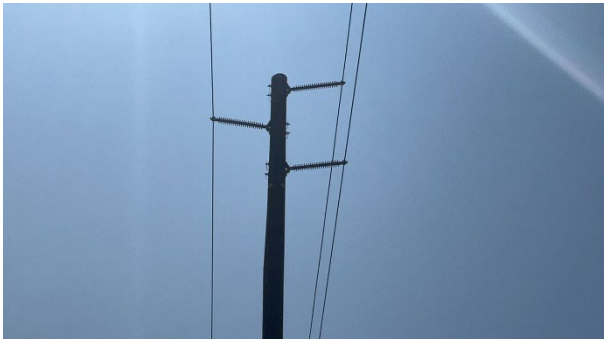
Item2IA1Img1: Transmission only line, no distribution present

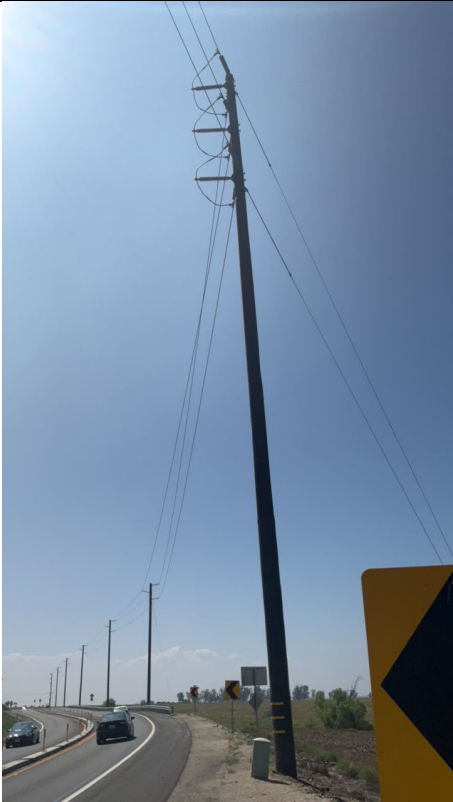
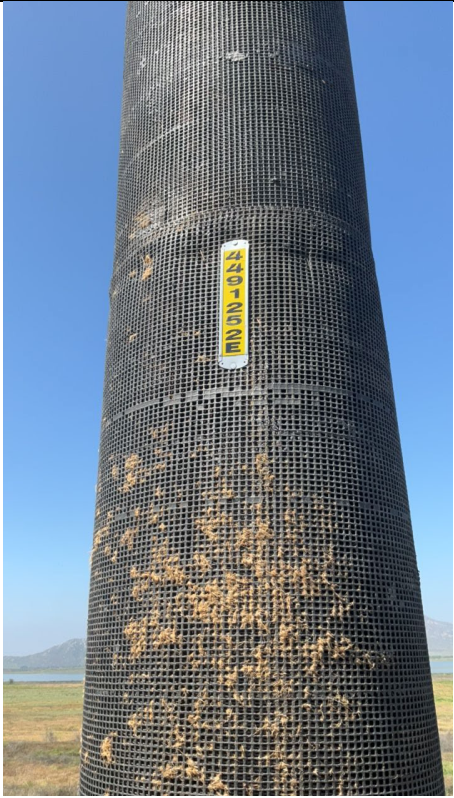
Violation 4: On pole ID4491252E, Grid Hardening ID 410903684-4491252E at 15759-15859 Gilman Springs Rd, Moreno Valley, CA, 92555, USA, 33.893433561885, -117.080986133899, the inspector observed that the tower carried only transmission infrastructure, even though a distribution infrastructure-related initiative was reported completed at the location. The inspector's observation is documented in Violation 4 photographs, which are an attachment to this report. Photo number Item4IA1Img1 depicts only transmission infrastructure, and no distribution infrastructure, while the distribution infrastructure-related initiative was reported complete at the location.

A close-up photograph of the lattice structure of the utility pole. A yellow identification tag is attached to the pole, displaying the number '4491252E'. The lattice is dark and shows some signs of weathering or rust.
<p>Item4GImg1: Overall pole</p>	<p>Item4GImg2: Pole ID</p>

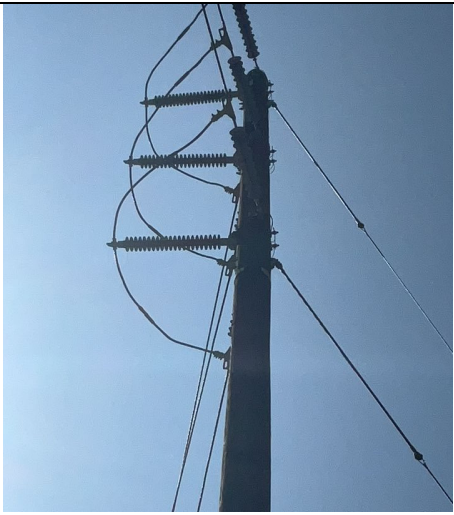
A close-up photograph of the transmission line hardware on the pole, showing insulators and the arrangement of the power lines. The background is a clear blue sky.	
<p>Item4IA1Img1: Transmission only line, no distribution present</p>

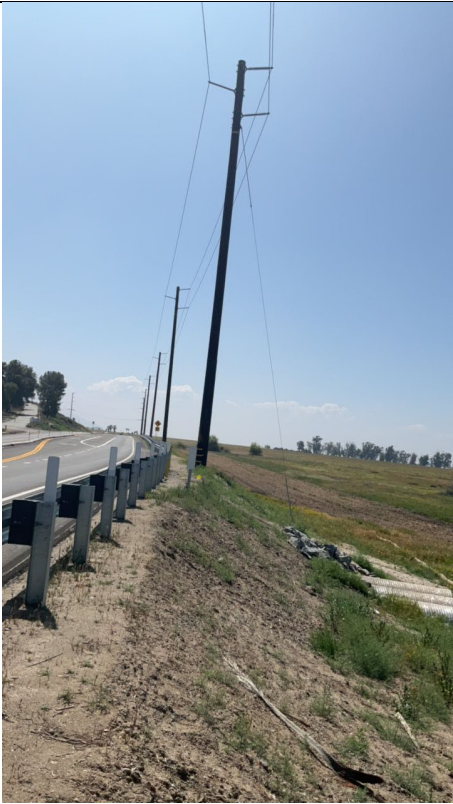
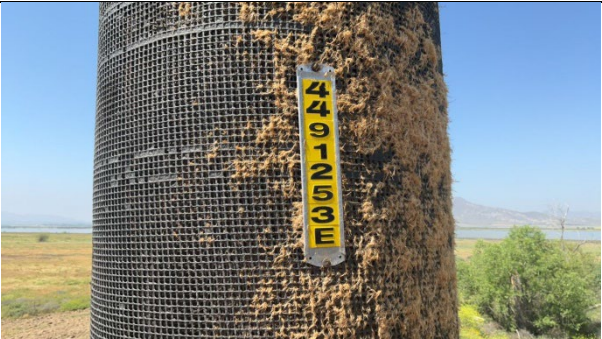
Violation 5: On pole ID4491253E, Grid Hardening ID 410903685-4491253E at 15759-15859 Gilman Springs Rd, Moreno Valley, CA, 92555, USA, 33.8927718583486, -117.080268679126the inspector observed that the tower carried only transmission infrastructure, even though a distribution infrastructure-related initiative was reported completed at the location. The inspector's observation is documented in Violation 5 photographs, which are an attachment to this report. Photo number Item5IA1Img1 depicts only transmission infrastructure, and no distribution infrastructure, while the distribution infrastructure-related initiative was reported complete at the location.

<p>Item5GIimg1: Overall pole</p>	<p>Item5GIimg2: Pole ID</p>

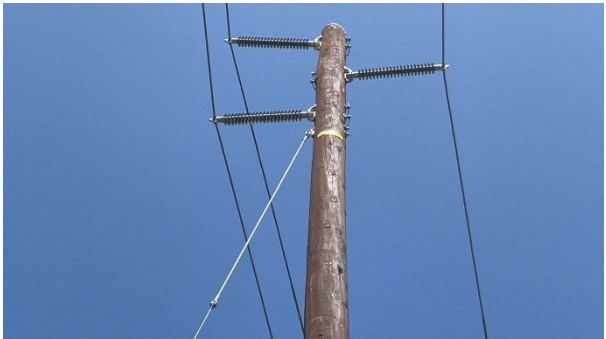
<p>Item5IA1img1: Transmission only line, no distribution present</p>
