NOTICE OF VIOLATION

On July 10, 2025, Energy Safety conducted an inspection of Southern California Edison Company's WMP initiatives in the vicinity of the city of Fallbrook, California. The inspection report is enclosed herewith. Energy Safety found the following violation(s):

INSPECTION REPORT

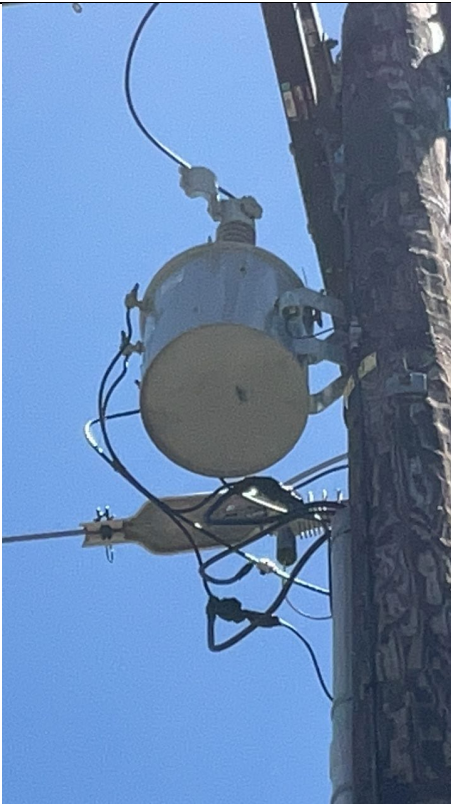
On pole ID 4527226E, Grid Hardening ID 414053882-4527226E at 47749 Rock Mountain Dr, Fallbrook, CA, 92028, USA, 33.436004, -117.236473, the inspector observed that the transformer bushing cover was opened. The inspector's observation is documented in Violation 1 photographs, which are attachments to this report. Photo numbers IA1Img1, IA1Img2, IA1Img3 depict that the transformer bushing cover was open. Per information provided by SCE to the Compliance Inbox on April 3, 2025, at 12:15 pm, the condition of opened transformer bushing was remediated.

1. Southern California Edison Company's 2024 WMP 8.1.3.1 Distribution Detailed Inspections and Remediations work identified that the remediating of opened roadside primary transformer bushing cover was completed at the location.
2. The transformer bushing cover was opened.

IA1Img1: View showing opened transformer bushing cover

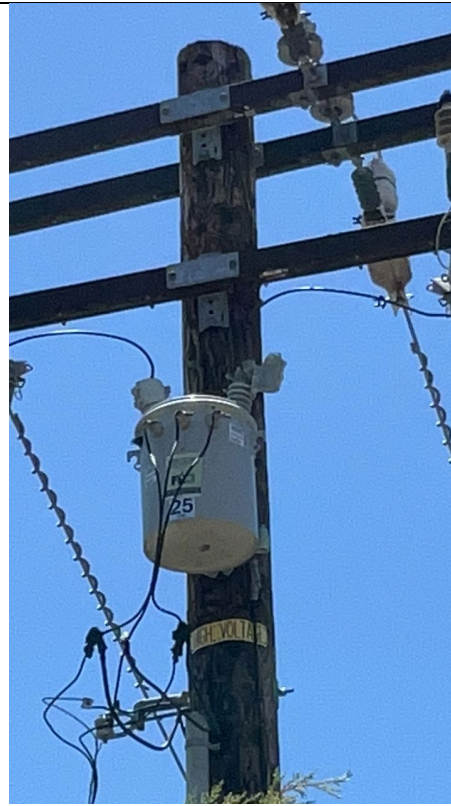
IA1Img2: View showing opened transformer bushing cover

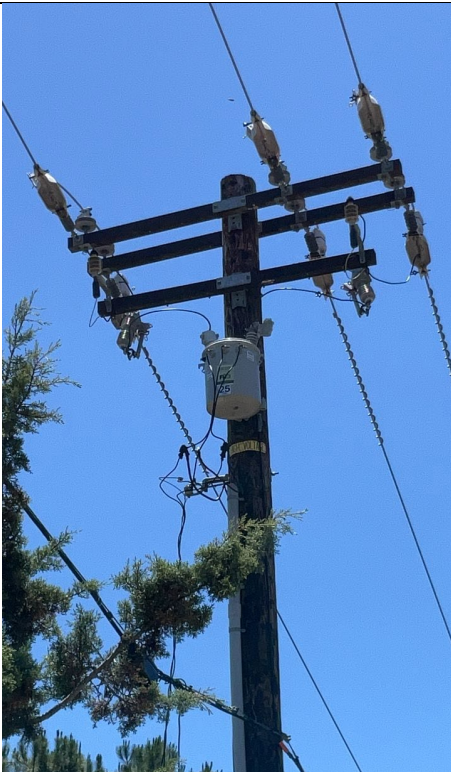
IA1Img3: View showing opened transformer bushing cover
