## NOTICE OF VIOLATION

On July 8, 2025, Energy Safety conducted an inspection of SCE's WMP initiatives in the vicinity of the city of Temecula, California. The inspection report is enclosed herewith. Energy Safety found the following violation:

# INSPECTION REPORT

Structure ID: 2064582E

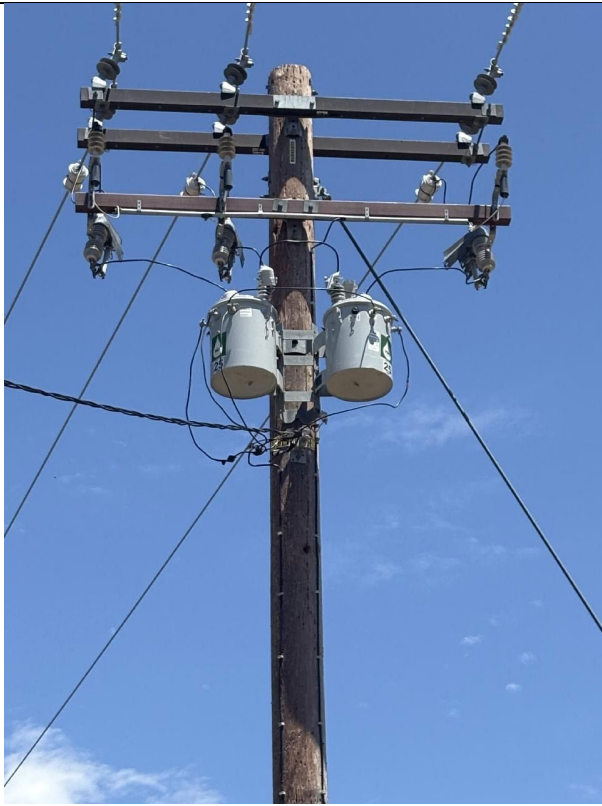
Violation 1. Energy Safety observed that in implementing 2024 WMP initiative 8.1.3.1 - Distribution High Fire Risk-Informed (HFRI) Inspections and Remediations (IN-1.1), SCE failed to complete the remediation of avian protection on Pole ID 2064582E, Grid Hardening ID 413885139-2064582E at coordinates 33.470833, - 117.299352. Energy Safety considers this completeness violation to be in the Minor risk category.

On Pole ID 2064582E, Grid Hardening ID 413885139-2064582E at 45599 Los Gatos Rd, Temecula, CA, 92590, 33.470833, -117.299352, the inspector observed that the avian protection replacement work was not completed. The inspector's observation is documented in Violation 1 photographs, which are attachments to this report. Photo numbers IA1Img1, IA1Img2 and IA1Img3 depict that both transformers each had an unhinged bushing, and the transformers' external connecting terminals were exposed. Per information provided by SCE to the Compliance Inbox on April 3, 2025, at 12:15 pm, the unsecured transformer bushings were repaired.

1. Southern California Edison Company's 2024 WMP 8.1.3.1 Distribution Detailed Inspections and Remediations work identified that the unsecured transformer bushings were repaired at this location.
2. The transformers' bushings were unhinged, and the external connecting terminals were exposed to wildlife.

**IA1Img1:** Transformer bushings unhinged

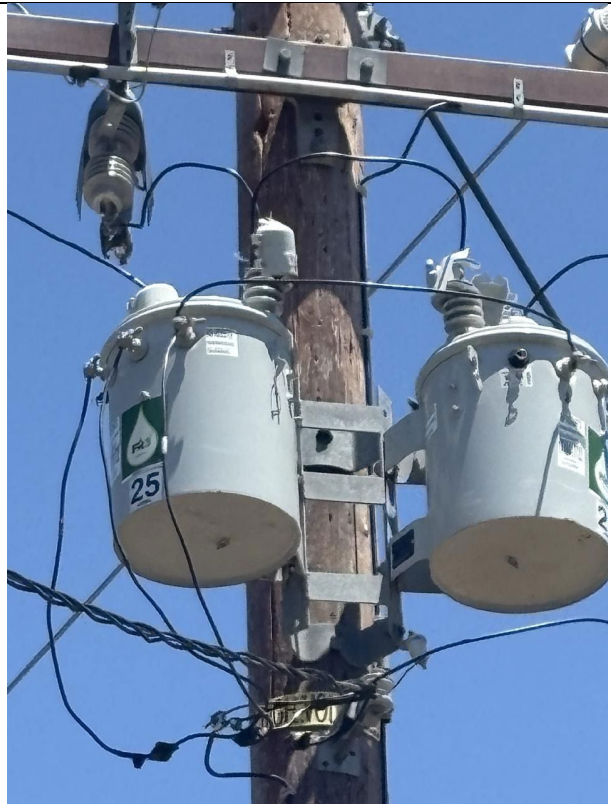
**IA1Img2:** Transformer bushings unhinged

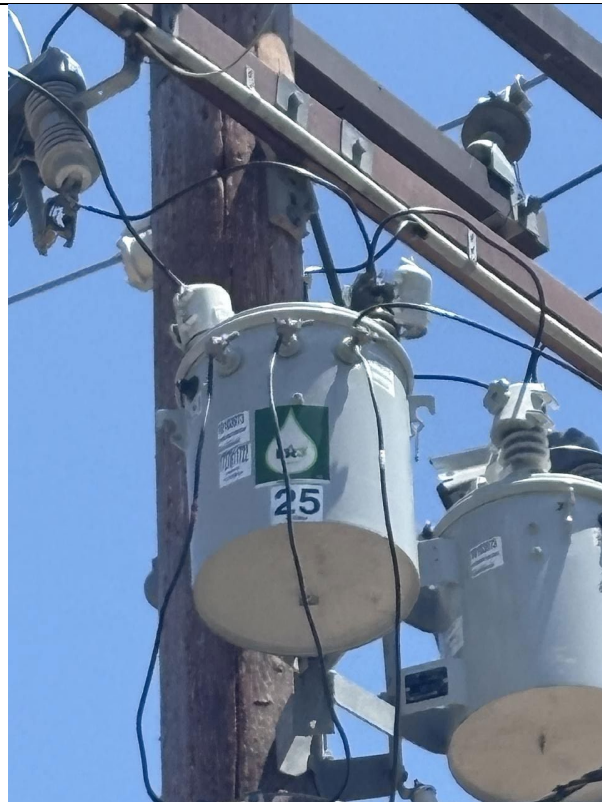
**IA1Img3:** Transformer bushings unhinged
