NOTICE OF NON-PERFORMANCE

On August 14, 2025, Energy Safety conducted an inspection of SCE's WMP initiatives in the vicinity of the city of Perris, California. The inspection report is enclosed herewith. Energy Safety found the following deficiency:

INSPECTION REPORT

Electrical Corporation:	Southern California Edison Company
Report Number:	CAD_SCE_SIS_20250814_0654
Inspector:	Samuel Isaiah
WMP Year Inspected:	2025
Quarterly Data Report (QDR) Referenced:	Quarter 1 (Q1)
Inspection Selection:	Energy Safety viewed the contents of the Q1 QDR and performed an analysis that resulted in the selection of the WMP initiatives and locations referenced in this report.
Relevant WMP Initiative(s):	8.1.3.1 - Distribution Detailed Inspections and Remediations (IN-1.1)
Date of inspection:	August 14, 2025
City and/or County of Inspection:	Perris, Riverside County
Inspection Purpose:	Assess the accuracy of Southern California Edison Company's QDR data, completeness of its work, and performance of WMP requirements.

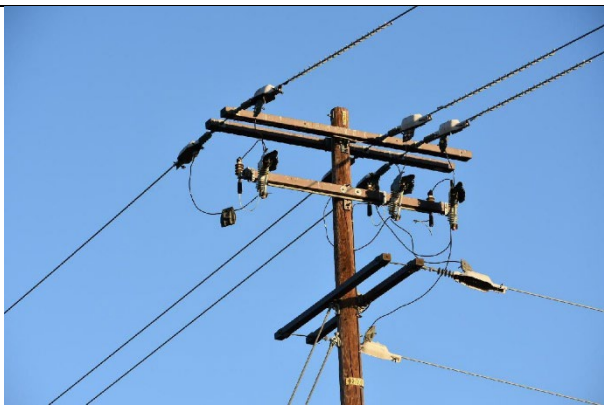
On Pole ID 4943605E, Grid Hardening ID 413373230-4943605E at 22781-22799 Rolling Meadows Dr, Perris, CA, 92570, 33.787633, -117.371744, the inspector observed that one of the bird guards was out of place. The inspector's observation is documented in Deficiency 1 photographs, which are attachments to this report. Photo numbers IA1Img1, IA1Img2, IA1Img3 and IA1Img4 depict one of the primary connection covers slipped down the conductor and connection device was exposed. Per information provided by SCE to the Compliance Inbox on August 12, 2025, at 11:25 am, two dead end bird guard covers were out of place, and that work to mitigate the condition was complete.

1. Southern California Edison Company's 2024 WMP 8.1.3.1 Distribution Detailed Inspections and Remediations work identified that the work to mitigate the bird guards that were out of place was completed.
2. The primary avian bird guard slipped down the conductor, and the connector was exposed.

<p>IA11mg1: Bird Guard Out of Place</p>	<p>IA11mg2: Bird Guard Out of Place</p>

Deficiency 1. Energy Safety observed that in implementing 2025 WMP initiative 8.1.3.1 - Distribution High Fire Risk-Informed (HFRI) Inspections and Remediations (IN-1.1), SCE failed to complete the remediation of bird guards on Pole ID 4943605E, Grid Hardening ID 413373230-4943605E at coordinates 33.787633, -117.371744. Energy Safety considers this non-performance to be in the Minor risk category. SCE must complete a corrective action for this deficiency by 12 months from date of this notice.

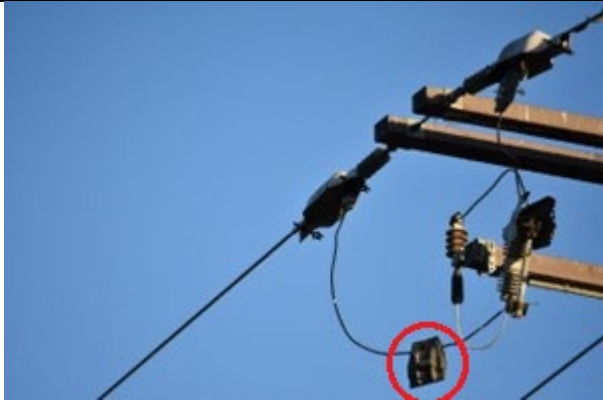
IA1Img3: Bird Guard Out of Place

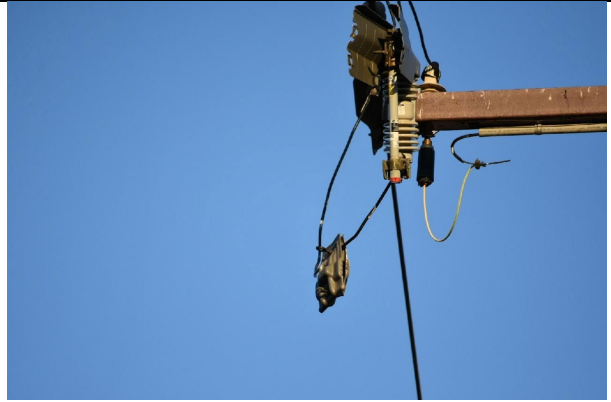
IA1Img4: Bird Guard Out of Place
