NOTICE OF NON-PERFORMANCE

On August 13, 2025, Energy Safety conducted an inspection of SCE's WMP initiatives in the vicinity of the city of Perris, California. The inspection report is enclosed herewith. Energy Safety found the following deficiency:

INSPECTION REPORT

Electrical Corporation:	Southern California Edison Company
Report Number:	CAD_SCE_SIS_20250813_0918
Inspector:	Samuel Isaiah
WMP Year Inspected:	2025
Quarterly Data Report (QDR) Referenced:	Quarter 1 (Q1)
Inspection Selection:	Energy Safety viewed the contents of the Q1 QDR and performed an analysis that resulted in the selection of the WMP initiatives and locations referenced in this report.
Relevant WMP Initiative(s):	8.1.3.1 - Distribution Detailed Inspections and Remediations (IN-1.1)
Date of inspection:	August 13, 2025
City and/or County of Inspection:	Perris, Riverside County
Inspection Purpose:	Assess the accuracy of Southern California Edison Company's QDR data, completeness of its work, and performance of WMP requirements.

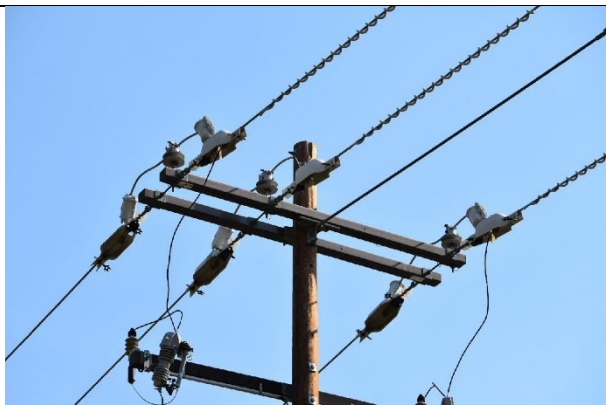
On Pole ID 2105947E, Grid Hardening ID 413332973-2105947E at 14200 Descanso Dr, Perris, CA, 92570, 33.805394, -117.409172, the inspector observed that work to replace a missing connector cover on the primary conductor was not completed. The inspector's observation is documented in Deficiency 1 photographs, which are attachments to this report. Photo numbers IA1Img1, IA1Img2, IA1Img3 and IA1Img4 depict that the mid-phase connector cover is missing. Per information provided by SCE to the Compliance Inbox on August 12, 2025, at 11:25 am, the missing connector cover on the primary was identified and fixed.

1. Southern California Edison Company's 2024 WMP 8.1.3.1 Distribution Detailed Inspections and Remediations work identified that the missing connector cover on the primary conductor was replaced.
2. The mid-phase connector cover is missing.

1: Middle phase missing connector cover

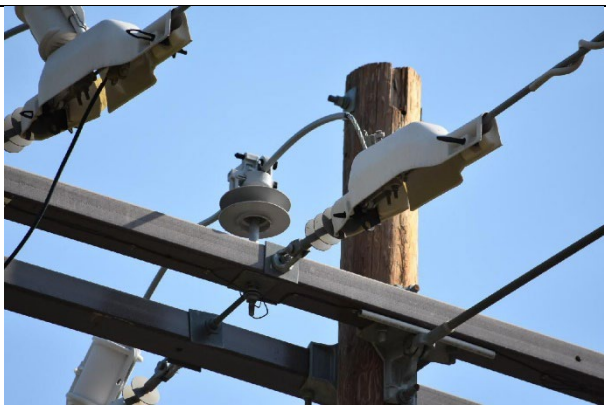
2: Middle phase missing connector cover

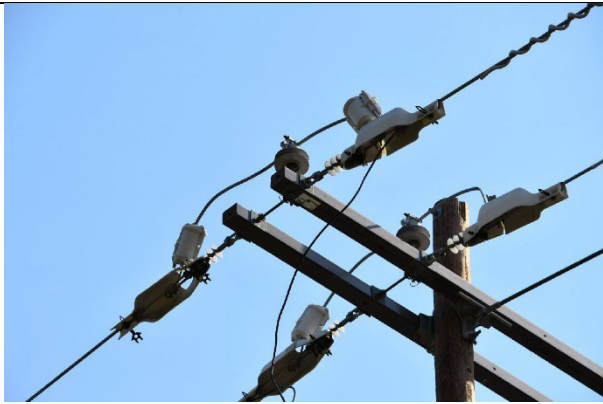
IA1Img3: Middle phase missing connector cover

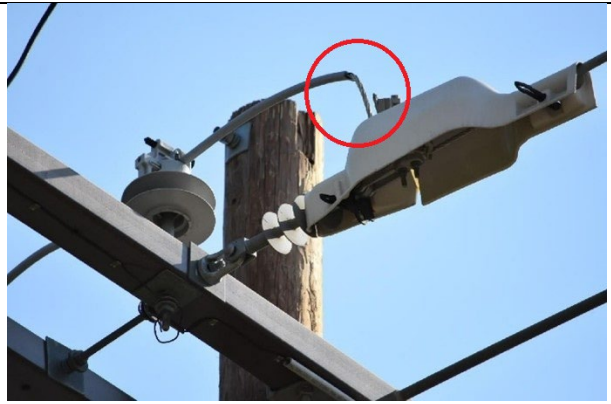
IA1Img4: Middle phase missing connector cover
