NOTICE OF NON-PERFORMANCE

INSPECTION REPORT

Energy Safety found a “Moderate” Adherence to Protocol deficiency at VMP ID DN_Insp_2025_5G19 near Pole ID 06247006-281900 in HFTD Tier 2. PacifiCorp did not perform its Clearance program (WMP Initiative number 8.2.3.2) as required in the WMP, instead a tree was within the minimum clearance distance along the conductor.

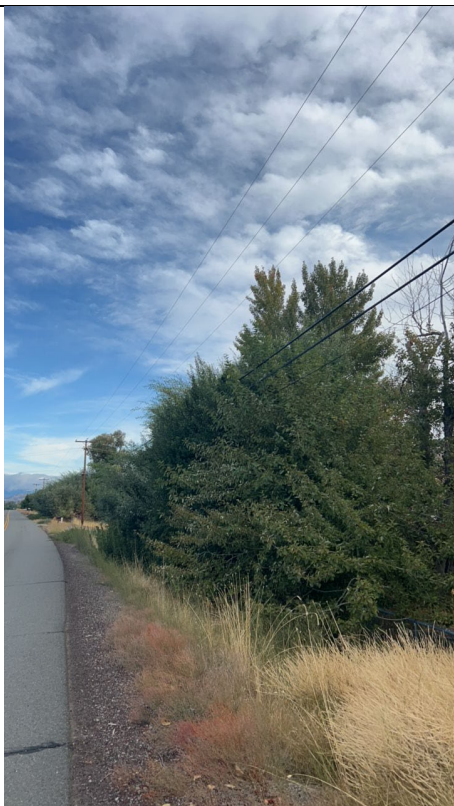
Energy Safety considers this deficiency as “Moderate” because the identified vegetation is located within 1 foot of the distribution lines and given the relatively fast growth rate of willow trees, it was not trimmed to a sufficient distance at the time of trim as required by PacifiCorp’s WMP (12 feet) and Vegetation SOP (16 feet). Additionally, the tree will likely exceed the height of the conductor lines before PacifiCorp’s next inspection cycle.

The inspector measured the height of both the tree and conductors using a Nikon Forestry Pro II laser rangefinder. The tree measured 22 feet tall, and the conductor measured 23 feet above the ground, resulting in a clearance of approximately 1 foot, which is within the “Minimum Clearance Distance” of 12 feet as outlined in the WMP. The inspector’s observation is documented in Exhibit A photographs (Deficiency 1), which are attached to this report. Photo numbers 1 - 3 depict the subject tree within one foot of the conductors.

Photo 1: View of the willow located approximately 0.5 span from pole ID 06247006-281900. The photo was taken facing northwest from the pole.

Deficiency 1. Energy Safety observed that in implementing 2025 WMP initiative 8.2.3.2 Clearance, PacifiCorp failed to adhere to its protocol of achieving vegetation clearance for distribution lines along the conductor near Pole ID 06247006-281900, Vegetation Management ID DN_Insp_2025_5G19 at coordinates 41.901145, -122.552182. Energy Safety considers this non-performance to be in the Moderate risk category. PacifiCorp must complete a corrective action for this non-performance by 6 months from date of this notice.¹

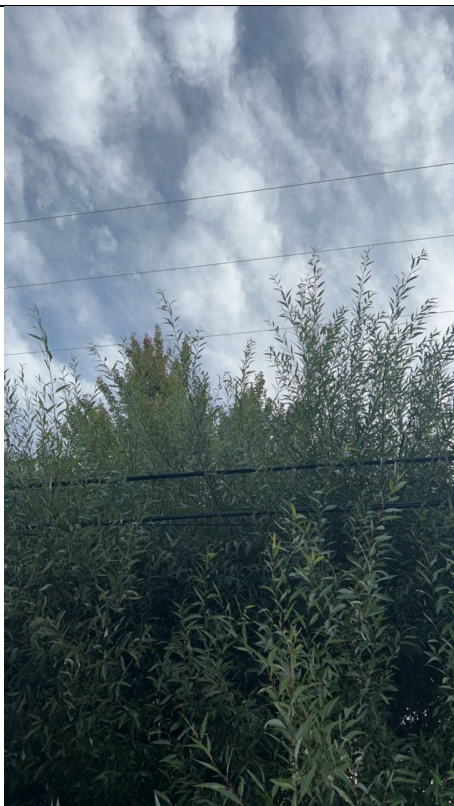
Photo 2: View of the willow branches located within 1 foot of the distribution line. The photo was taken facing north from the street.

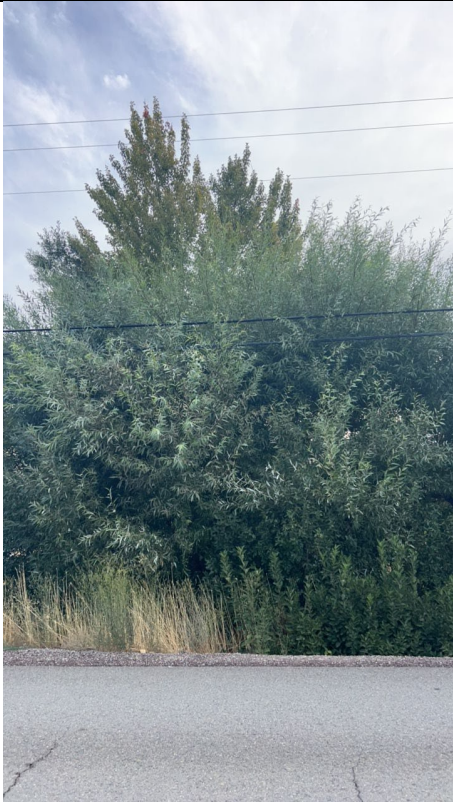
Photo 3: View of the willow branch located within 1 foot of the distribution line. The photo was taken facing northeast from the street.
