## NOTICE OF NON-PERFORMANCE

# INSPECTION REPORT

| Report Number: | NON_ESD_PC_MAZ_20250910_0906 |

Exhibit A: Photo Log  
Structure ID: 06247006-211003  
Deficiency 1

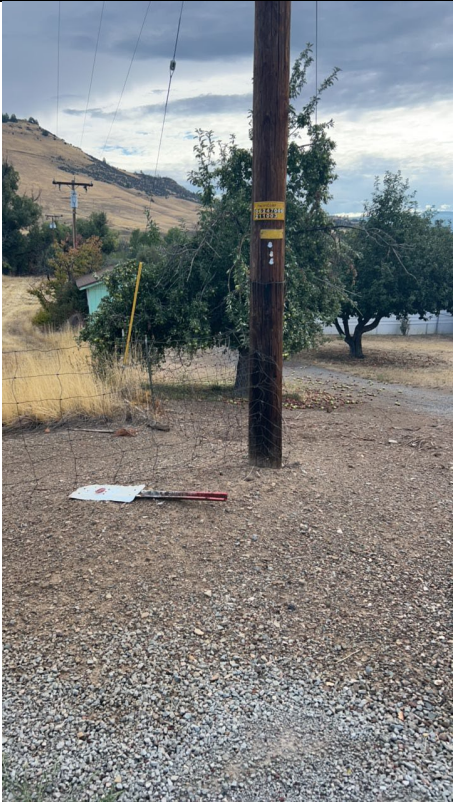
The inspector measured the height of both the tree and conductors using a Nikon Forestry Pro II laser rangefinder. The tree measured 19 feet tall, and the conductor heights measured 22 feet above the ground, resulting in a clearance of approximately three feet, which is within the "Minimum Clearance Distance" of 12 feet as outlined in the WMP. The inspector's observation is documented in Exhibit A photographs (Deficiency 1), which are attached to this report. Photo numbers 1 - 4 depict the subject tree within three feet of the conductors.

| <p><b>Photo 1:</b> Pole ID 06247006-211003</p> | <p><b>Photo 2:</b> View of the tree facing northwest from the pole.</p> |

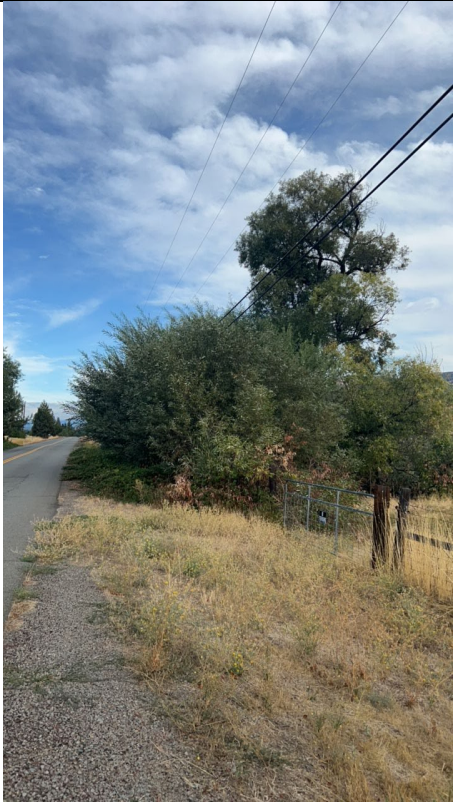
Energy Safety considers this deficiency as "Moderate" because the identified vegetation is located within 3 feet of the distribution lines and given the relatively fast growth rate of willow trees, it was not trimmed to a sufficient distance at the time of trim as required by PacifiCorp's WMP (12 feet) and Vegetation SOP (16 feet). Additionally, the tree will likely exceed the height of the conductor lines before PacifiCorp's next inspection cycle.

0.4 span northwest of pole ID 06247006-211003, near 14900 Hornbrook Road, Hornbrook, California 96044, growing directly under the conductors with branches within three feet of the conductors.

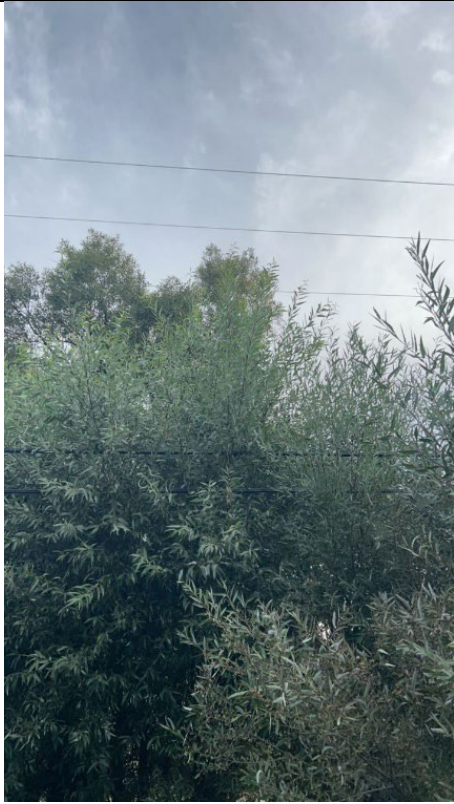
**Photo 3:** View of the tree branches located within 3 feet of the distribution line. The photo was taken facing northeast from the street.

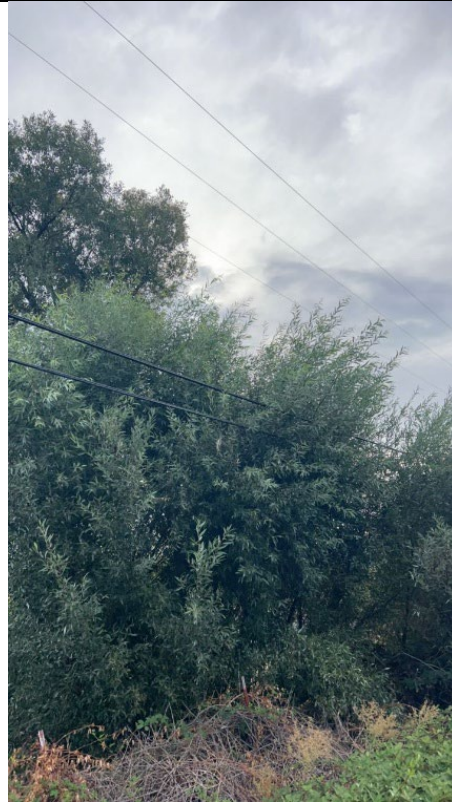
**Photo 4:** Secondary view of the tree branches located within 3 feet of the distribution line. The photo was taken facing east from the street.
