## NOTICE OF NON-PERFORMANCE

# INSPECTION REPORT

Electrical Corporation:	Liberty Utilities
Report Number:	NON_ESD_LU_RIB_20250916_1028
Inspector:	Ramzi Ibrahim
WMP Year Inspected:	2025
Quarterly Data Report (QDR) Referenced:	Quarter 2 (Q2)
Inspection Selection:	Energy Safety inspected the locations based on Liberty’s Q2 QDR.
Relevant WMP Initiative(s):	Fall-In Mitigation (2025 WMP initiative number 8.2.3.4)
Date of inspection:	September 16, 2025
City and/or County of Inspection:	South Lake Tahoe, California

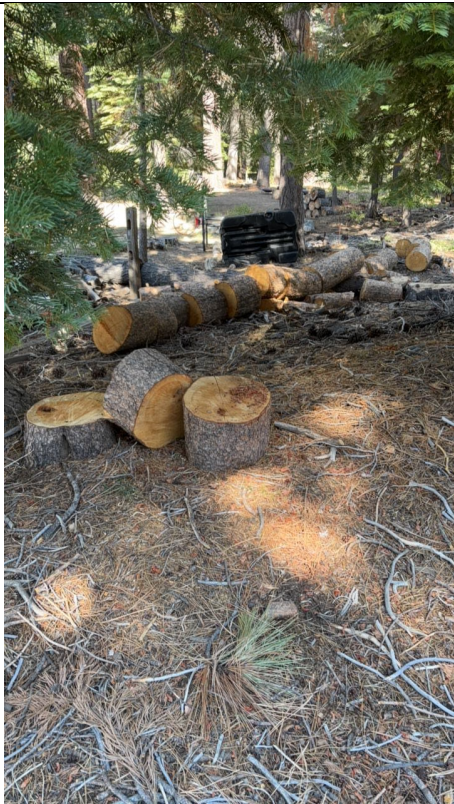
Liberty's Q2 2025 QDR indicated that Liberty removed a lodgepole pine and transported the slash to a biomass facility under its Fall-In Mitigation program (initiative 8.2.3.4), near GPS coordinates 38.872055, -120.001691 on June 8, 2025. Liberty identified this activity as Vegetation Management ID dd7c3473-870a-4832-b101-a88454914001. The inspector observed a cut lodgepole pine branch hanging from the branches of the surrounding trees directly above the felled log of a lodgepole pine. The inspector's observation is documented in Exhibit A photographs, which are attached to this report. Photo numbers 1 and 2 depict the remaining wood material and the hanging branch, and photos 3 and 4 depict the surrounding area for identification purposes.

**Photo 1:** Felled and bucked lodgepole pine at the location of Vegetation Management ID dd7c3473-870a-4832-b101-a88454914001.

Deficiency 1. Energy Safety observed that in implementing 2025 WMP initiative 8.2.3.4 Fall-In Mitigation, Liberty failed to clear or lop and scatter all slash from the lodgepole pine associated with Vegetation Management ID dd7c3473-870a-4832-b101-a88454914001 at coordinates 38.872055, -120.001691. Energy Safety considers this non-performance to be in the Minor risk category. Liberty must complete a corrective action for this non-performance by 12 months from date of this notice.

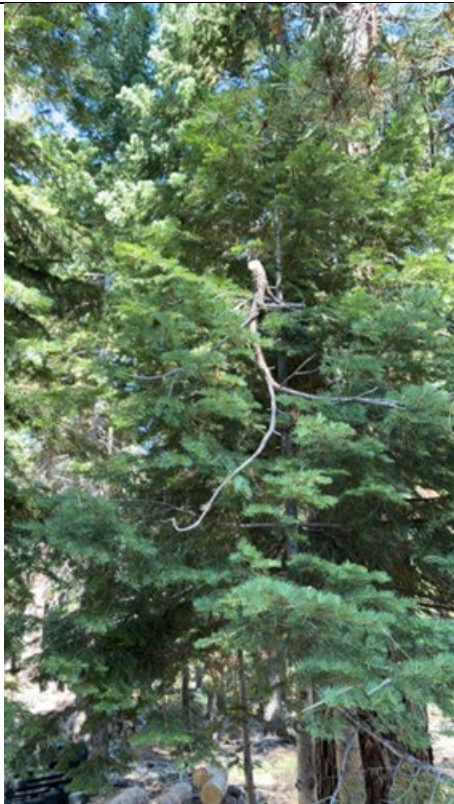
Energy Safety found a “Minor” Adherence to Protocol deficiency at WMP-VM-VFM-06 near pole ID 107489 in HFTD Tier 3. Liberty did not perform its Fall-In Mitigation program (WMP Initiative number 8.2.3.4) as required in the WMP, instead Liberty left a lodgepole pine branch hanging from the tree canopy during its vegetation management activities. Liberty must complete a corrective action by 12 months from the date of this notice.

Energy Safety considers this violation "Minor" because the slash remaining on site poses a low probability of wildfire risk.

**Photo 2:** Cut lodgepole pine branch left in the branches of adjacent trees.

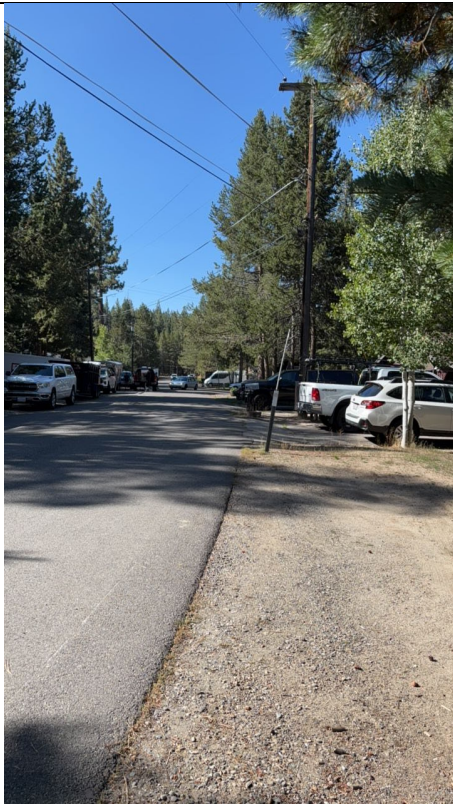
**Photo 3:** View facing southwest from the lodgepole pine down Tam O Shanter Drive towards pole ID 107489.

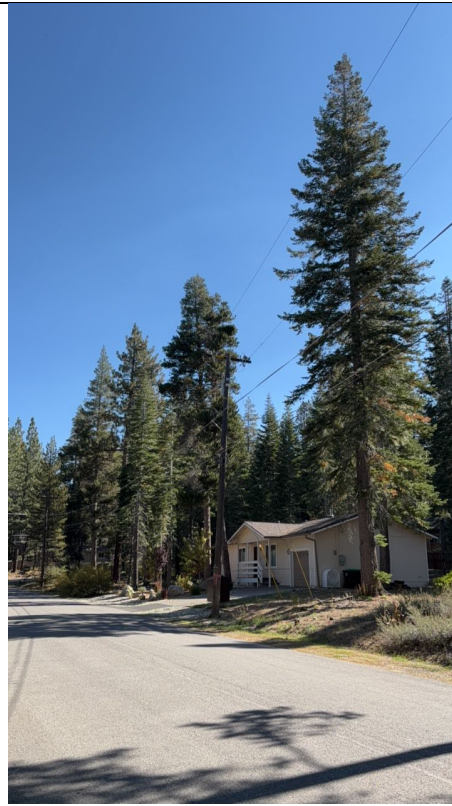
**Photo 4:** View facing northeast from the lodgepole pine down Tam O Shanter Drive towards pole ID 107488.
