NOTICE OF NON-PERFORMANCE

INSPECTION REPORT

Electrical Corporation:	PacifiCorp
Report Number:	NON_ESD_PC_AKM_20250911_1105
Inspector:	Akiko Masuda
WMP Year Inspected:	2025
Quarterly Data Report (QDR) Referenced:	Quarter Q2
Inspection Selection:	Energy Safety inspected the locations based on PacifiCorp’s Q2 QDR.
Relevant WMP Initiative(s):	2025 WMP 8.2.3.1.1 Wood and Slash Management
Date of inspection:	September 11, 2025
City and/or County of Inspection:	City of Sims, Siskiyou County, California

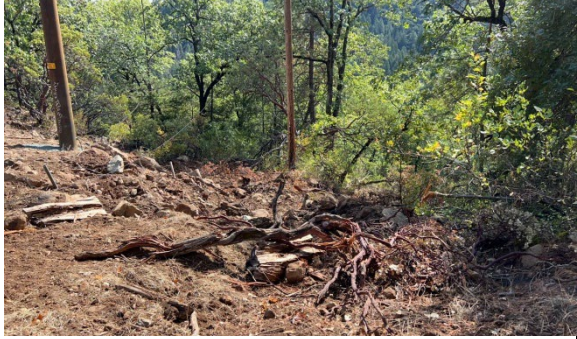
Although the wood and slash did not result from work performed pursuant to Distribution Clearance program's (VM-06 WMP Initiative number 8.2.3.2) vegetation management, the conditions created by the line rebuild construction work create the same fire hazard that PacifiCorp's WMP requires PacifiCorp to mitigate when trimming vegetation. For that reason, Energy Safety finds that leaving the slash in this condition is a failure to perform the work required by the WMP. According to PacifiCorp's Vegetation Management SOP, debris in rural off-road areas must be lopped into lengths no greater than three feet, scattered in piles no more than two feet high, and only stems larger than six inches in diameter should be left on site. The slash pile exceeds these specifications and includes smaller stems, indicating the non-performance with PacifiCorp's WMP and Vegetation SOP.

<p>Photo 5: Closer view of the wood and slash piled and left onsite near the pole. The photo was taken south of the pole.</p>
