## NOTICE OF NON-PERFORMANCE

On September 11, 2025, Energy Safety conducted an inspection of PacifiCorp's WMP initiatives in the vicinity of Sims, California. The inspection report is enclosed herewith. Energy Safety found the following deficiency:

# INSPECTION REPORT

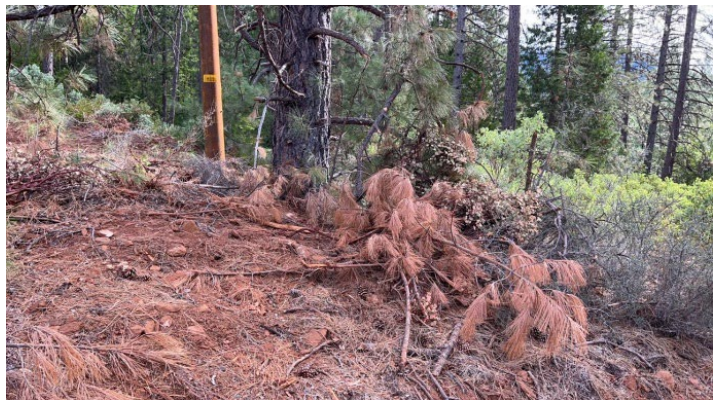
Energy Safety considers this deficiency as "Minor" because the presence of slash creates a potential fuel source for wildfire.

when trimming vegetation. For that reason, Energy Safety finds that leaving the slash in this condition is a failure to perform the work required by the WMP. According to PacifiCorp's Vegetation Management SOP, debris in rural off-road areas must be lopped into lengths no greater than three feet, scattered in piles no more than two feet high, and only stems larger than six inches in diameter should be left on site. The slash pile exceeds these specifications and includes smaller stems, indicating the non-performance with PacifiCorp's WMP and Vegetation SOP.

**Photo 2:** View of the slash left onsite. The photo was taken south of the pole from the dirt road.

Deficiency 1. Energy Safety observed that in implementing 2025 WMP initiative 8.2.3.1.1 Wood and Slash Management, PacifiCorp failed to adhere to its protocol of managing wood and slash near Pole ID 00194900-06237004, Vegetation Management ID DN\_Insp\_2025\_5G97 at coordinates 41.082722, -122.358831. Energy Safety considers this non-performance to be in the Minor risk category. PacifiCorp must complete a corrective action for non-performance by 12 months from date of this notice.

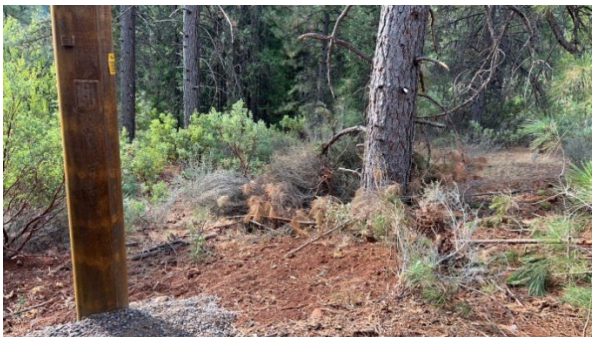
**Photo 3:** View of the slash near pole ID 00194900-06237004. The photo was taken east of the pole.

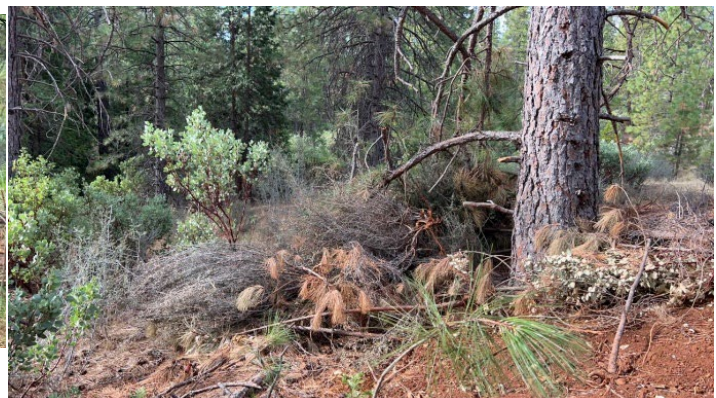
**Photo 4:** Closer view of the slash left onsite, showing a slash pile exceeding two feet in height and three feet in width.
