## NOTICE OF NON-PERFORMANCE

# INSPECTION REPORT

Energy Safety found a “Minor” Adherence to Protocol deficiency at VMP ID DN\_Insp\_2025\_5G99 near pole 06236005-335001 in HFTD Tier 2. PacifiCorp did not perform its Wood and Slash Management (WMP Initiative number 8.2.3.1.1) as required in the WMP and section 2.4.3 Debris Disposal in the Vegetation SOP, which is documented in Exhibit B. This resulted in accumulations of wood and slash left onsite. PacifiCorp must complete a corrective action by 12 months from date of this notice.

| Report Number: | NON_ESD_PC_AKM_20250911_1055 |

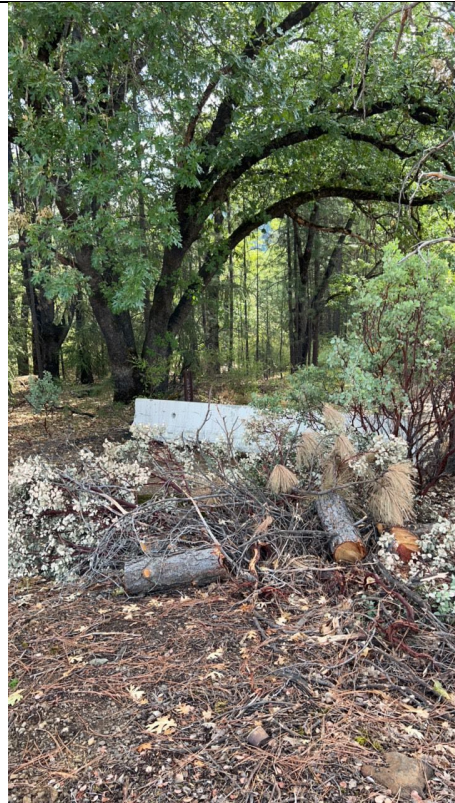
**Photo 2:** View of wood and slash against manzanita brush and near a concrete barrier along a dirt road. The photo was taken facing northeast from the pole.

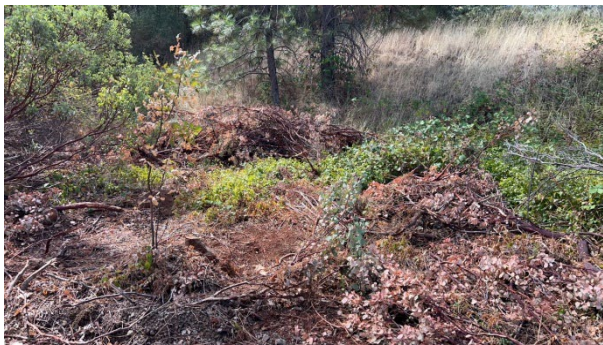
**Photo 3:** View of slash from a manzanita left onsite north of the pole along the road. The photo was taken facing south from the pole.

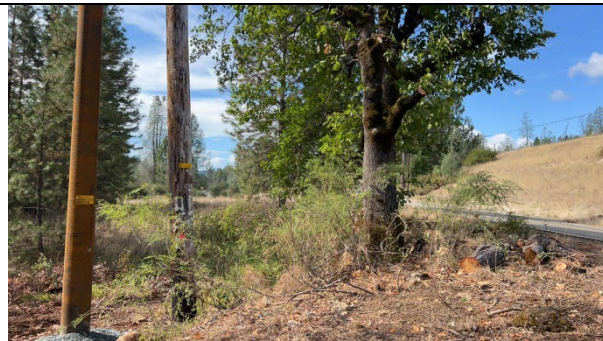
**Photo 4:** View of wood and slash left onsite between the pole and the road, piled around the

| | trimmed oak tree. The photo was taken north of the pole. |

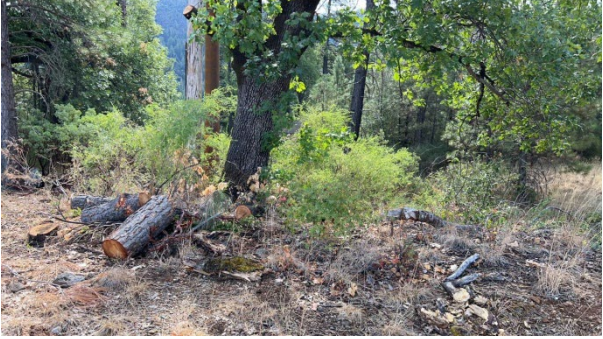
| <b>Photo 5:</b> Closer view of the wood and slash piled onsite near the trimmed oak tree. The photo was taken west of the pole. | |
