**Subject:** Liberty's Response to Notice of Violation – NOV\_CAD\_LU\_CYA\_20250508\_1021

**Finding:** Failure to remove tree attachment.

| Notice | Violation # | Structures |
|---|---|---|
| NOV_CAD_LU_CYA_20250508_1021 | Violation 1 | 81315 |

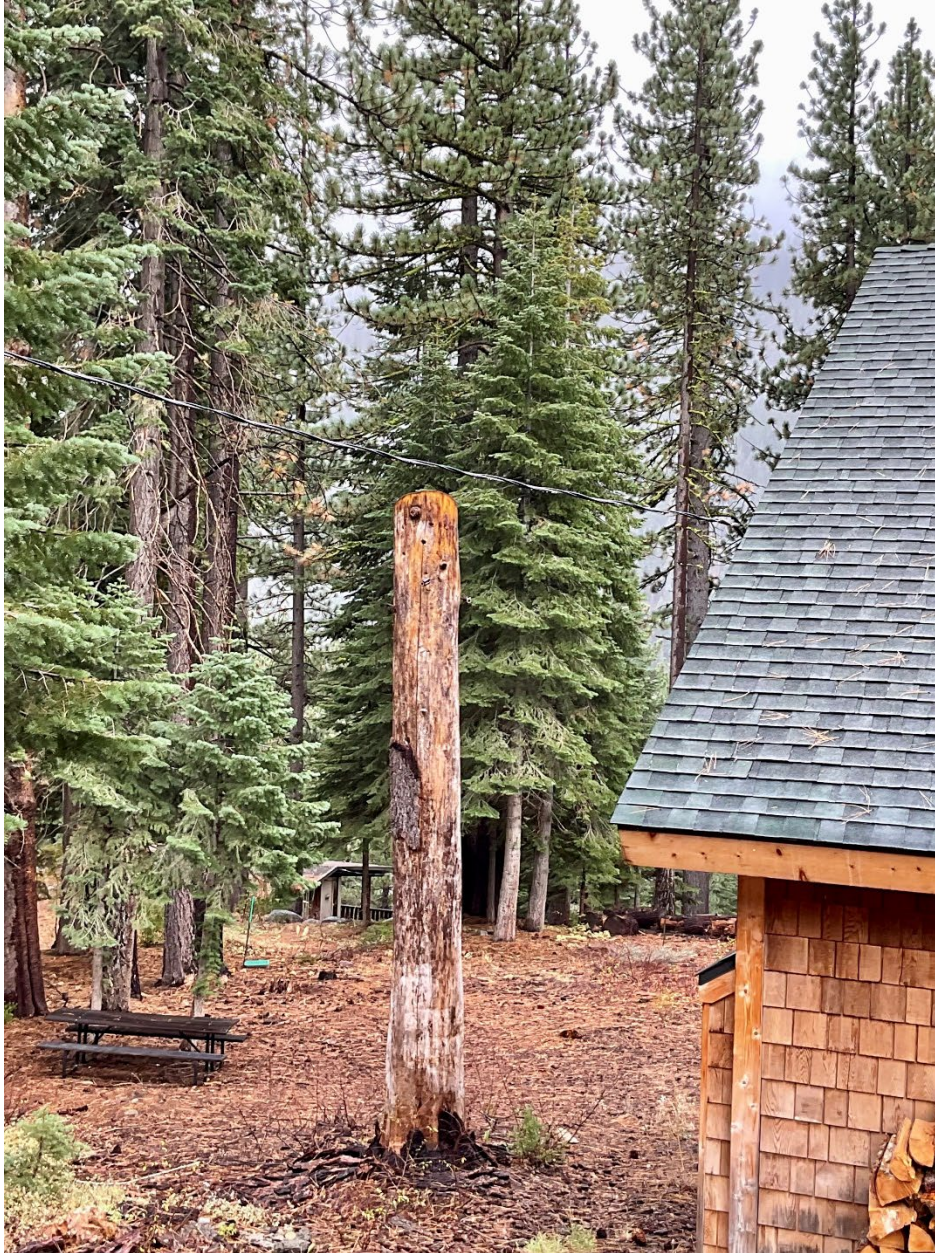
Liberty disagrees with Energy Safety's observation that it failed to complete the removal of a tree attachment at the pole ID 81315 location. Liberty did complete that tree attachment removal as reported in its Quarter 3 2024 WMP quarterly data report. It is possible that Energy Safety's observation was of other tree attachments in the vicinity. Additionally, Liberty replaced the removed tree attachment with a midspan connection and not a new pole. The following photo identifies the completed work at the pole ID 81315 location, showing the dead tree from which the reported tree attachment was removed.
